Issued May 26, 2023

MIR-23-10

## Contact of Cruise Ship *Radiance of the Seas* with Sitka Sound Cruise Terminal Pier

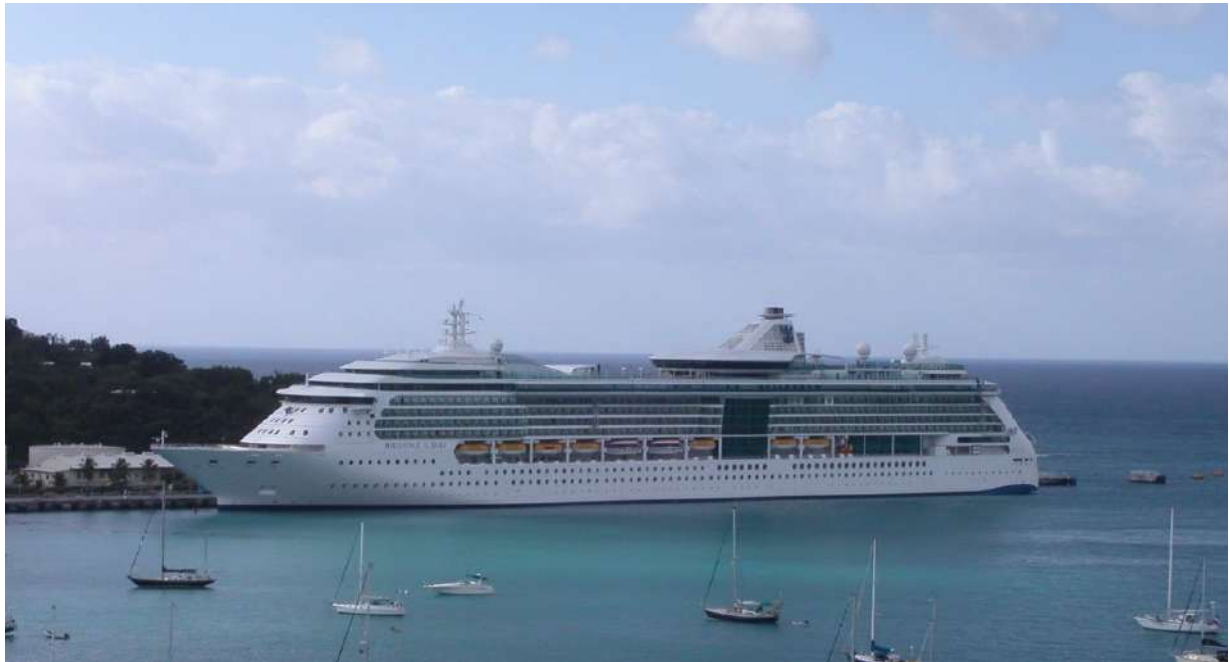
**Figure 1.** *Radiance of the Seas* before the casualty.

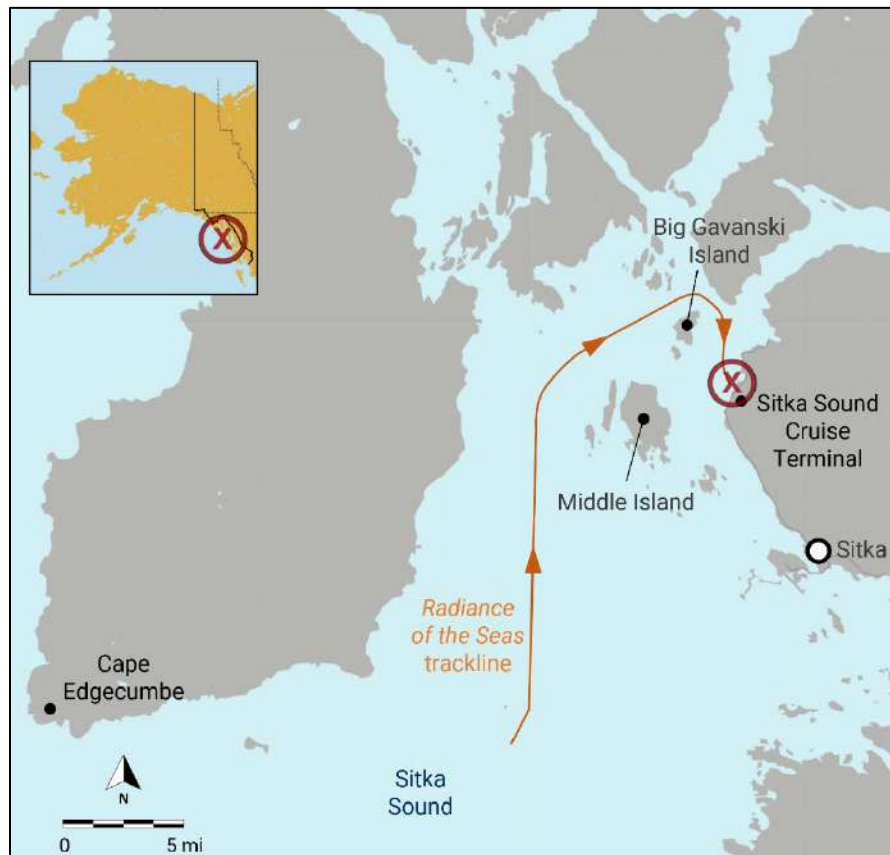
**Figure 2.** Area where *Radiance of the Seas* contacted the Sitka Sound Cruise Terminal mooring dolphin, as indicated by a red X. (Background source: Google Maps)
