CHIRP

An independent and confidential
reporting system for the Maritime industry

Annual Digest of Reports and Insight Articles 2022

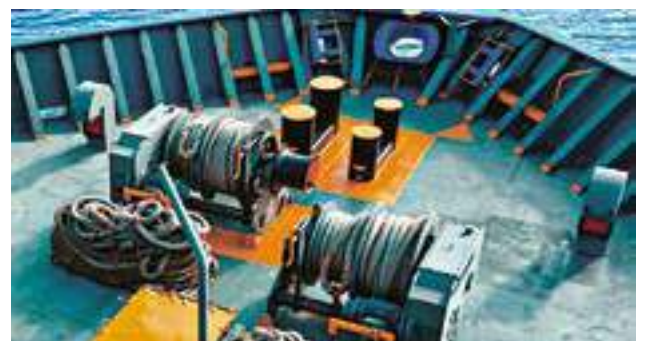
An ordinary seaman (OS) eased the tug's mooring rope out through the closed chock (Panama lead) and had taken a turn of the messenger rope around the bits. As the tanker turned to starboard to align itself with the berth the tug's line was in the water and as the separation between the tanker's bow and the tug increased, the messenger line paid out at an increased speed which was not anticipated by the line handlers.

The officer in charge of the mooring operation warned the OS to step clear from the messenger rope. The OS attempted to do so but slipped on the deck and became entangled with the rope which dragged him overboard through the Panama chock. The OS was recovered from the water by the tug and resuscitation and first aid was immediately administered until the ambulance took them to hospital. Tragically the OS died the next day.

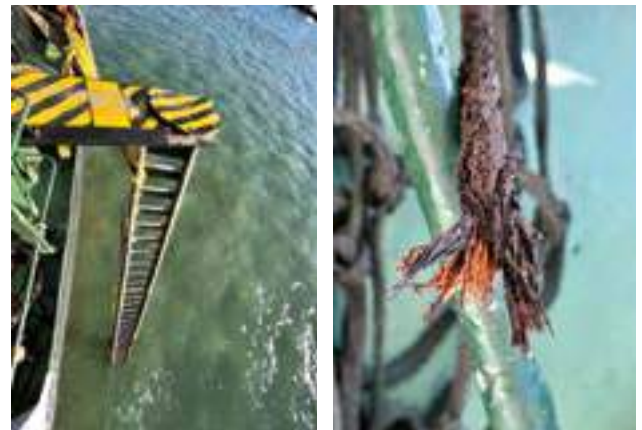
SOLAS regulation II-1/3-9 states that all wires used to support the means of embarkation and disembarkation shall be maintained as specified in SOLAS regulation III/20.4 which states that falls should be 'renewed when necessary due to the deterioration of the falls or at intervals of not more than 5 years, whichever is the earlier'.

Reducing the periodicity for changing the falls to between 18 and 30 months for vessels that have accommodation ladders in these exposed areas should be considered, as should changes to the design for securing the falls. However, thorough maintenance must always be provided to the wires, sheaves and fixtures no matter how difficult the access to the wires may be.

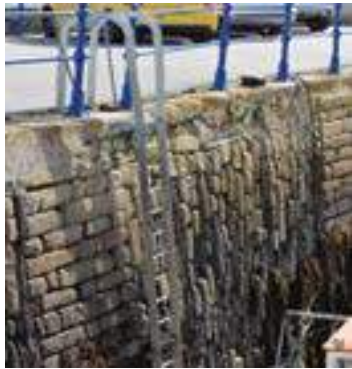
A fisher returned to their vessel with a guest in the late evening after they had met ashore. Both had drunk alcohol. It was low tide, and the vessel was approximately 6m below the quay edge due to the tidal range in that port.

As they climbed down the vertical quayside ladder, the guest fell off the ladder and hit the vessel's hull before falling, injured, into the water. The sea temperature was approximately 10° C (50° F).

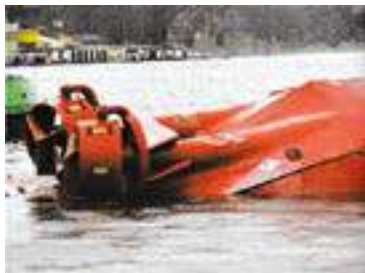
A tug had been engaged to assist a RO-RO passenger ferry in berthing in high winds. The ferry's master held a pilotage exemption certificate for the port, so no pilot was embarked. The tug was manoeuvring close to the port bow of the

ferry and attempting to connect a tow line when its stern collided with the ferry's bulbous bow, where it became pinioned, heeled to port and took on water. This caused the tug to capsize, resulting in the loss of 2 crew.

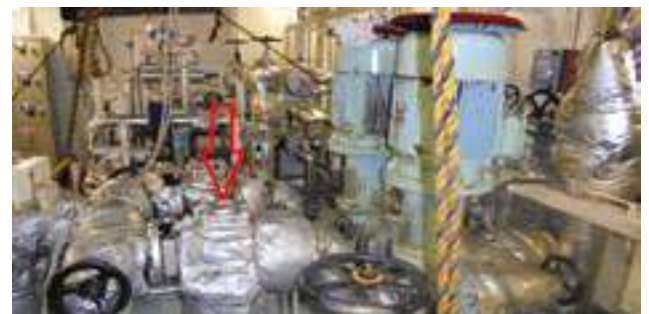
Personal Injury: Multiple crew burns in engine room

An engine crew suffered burns from the fuel oil pump of the auxiliary boiler

Risk Category/Severity: High (2 LWC Lost Workday Case, 1 RWC Restricted Workday case, 1 FAC First aid case)

The reporter told us that the chief engineer held the daily meeting at 8 am to discuss the work plan for the day with the senior engineer and the rest of the engine officers and crew. Among others, the inspection and maintenance of the auxiliary boiler's No1 fuel oil pump filter was discussed. A Toolbox meeting was held regarding the precautions and hazards associated with the maintenance work.

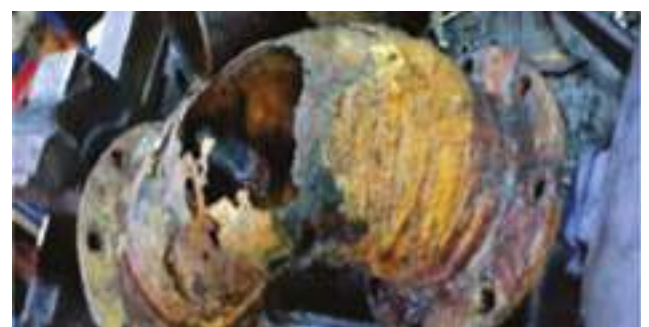
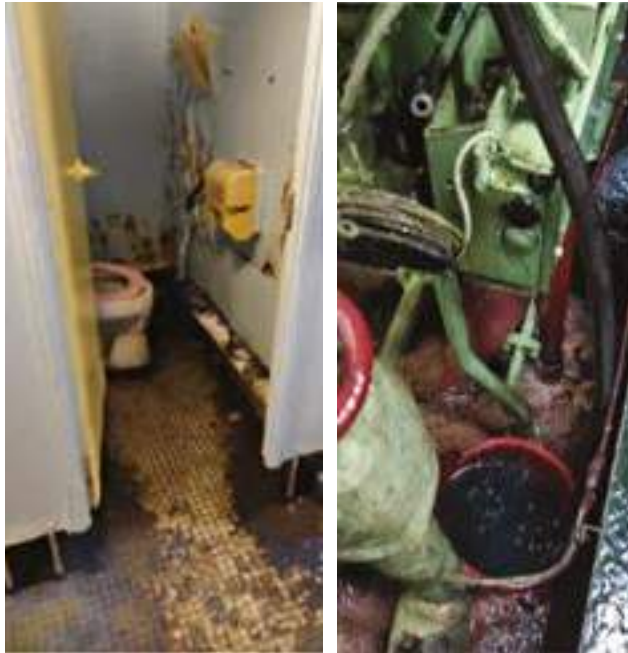
M2028 (submitted by ISWAN)

Enforcement of safety regulations – is it adequate?

A seafarer complained about awful working conditions on board their ship. The accommodation was unhygienic, food was insufficient, and the equipment was in disrepair: the main engine and gearbox leaked oil, and the seafarer claimed that oil and garbage were frequently discharged overboard. The air conditioning was also broken.
