**M/V “EVER GIVEN”**  
**IMO No. 9811000**  
**R-026-2021-DIAM**  
**CASUALTY DATE: March 23<sup>rd</sup>, 2021**

**MARINE SAFETY**  
**INVESTIGATION REPORT**  
**GROUNDING**  
**OF**  
**MV EVER GIVEN**  
**AT**  
**SUEZ CANAL EGYPT**  
**ON**  
**MARCH 23, 2021**

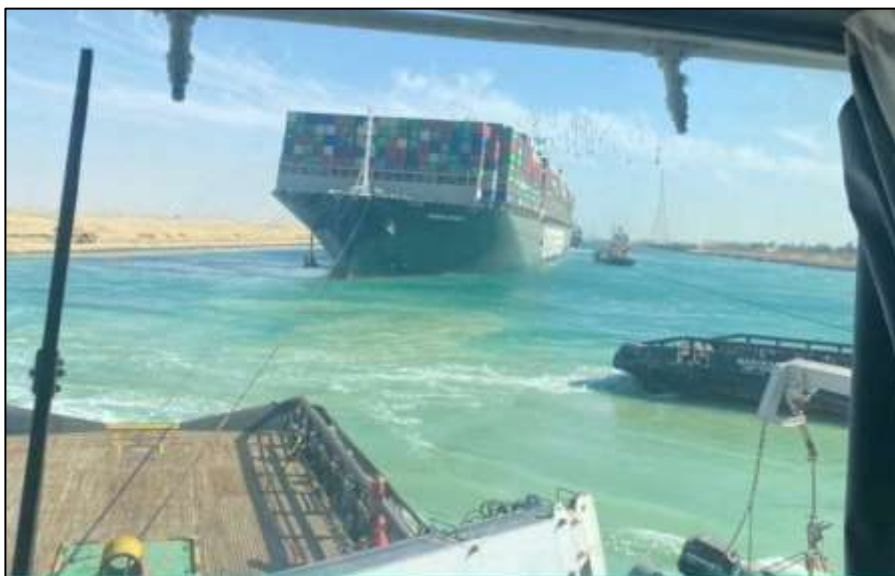
**FIGURE 10: M/V EVER GIVEN PULLED FREE**

On **29 March 2021**, the stern of M/V EVER GIVEN was refloated at **04:30 HRS / LT** and on **15:05 HRS / LT** local time the ship was pulled free, and was towed to the Great Bitter Lake for inspection.

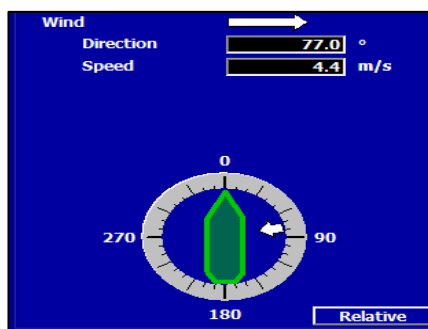
FIGURE 12: Wind Indicator - (Source: Extracted from VDR data)

Vessel's wind speed and direction indicator were properly connected on VDR, without any error alarms.

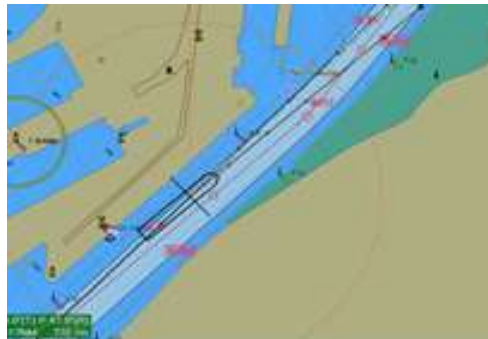
**Important Event**

The loss of steering control likely started in this moment due to the Bank Effect  
 The South wind pushing the vessel towards the portside bank of the canal.

<b>Key Issues</b>	No any alarm
<b>Relat. Wind Direction/Speed</b>	084°/7.0 m/s
<b>Speed (STW)</b>	6.6 kts
<b>Depth</b>	12 m
<b>Heading</b>	047°8

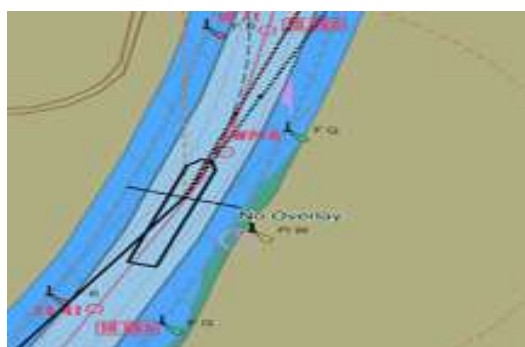
**Important Event**

The **swinging** between starboard side and portside banks of the canal already started.

<b>Key Issues</b>	No any alarm Extreme Steering angles
<b>Relat. Wind Direction/Speed</b>	<b>155°/12.1 m/s</b>
<b>Speed (STW)</b>	<b>10.4 kts</b>
<b>Depth</b>	<b>11.5 m</b>
<b>Heading</b>	<b>015.1°</b>

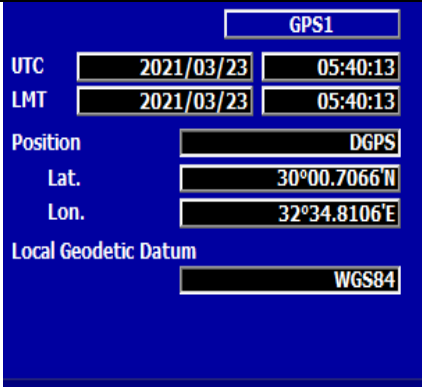
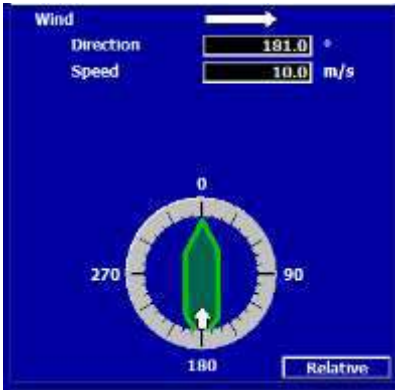
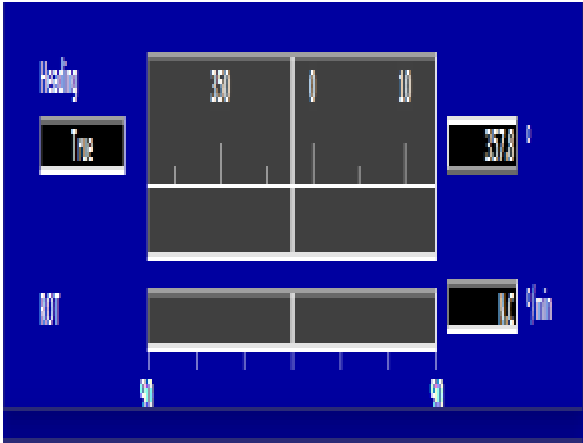
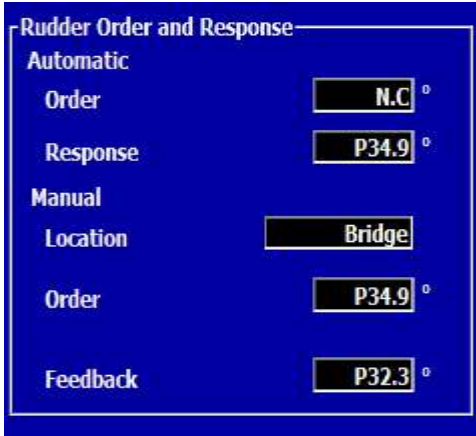
Date/Time: 23.03.2021/05:40 UTC  
Event: Transiting Suez Canal

<p>Analysis from: 05:37 hrs UTC, to 05:40 hrs UTC Navigation:</p> <ul style="list-style-type: none"> <li>Recording started at 00:00:00 UTC</li> <li>All data available from 00:00:00 UTC onwards.</li> <li>At 0511 hrs (UTC) entering Suez Canal</li> </ul>	
<b>Key Issues</b>	No any alarm
<b>Important Event</b>	None
<b>Relat. Wind Direction/Speed</b>	<b>181°/10. m/s</b>
<b>Speed (STW)</b>	<b>10.6 kts</b>
<b>Depth</b>	<b>12.5 m</b>
<b>Heading</b>	<b>357.8°</b>

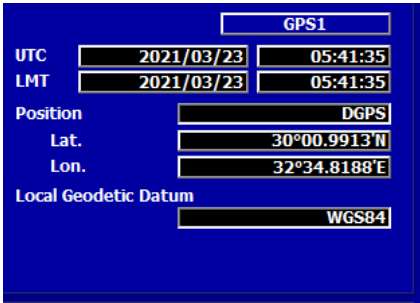
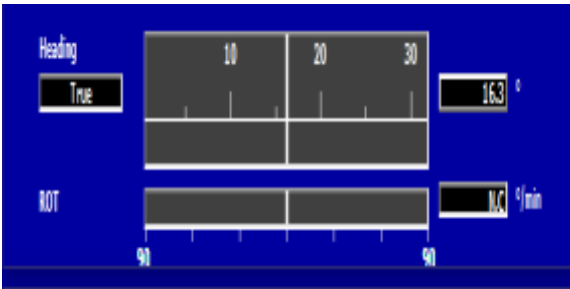
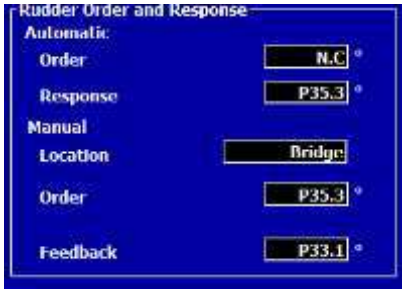
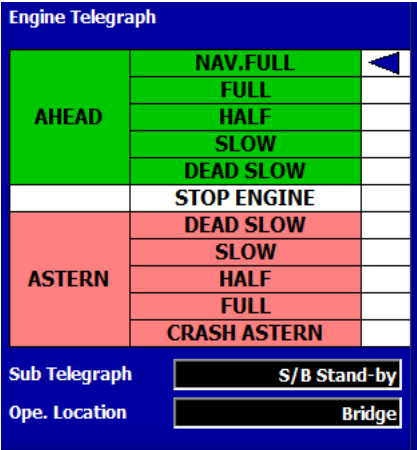
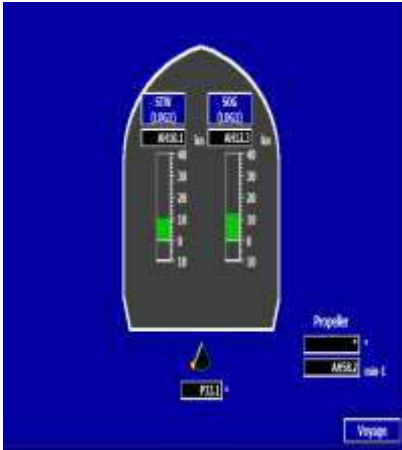
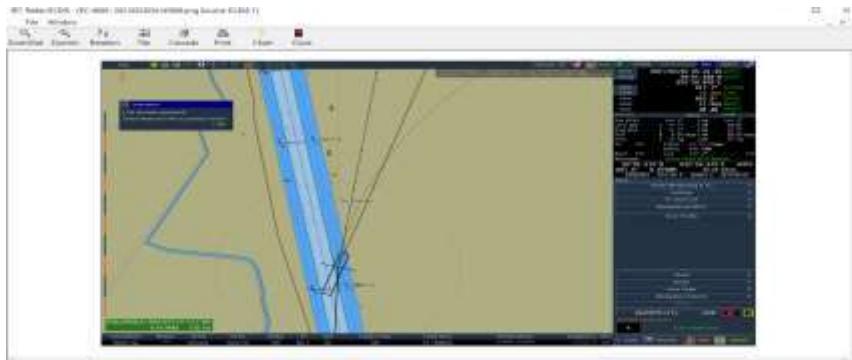
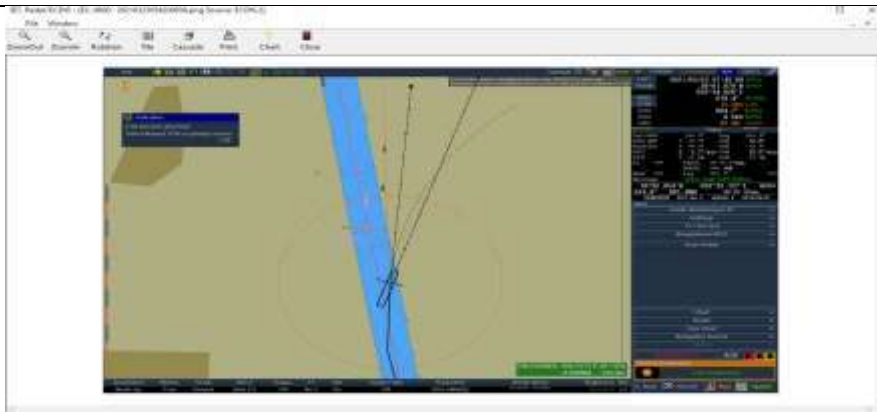
Date/Time: 23.03.2021/05:41 UTC  
 Event: Grounding

<b>Key Issues</b>	No any alarm Extreme Steering angles
<b>Relat. Wind Direction/Speed</b>	<b>152°/10.8 m/s</b>
<b>Speed (STW)</b>	<b>10.1 kts</b>
<b>Depth</b>	<b>2.5 m</b>
<b>Heading</b>	<b>016.3°</b>

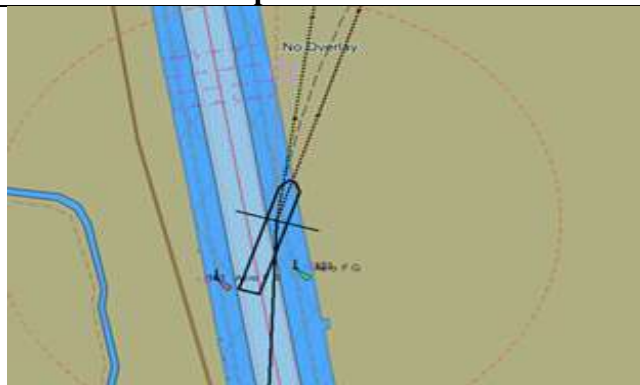
After the last swinging movement vessel runs **aground**
