Report on the investigation of the  
engine room fire and subsequent fatality on board  
the liquefied petroleum gas/ethylene carrier

***Moritz Schulte***

in Antwerp, Belgium

on 4 August 2020

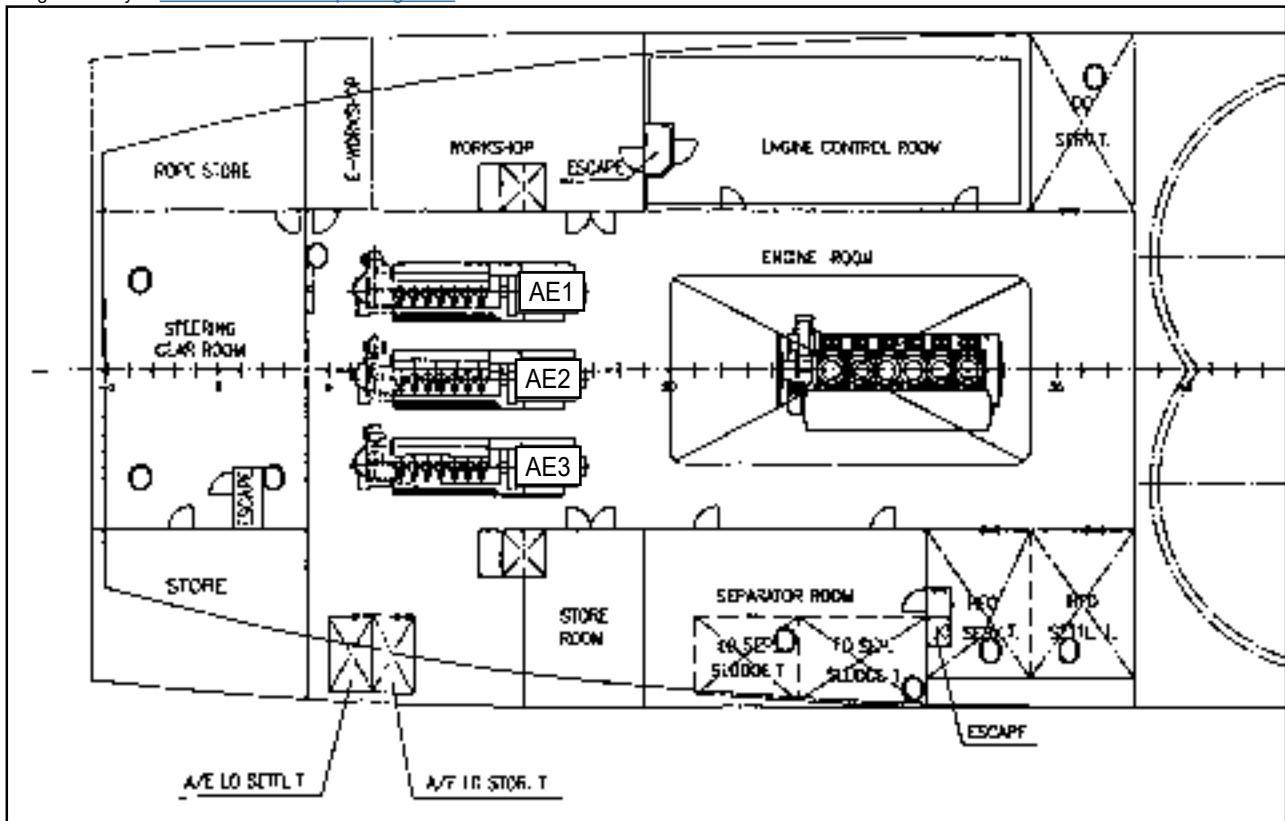
**Figure 1:** A Platform and engine control room

Between about 0800 and 0815, the ER team gathered in the engine control room (ECR) on the port side of A Platform (**Figure 1**) for a routine toolbox talk to discuss the jobs for that day. The team comprised the second engineering officer (2/E), third engineering officer (3/E) Rajendra Naidu Ponnada, the fourth engineering officer (4/E), who was also the duty engineering officer, the electrical technical officer (ETO), a fitter and an ER wiper. The chief engineering officer (C/E), although not directly involved in the meeting, was also in the ECR inputting information into the machinery planned maintenance system (PMS). The vessel's two gas engineers did not participate in the meeting.

A Platform (**Figure 1**) was an extended mezzanine deck that surrounded the upper part of the main engine, extending aft to AE1, AE2, AE3 and the SG room.

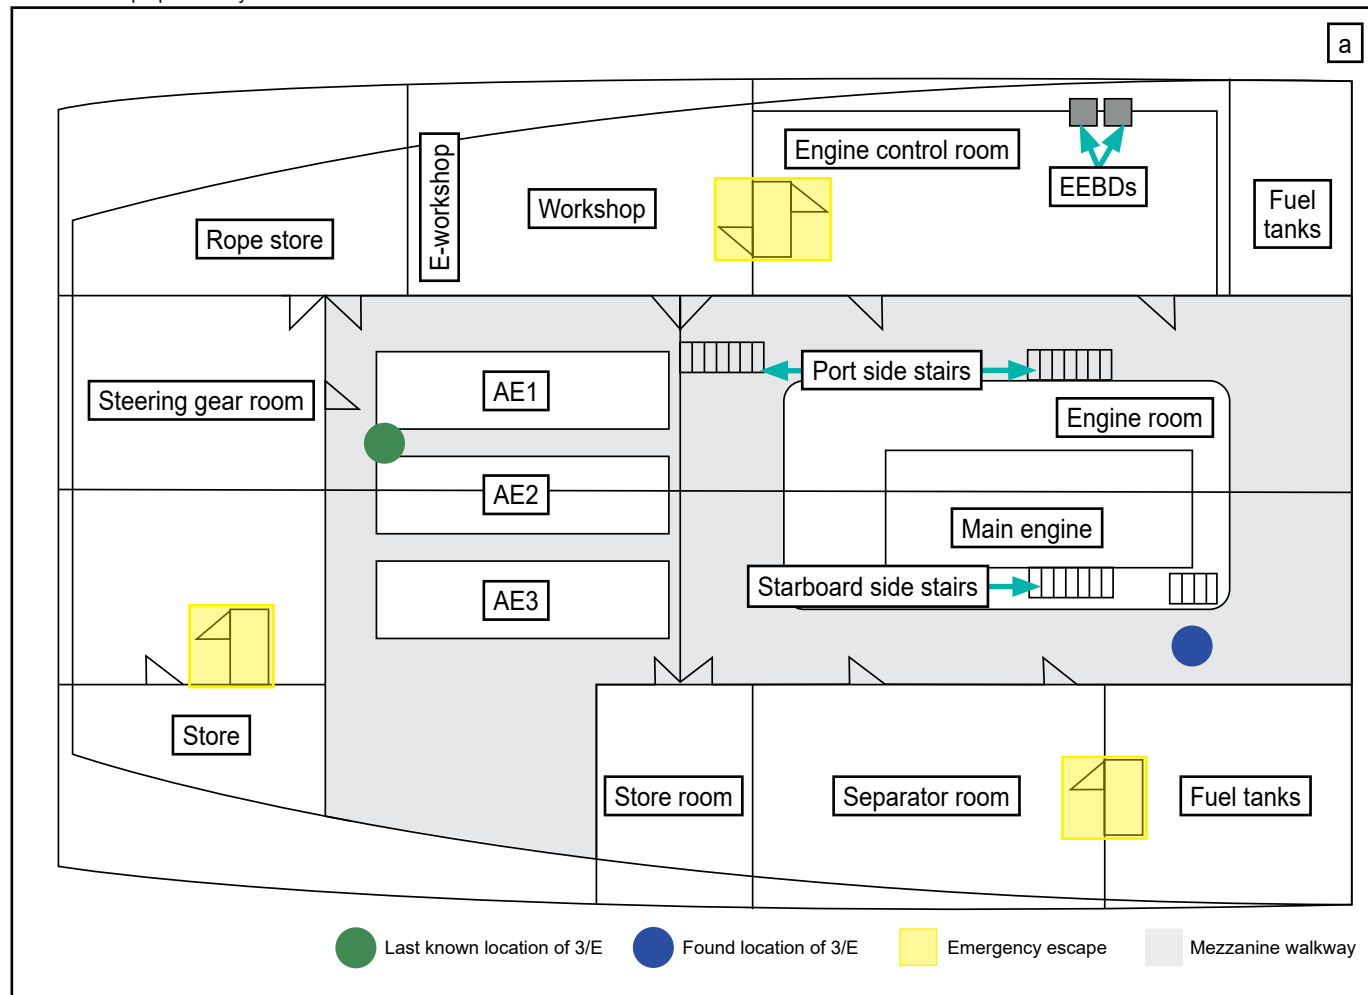
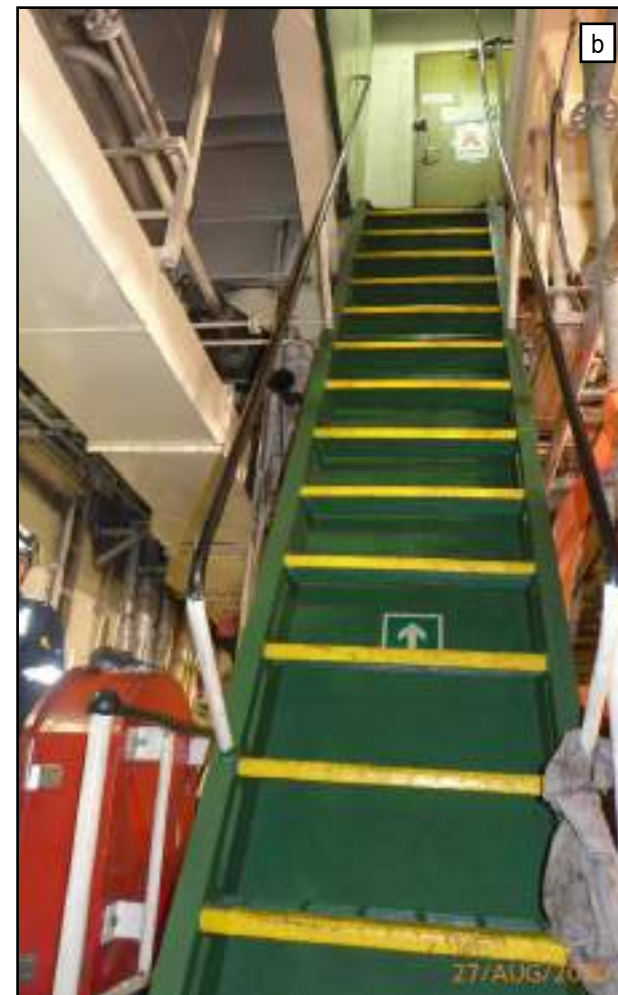
**Figure 7:** A Platform (a) and port side stairs leading to main deck (b)

The wiper heard the fire alarm from inside the workshop and, looking outside, saw thick black smoke. He escaped to the muster station via the port side main stairs (**Figures 7a and 7b**) instead of the workshop's emergency escape, holding his breath and using the handrail for guidance. He did not see any flames or the 3/E.

On the port side of the ER an enclosed escape trunking containing a vertical steel ladder extended from a combined workshop and ECR entrance up to the main deck (**Figure 7a**).

On the starboard side of the SG room an enclosed escape trunking containing a vertical steel ladder extended up to the poop deck (**Figure 7a**).

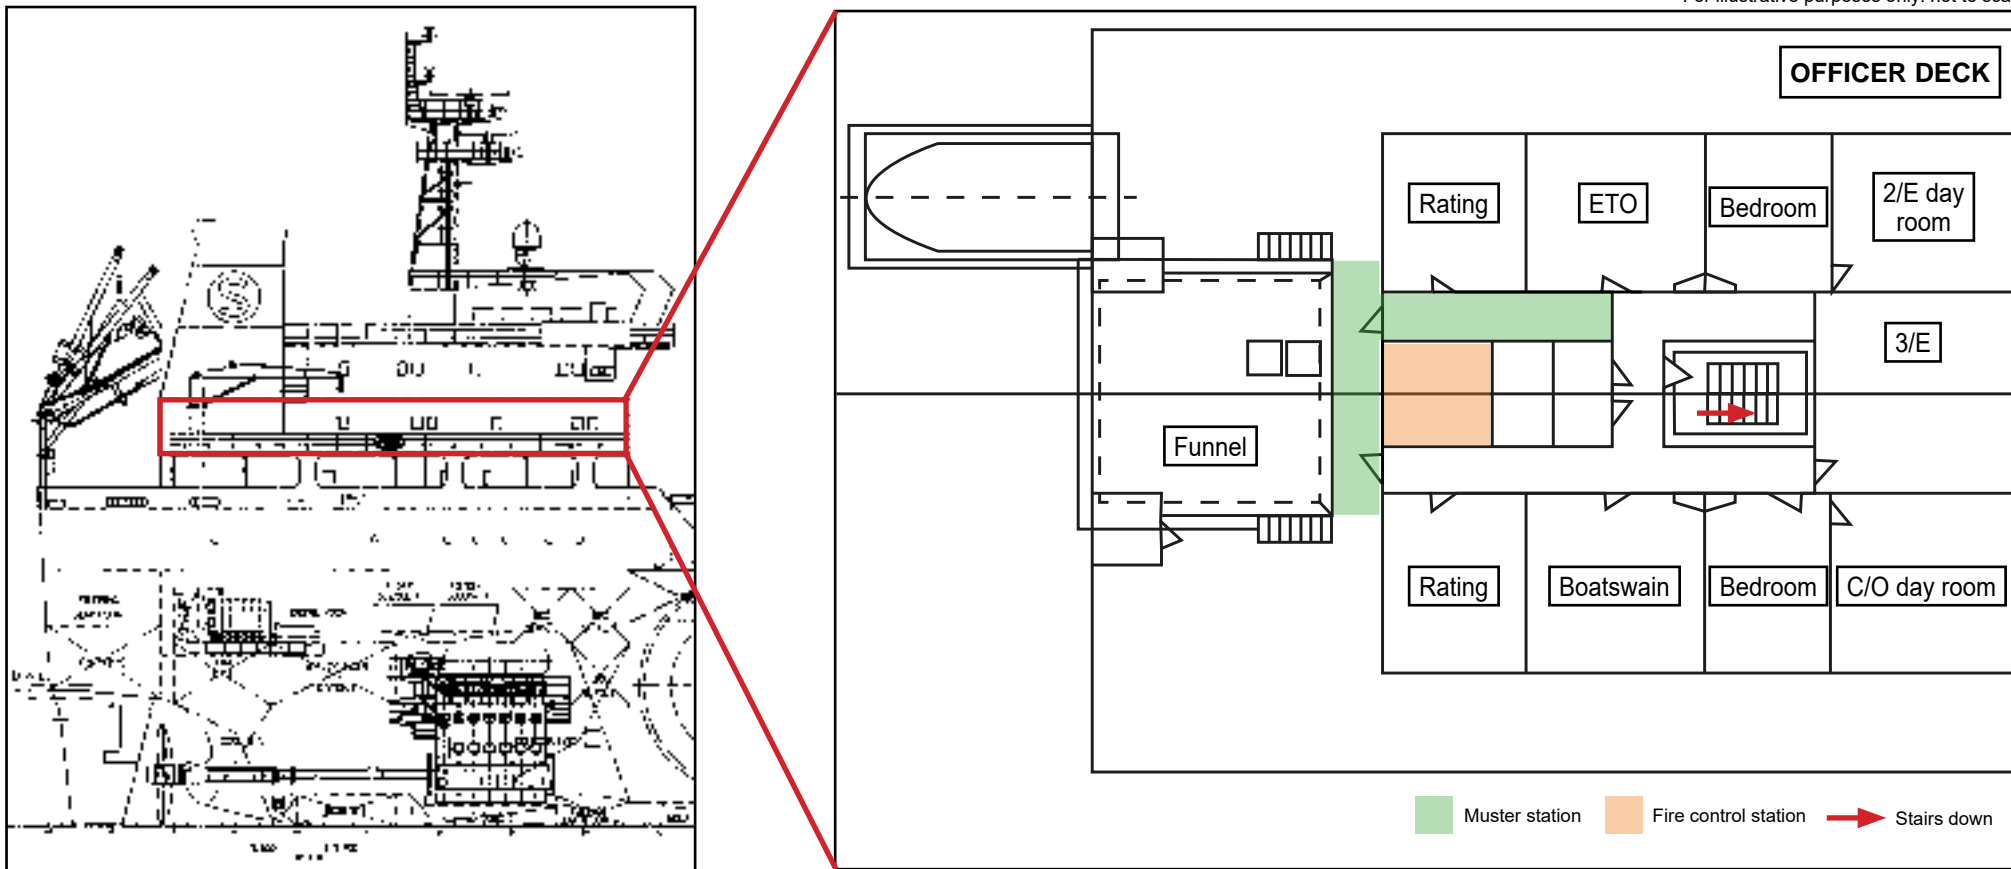
Figure 8: Muster and fire control station location

At 0918, the ER fire alarm sounded, which resulted in an immediate emergency shutdown of cargo discharge operations. The 4/E heard the fire alarm and went up to A Platform. Looking aft, he could see thick black smoke in the auxiliary engine (AE) area of the vessel. He held his breath and used the port side stairs (**Figures 7a and 7b**) to escape from the ER through the smoke. Outside the ER main entrance on the crew alleyway, he stopped the fitter who was about to enter the ER. The 4/E arrived at his muster station (**Figure 8**) on the officers' deck and informed those already present that he had last seen the 3/E near AE1.

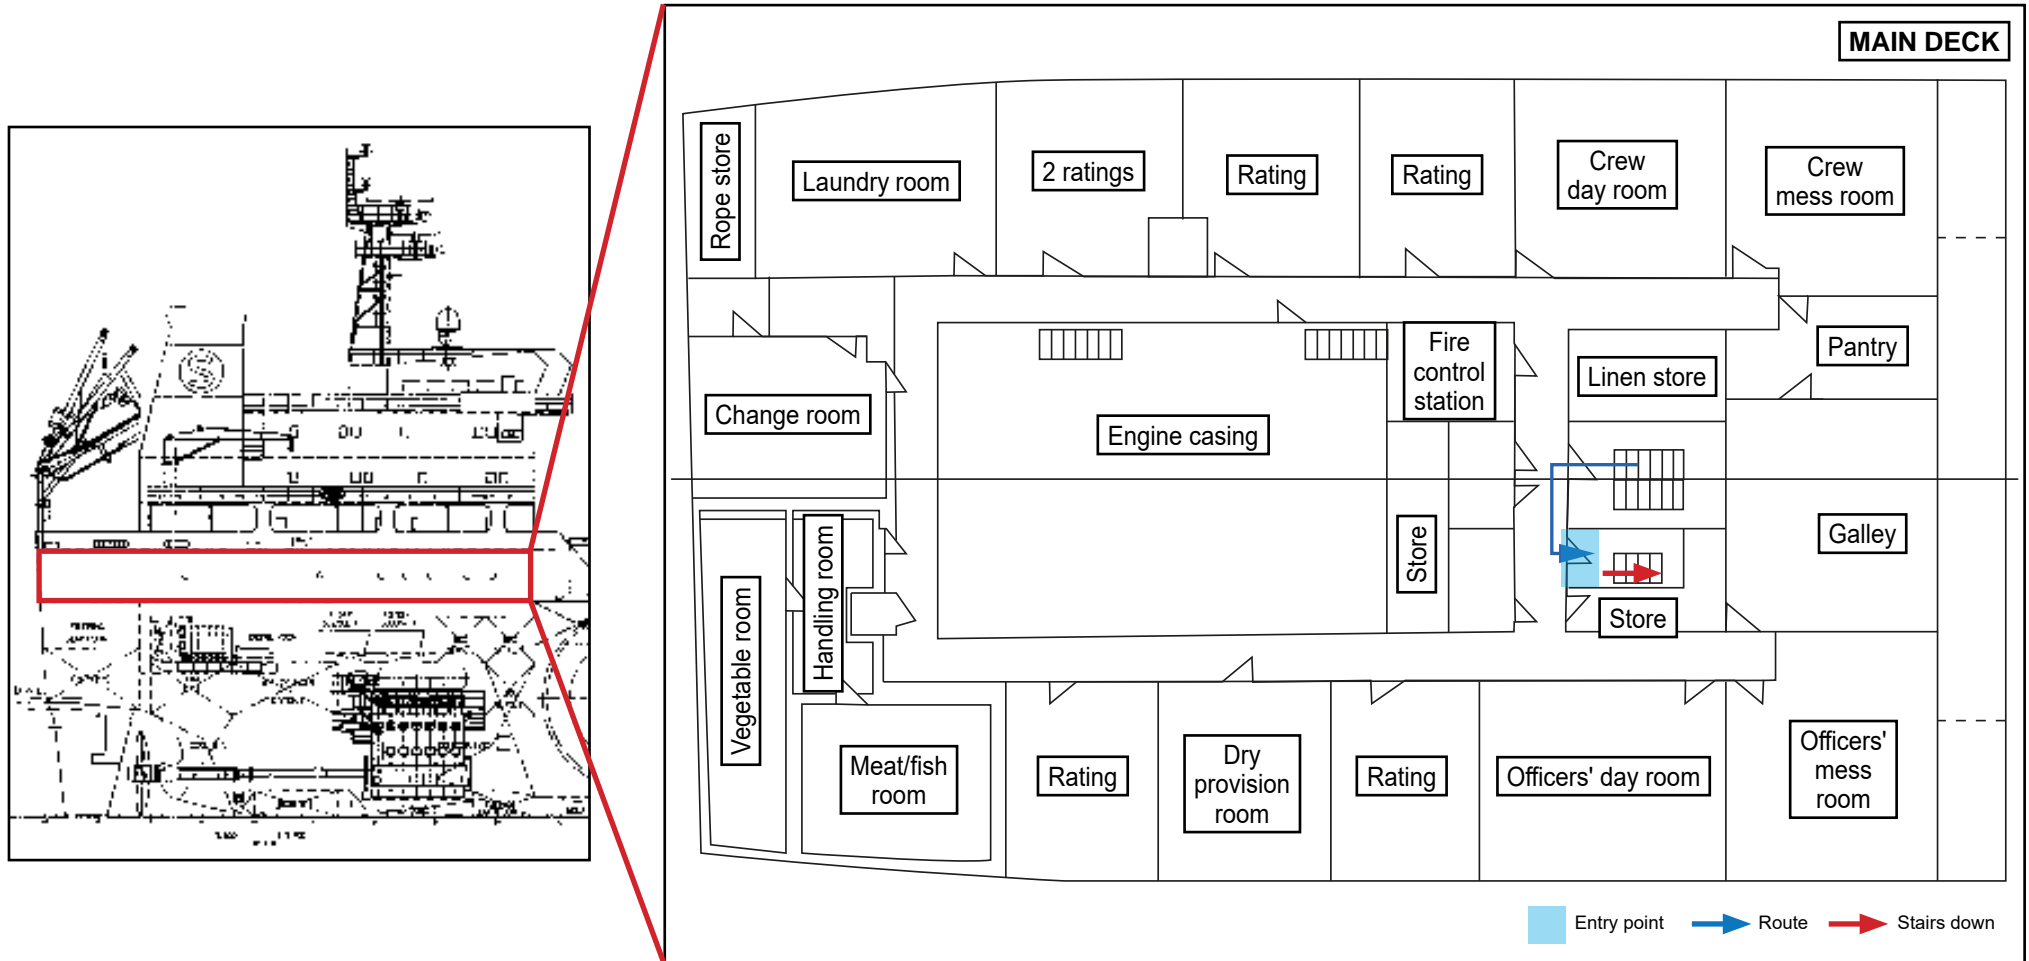
Figure 9: Third attempted entry from secondary entrance near officers' day room

At 0944, the 2/E decided to lead the search and rescue team and he and the fitter, who had replaced his BA cylinder, entered the ER via the secondary entrance near the officers' day room (**Figure 9**). The 2/E, connected to a lifeline, descended the starboard stairs to A Platform. In thick smoke, and with no visibility, the 2/E and the fitter turned and followed the starboard walkway aft past the separator room and towards AE3 (**Figure 10**). The 2/E found that AE3 was still running and stopped it locally from its aft end. Through the smoke, the 2/E could see small flames under the turbocharger at the aft end of AE2 and used a CO<sub>2</sub> fire extinguisher to put these

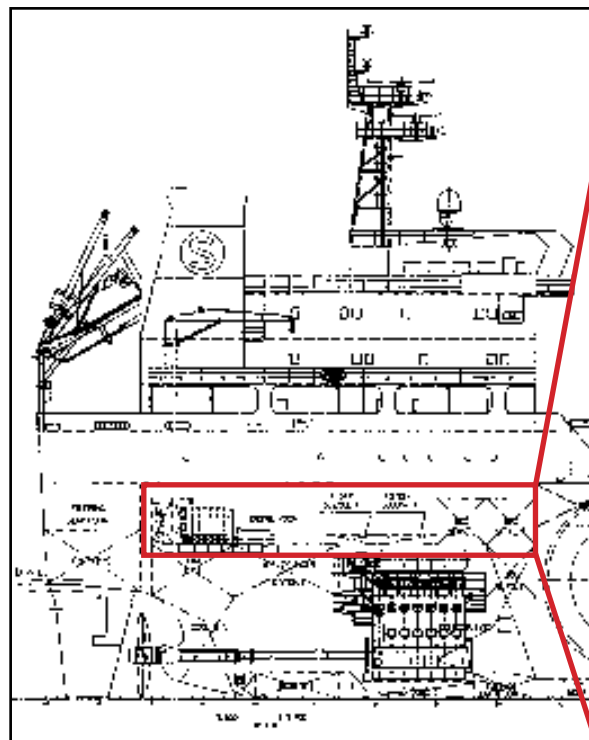
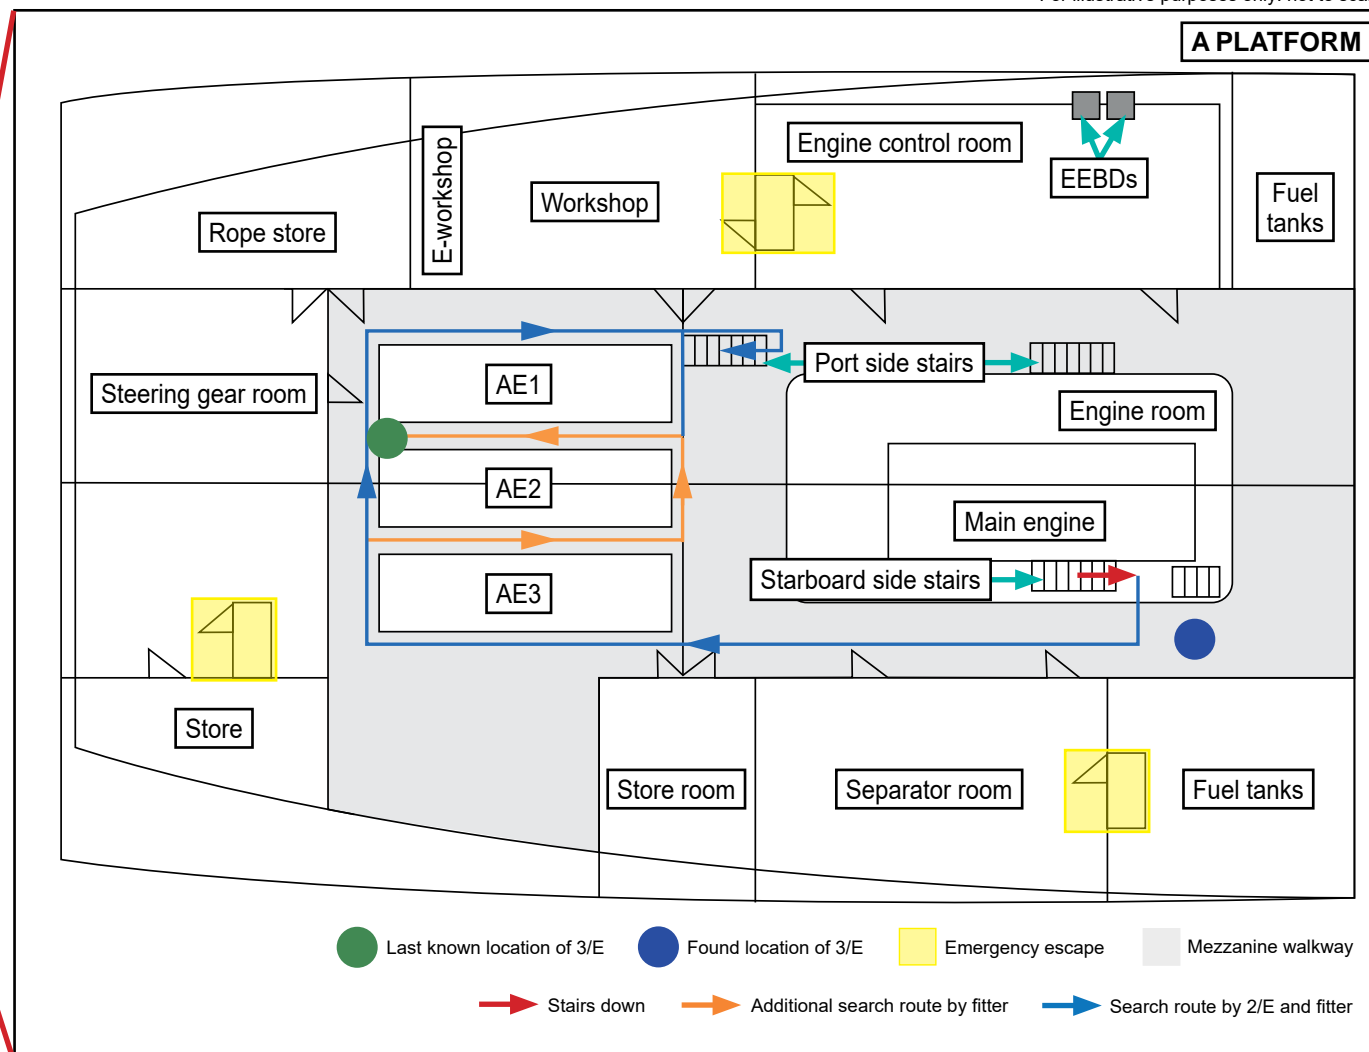
Figure 10: Second engineer's route from starboard access stairwell

out before he walked around AE1. Meanwhile, the fitter walked between AE2 and AE3 and then around the forward end of both AE2 and AE1, meeting the 2/E at the aft end of AE1.

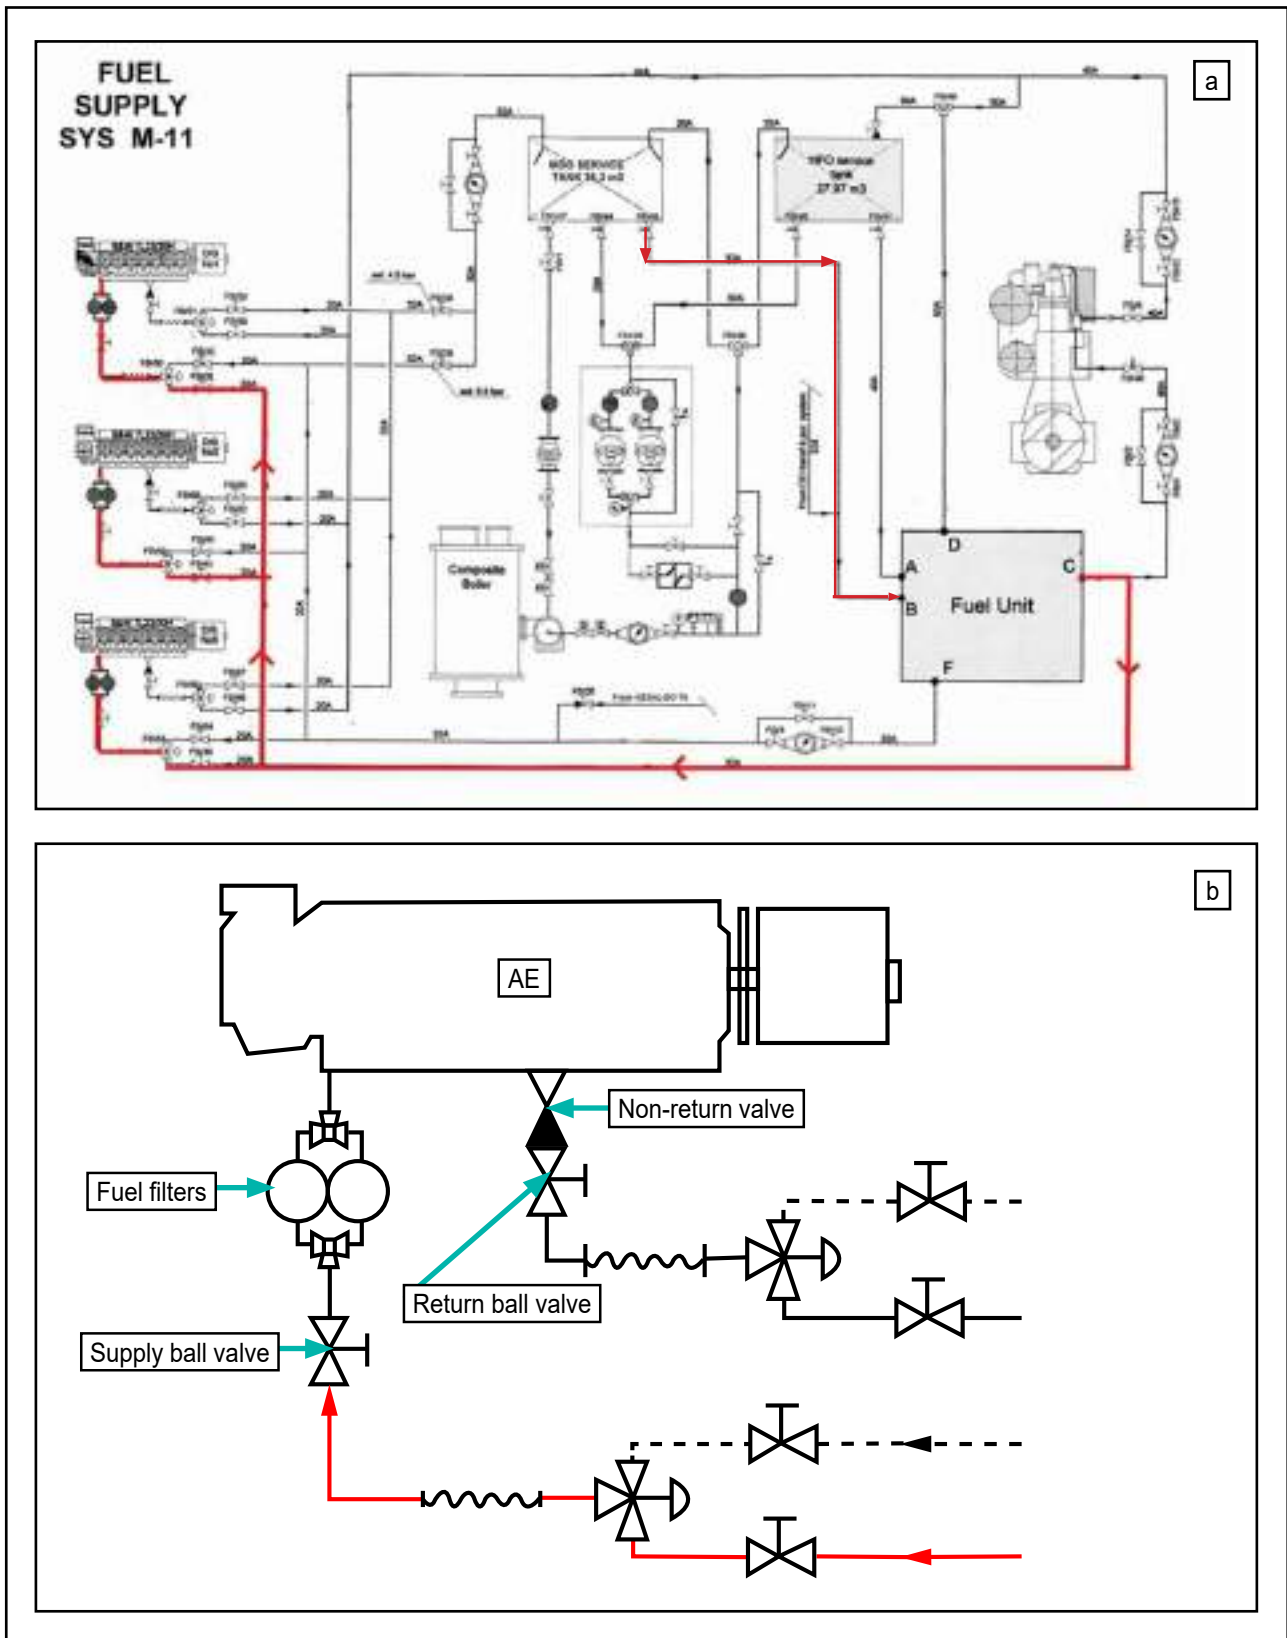
**Figure 13:** Fuel supply from MGO service tank to AE via fuel unit (a) and fuel supply to AE (b)

From the MGO service tank the fuel entered the fuel unit, which boosted and filtered the fuel (**Figure 13a**). The final filtration was provided by the AEs' engine-mounted duplex fuel filters. Isolating ball valves were fitted to the fuel supply and returns for each engine and non-return valves were also fitted to the return lines (**Figure 13b**).

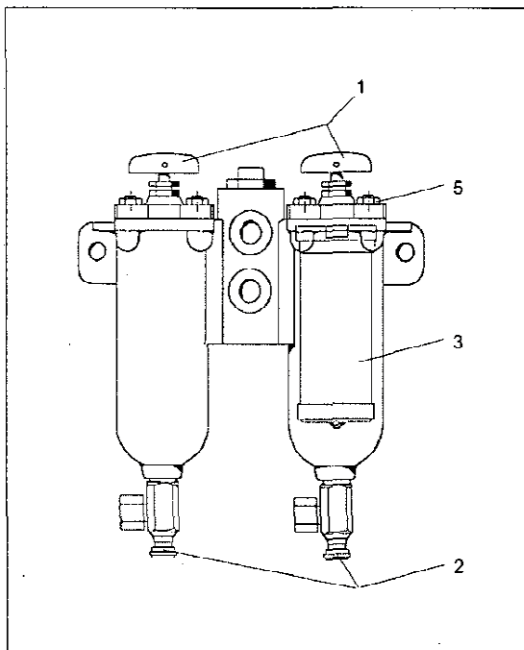
Fig 1 Fuel oil split filter

2) Normally the filters are cleaned during operation by turning the handle, (1) see fig 1, on the filter housing top a couple of turns. (clockwise).

Simultaneously with turning of the handle, the drain cock, (2) in bottom of the filter housing should be opened in order to drain of the dirt being scraped of the filter element, (3).

**Note:** Shut-off fuel oil, before dismantling filter element.

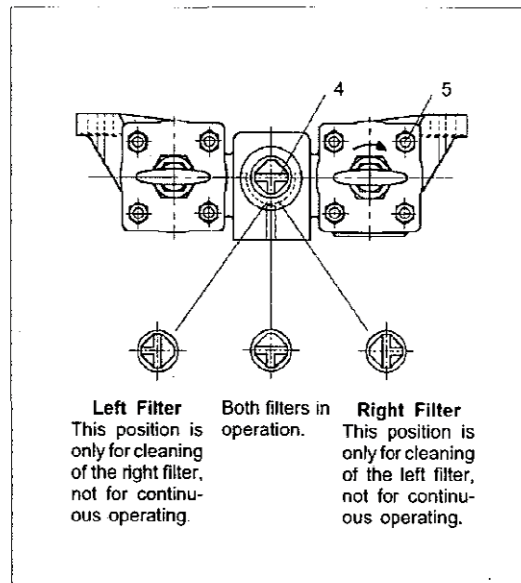
Fig 2. Fuel oil split filter (top view).

3) Position of three way cock, see fig 2.
