Report on the investigation of the collision
between the general cargo vessel
Scot Carrier
and the split hopper barge
Karin Høj
resulting in the capsizing of the barge with two fatalities
in the Bornholmsgat traffic separation scheme, Sweden
on 13 December 2021

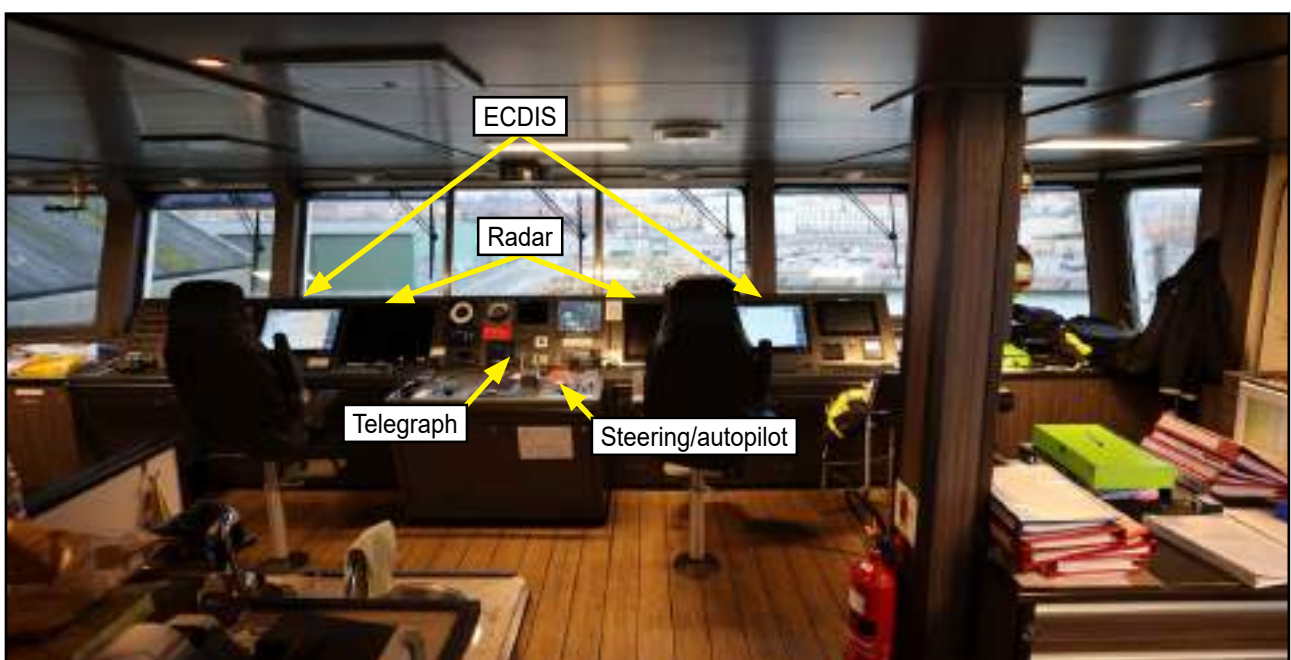
Figure 3: *Scot Carrier*'s bridge, showing displays and course and engine controls

Scot Carrier was heading 240° with autopilot engaged and making a speed of about 12 knots (kts). Both Electronic Chart Display and Information System (ECDIS) displays were in use, and the radars were set to 6nm and 12nm ranges on the port and starboard side sets, respectively (**Figure 3**). At 2321, the 2/O altered course to 244° to give more sea room to the ship being overtaken. Besides his navigational duties the 2/O sporadically watched a video on his personal tablet computer and listened to music.

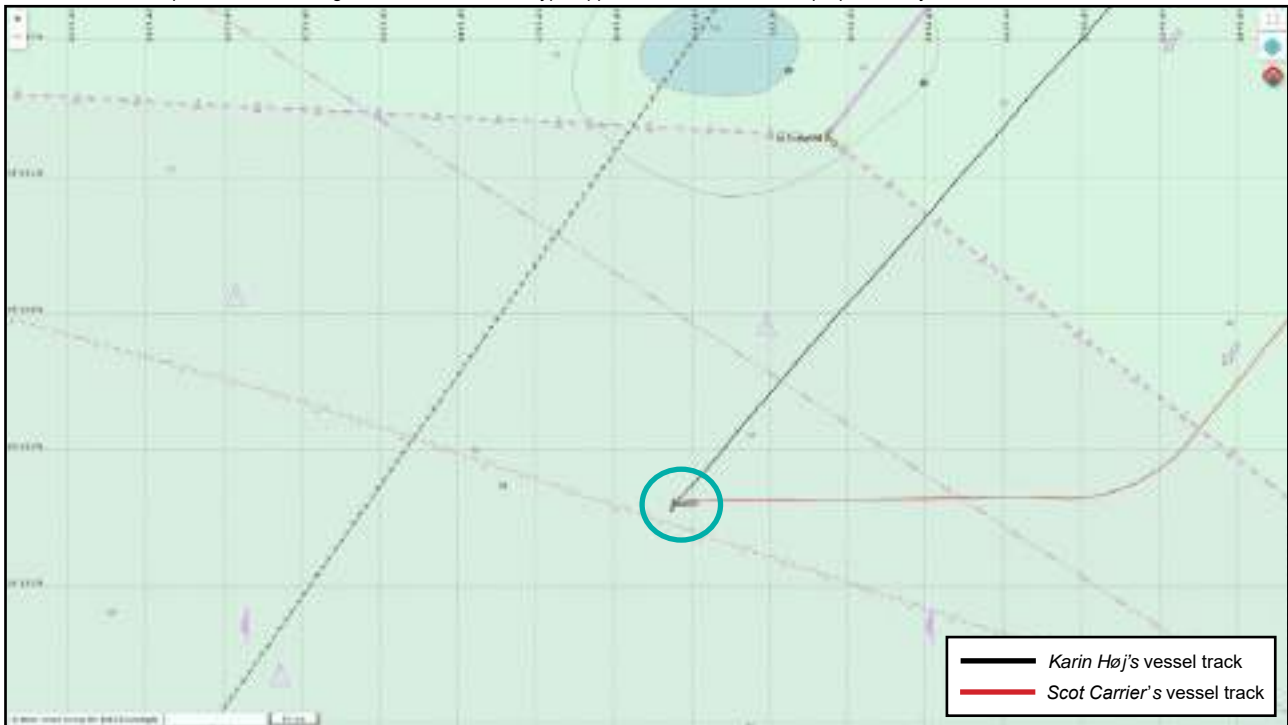
Figure 11: Point of collision at 0327:25

At 0326:35, while still in conversation, the 2/O observed a light close to *Scot Carrier*, between 20° to 30° off its starboard bow. He exclaimed "Wait, wait, wait!", pulled back the main engine propeller pitch control lever (telegraph), switched on a second steering motor and disengaged the autopilot. Fifteen seconds later, the 2/O moved the telegraph to full astern.

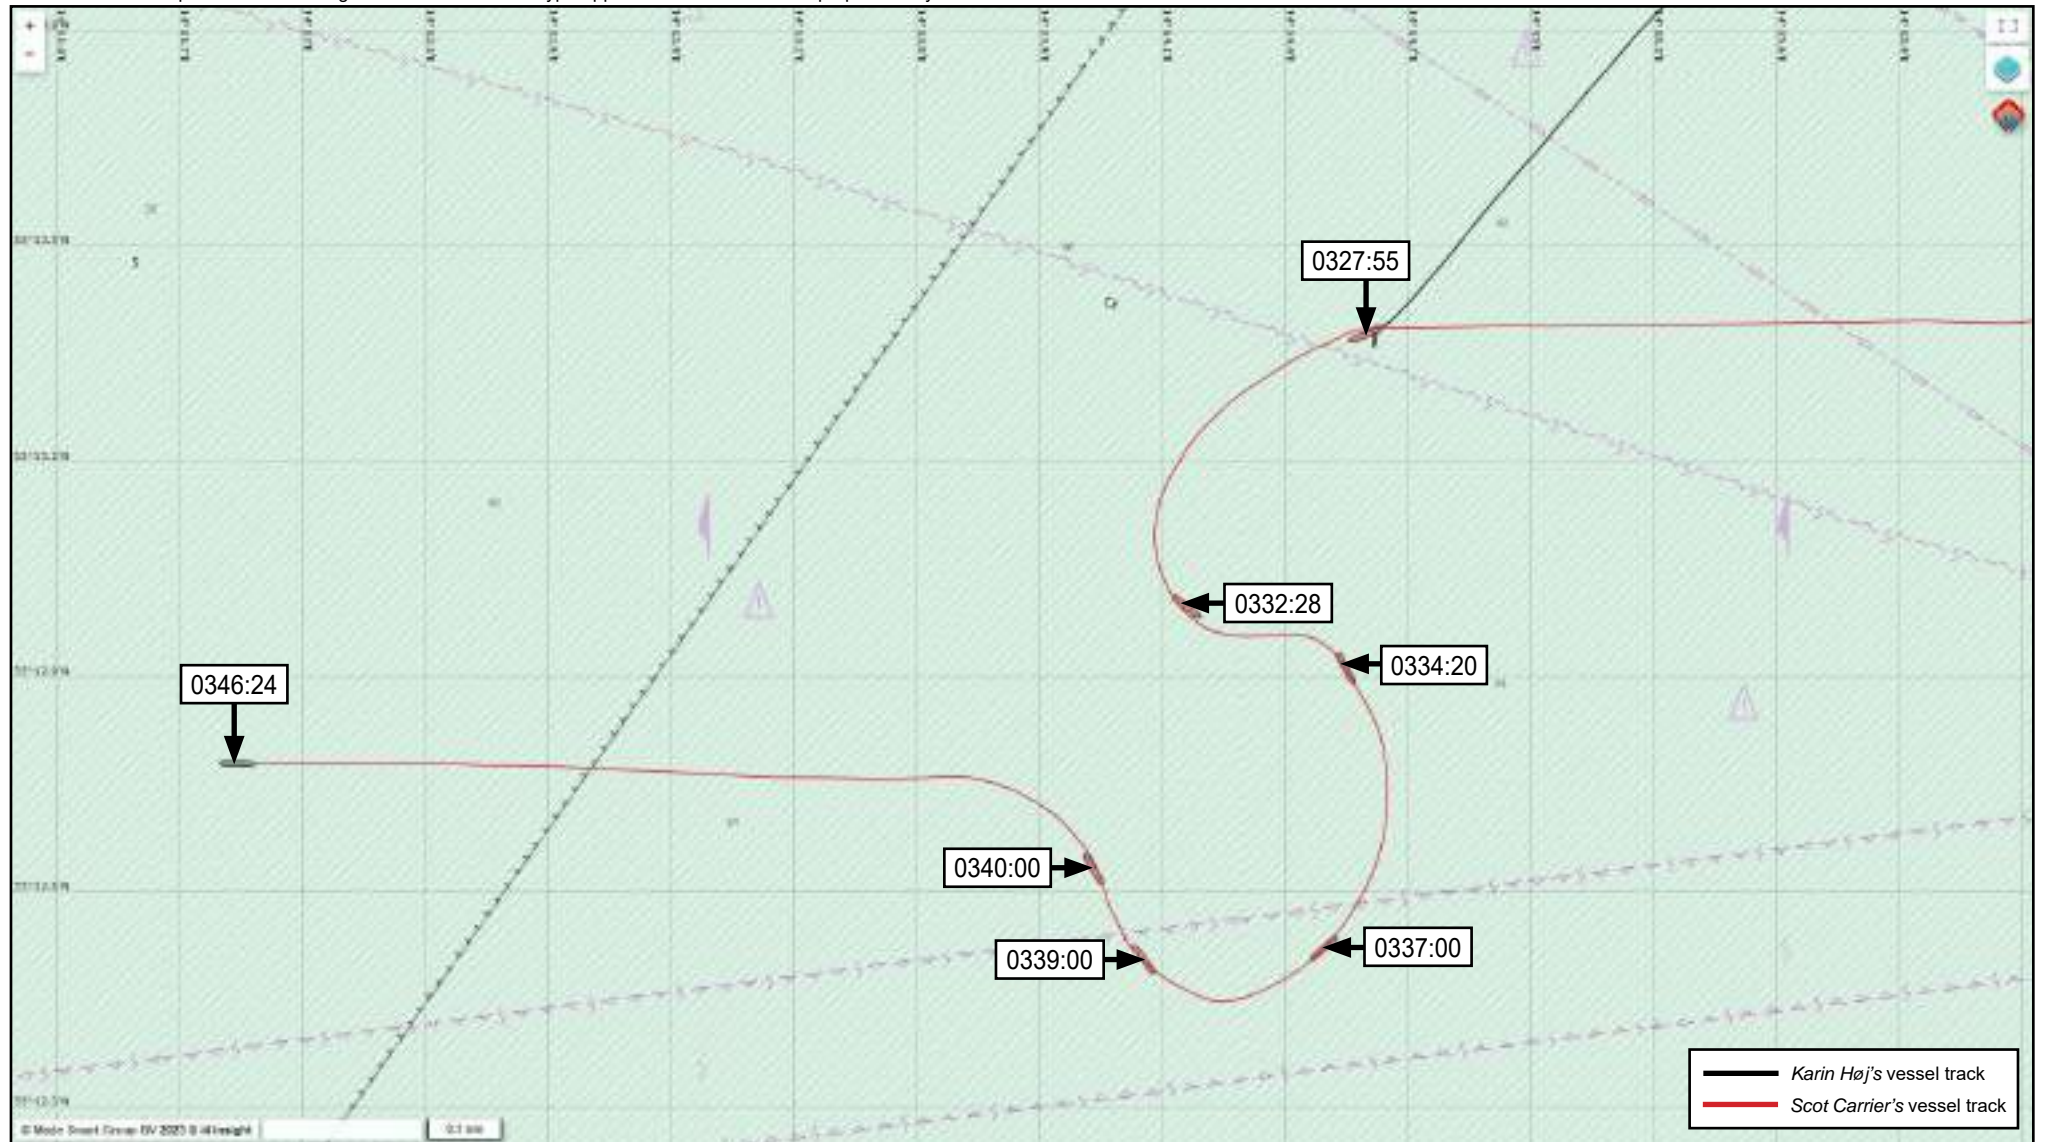
Figure 12: Scot Carrier's post-collision track

At 0327:55, the 2/O returned to the centre console and put the telegraph to full ahead. Five minutes later, after pacing up and down the bridge, he steadied the course (**Figure 12**) then, shortly afterwards, initiated a slow turn to starboard and switched the starboard radar range from 12 to 0.75nm.

At 0337, *Scot Carrier's* unmanned engine room alarm sounded on the bridge and in the chief engineer's (C/E) cabin. The C/E silenced the alarm and went to the engine room. The 2/O put the helm control to manual shortly afterwards and steadied the course at 305°. At 0339, the C/E called the bridge by telephone and asked the 2/O why two steering pumps were operating. The 2/O told him there was no problem and that he would switch the steering control back to autopilot.

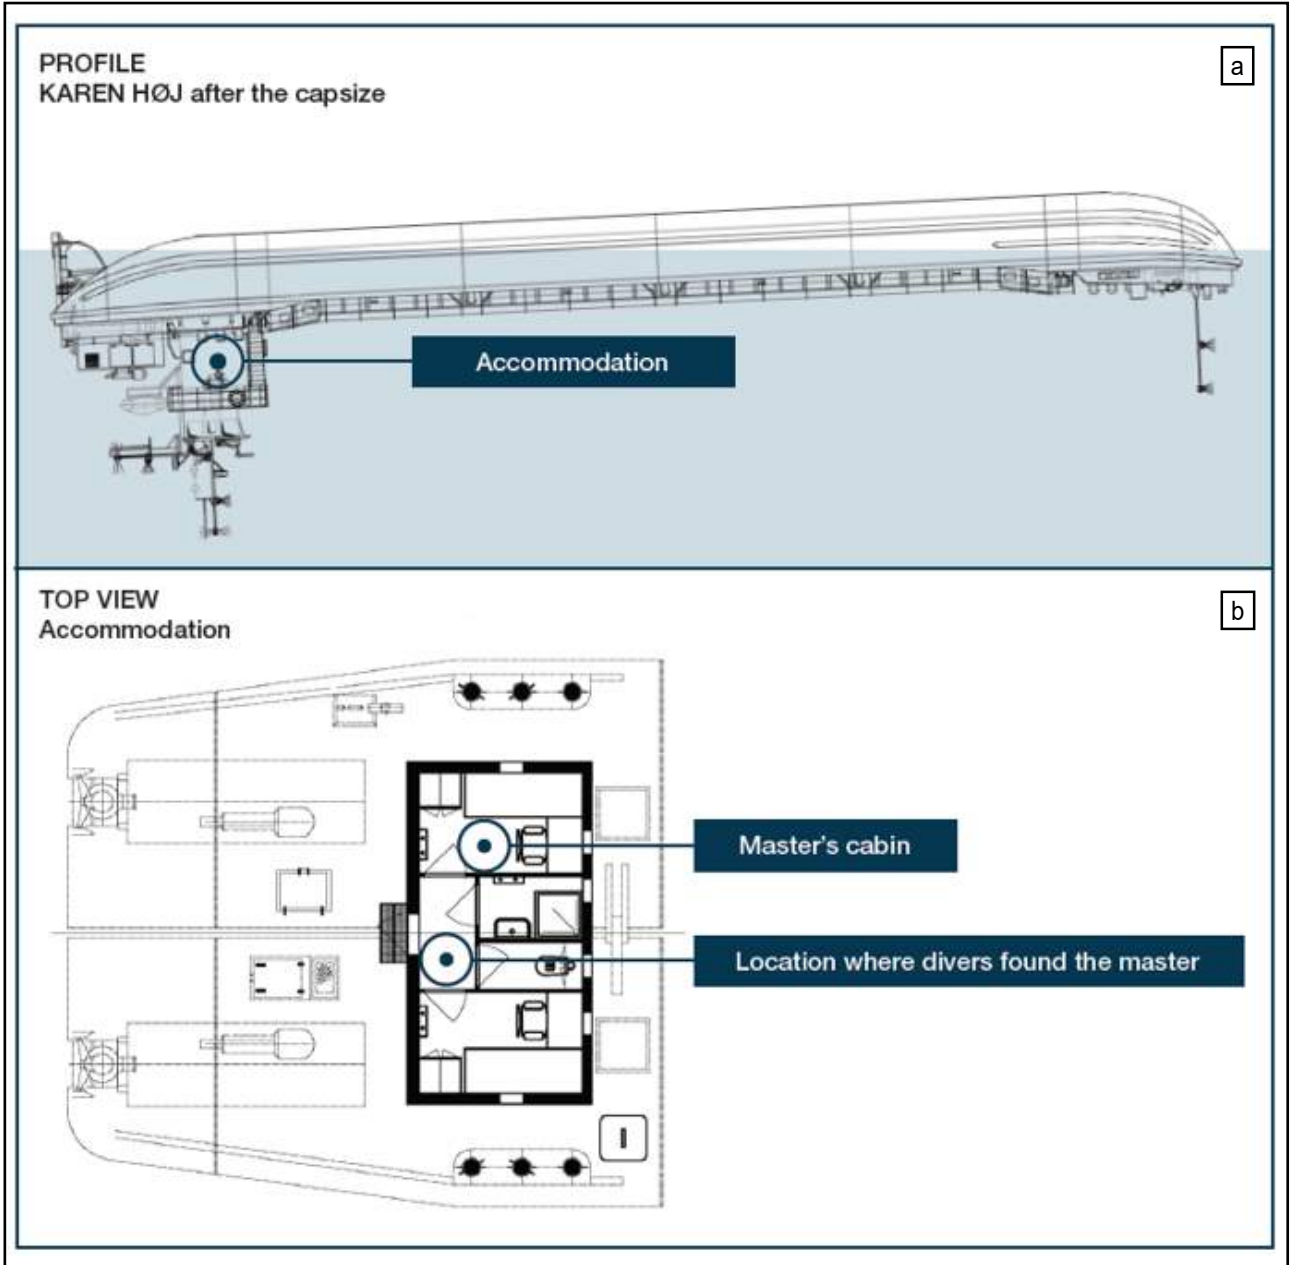
Figure 14: Karin Høj's accommodation (a) and cabin layout (b)

At 1340, Swedish rescue divers entered *Karin Høj*’s submerged accommodation and, 10 minutes later, found one partially clothed person in the accommodation hallway outside the starboard cabin (**Figure 14**). The person was later declared deceased and identified as the vessel’s master.

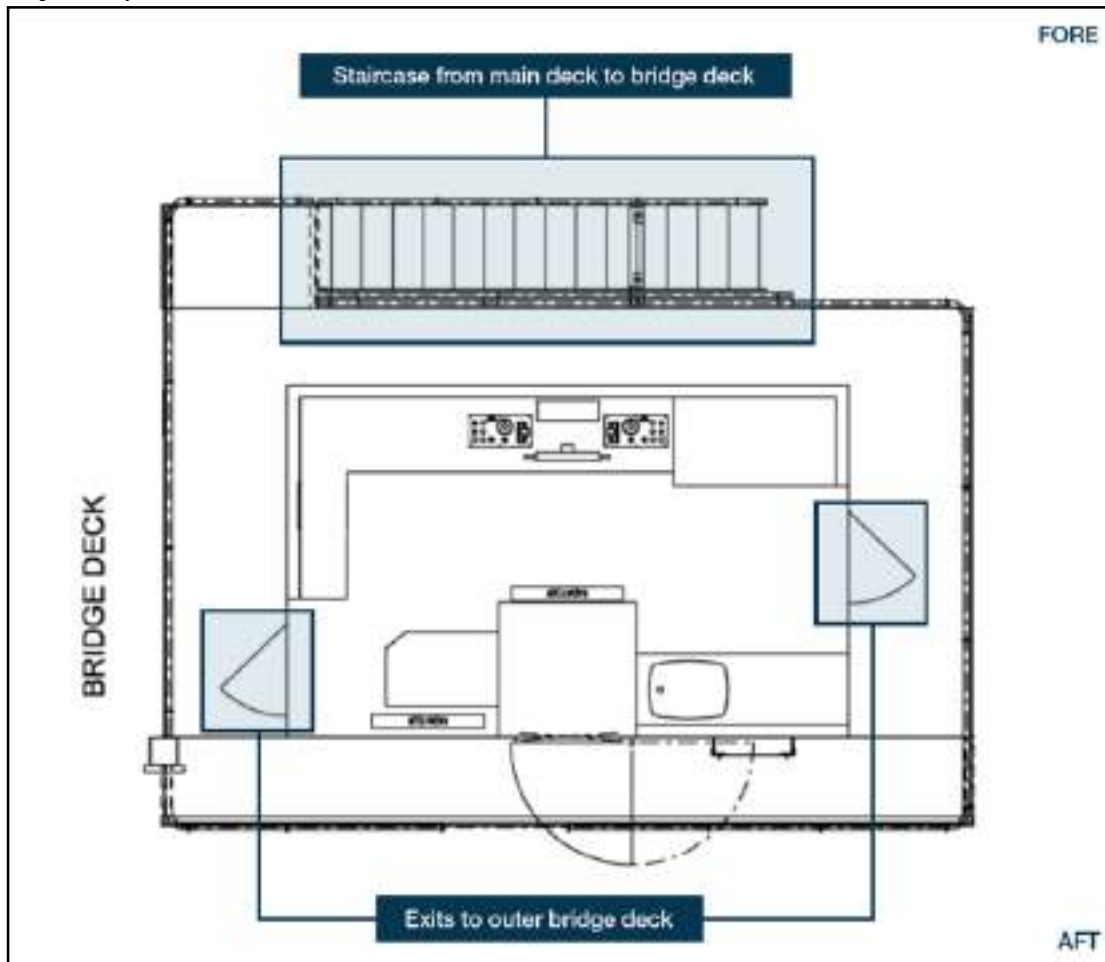
Figure 22: Karin Høj's bridge arrangement, modified from the fire plan

Karin Høj's bridge was accessed from the main deck by an external staircase to doors on the port and starboard side (**Figure 22**). It was not possible to enter the bridge directly from the accommodation. The bridge was fitted with windows on all sides.

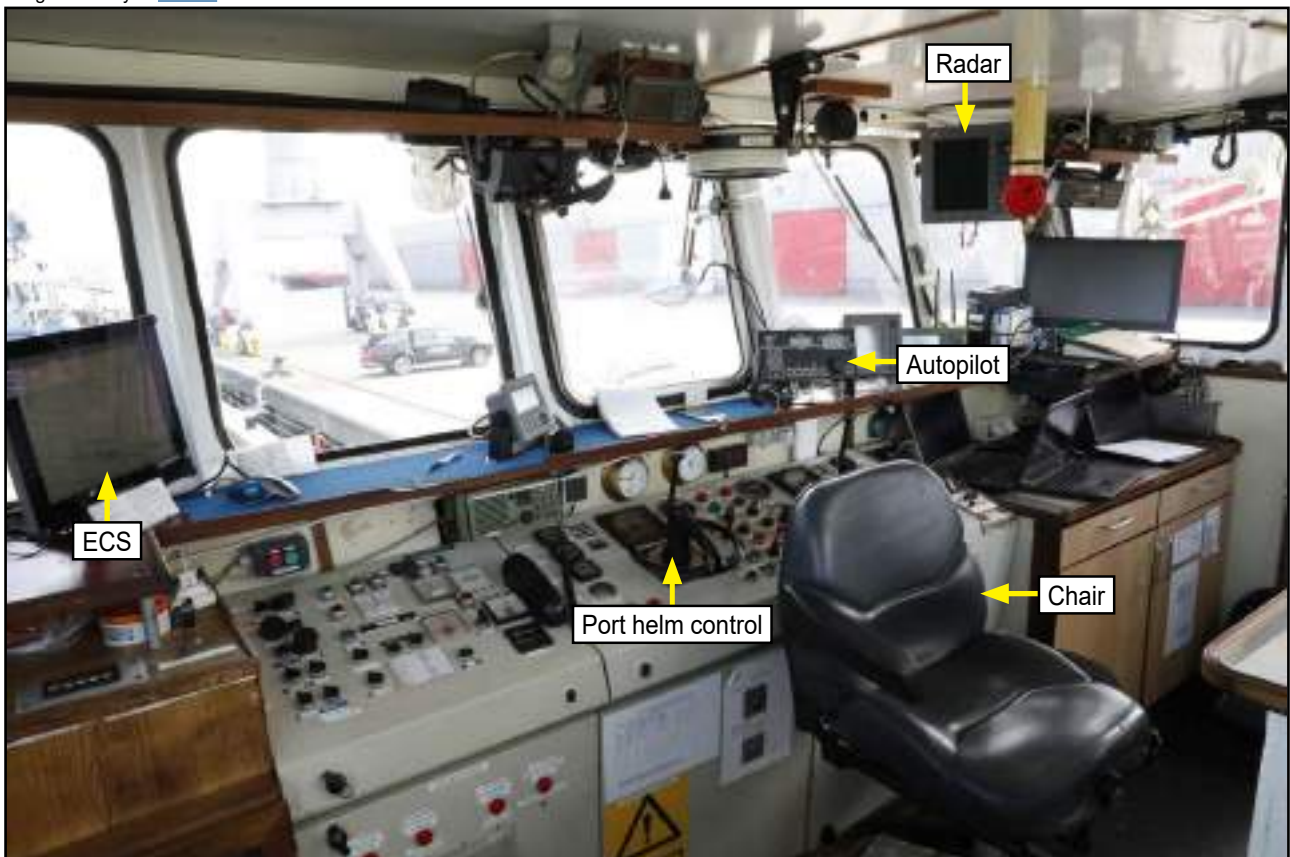
Figure 23: Karin Høj's bridge (2019)

A single fully rotating helm chair was mounted to the deck at the centre of the bridge. Monitors for electronic navigational equipment were mounted on the forward windowsill and suspended from the deckhead (**Figure 23**). The chart table was aft of the helm chair and a small adjustable lamp was fitted above it.

Autopilot control was connected to the starboard azimuth drive only, and the course was controlled by altering the heading selector on the autopilot unit. Switching from autopilot to manual control required pressing a button on the autopilot unit. Alternatively, the autopilot could be disengaged by pressing and holding the *off* button for 2 seconds. The operation of the azimuth drive port and starboard helm controls (**Figure 23**) did not override the autopilot.

Karin Høj's navigational equipment partially obstructed the forward view from the bridge, and the aftmost starboard windows were partially obstructed by a bookcase. There was limited space to move around on the bridge, but it was possible to have an all-round view of the sea if the OOW altered their physical position out of the bridge chair. The aft windows were fitted with solar film to shade the incoming light on the bridge and it was not possible to identify the degree of the tint as the window panes were missing after the barge was salvaged. However, the solar film would have reduced the crew's visibility of navigational lights from overtaking ships during the hours of darkness and may have been a contributory factor in its collision with *Scot Carrier*.

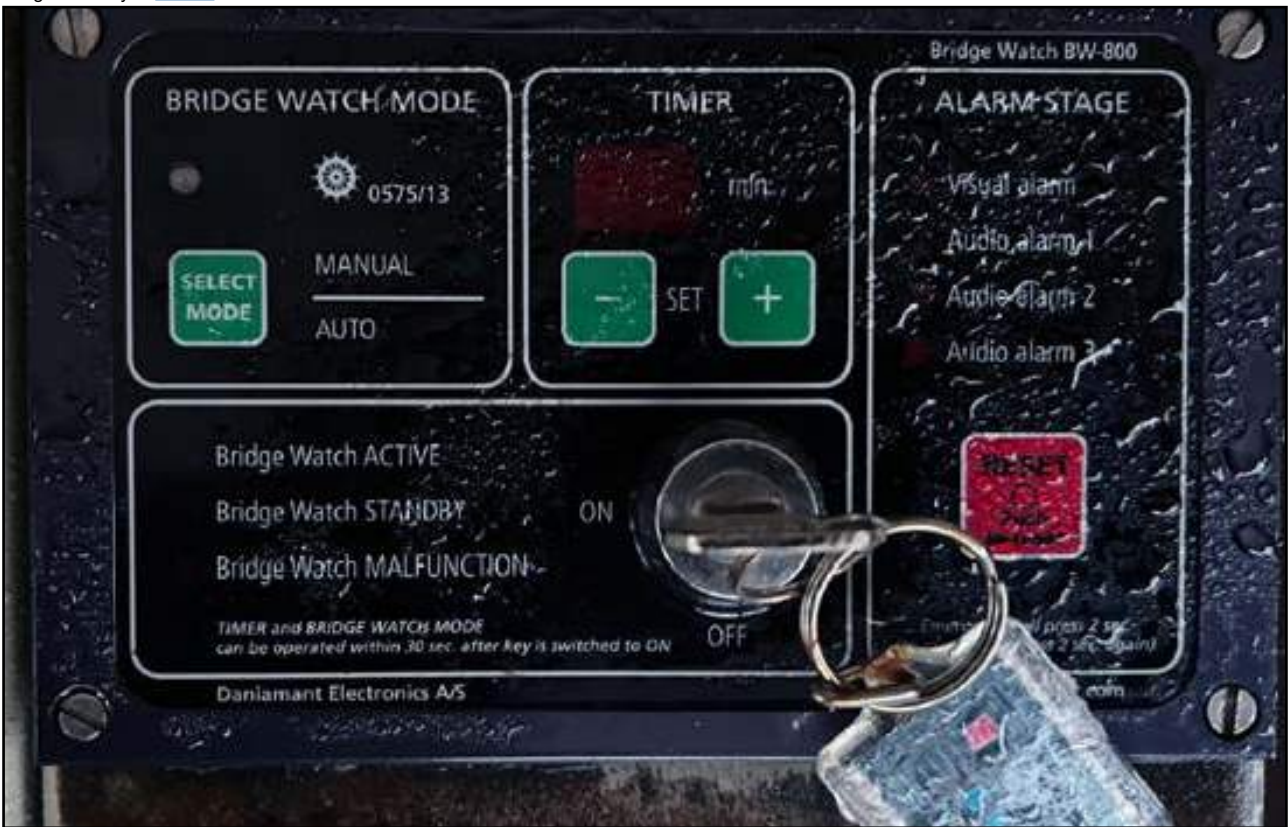
Figure 26: Karin Høj's BNWAS control panel

The switches to the masthead lights, port and starboard sidelights and stern light were in the *on* position (**Figure 25**). The key in the BNWAS control panel was in the *on* position (**Figure 26**). It was not possible to determine the BNWAS alarm interval setting selected.

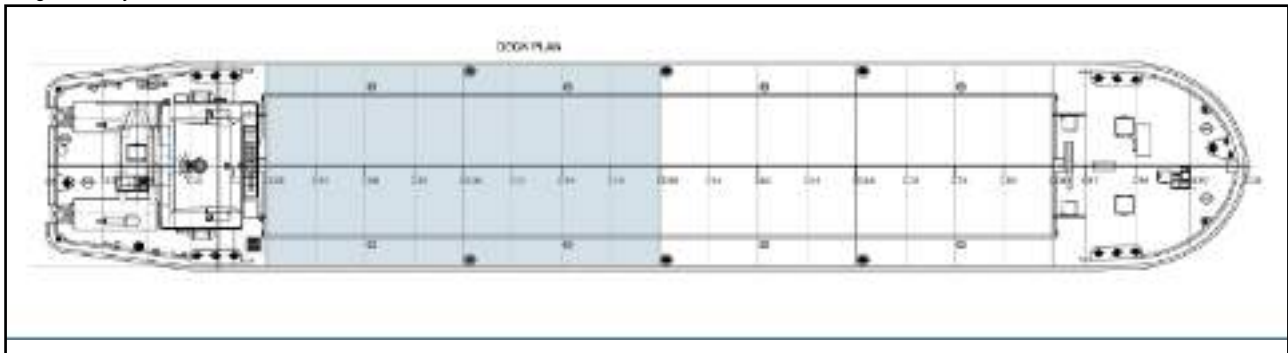
Figure 29: *Karin Høj's* void spaces in area of frames 20 to 52

DMAIB reconstructed the loading condition using the barge's estimated draught and stability booklet. It was calculated that *Karin Høj's* intact stability fulfilled the criteria set by the International Maritime Organization (IMO) in its adoption of the International Code on Intact Stability, 2008¹⁶. The vessel's damage stability was calculated in line with the accident condition and showed that the breached hull integrity at frame 33 to 34 allowed water ingress into the void spaces between frames 20 and 52 (**Figure 29**).

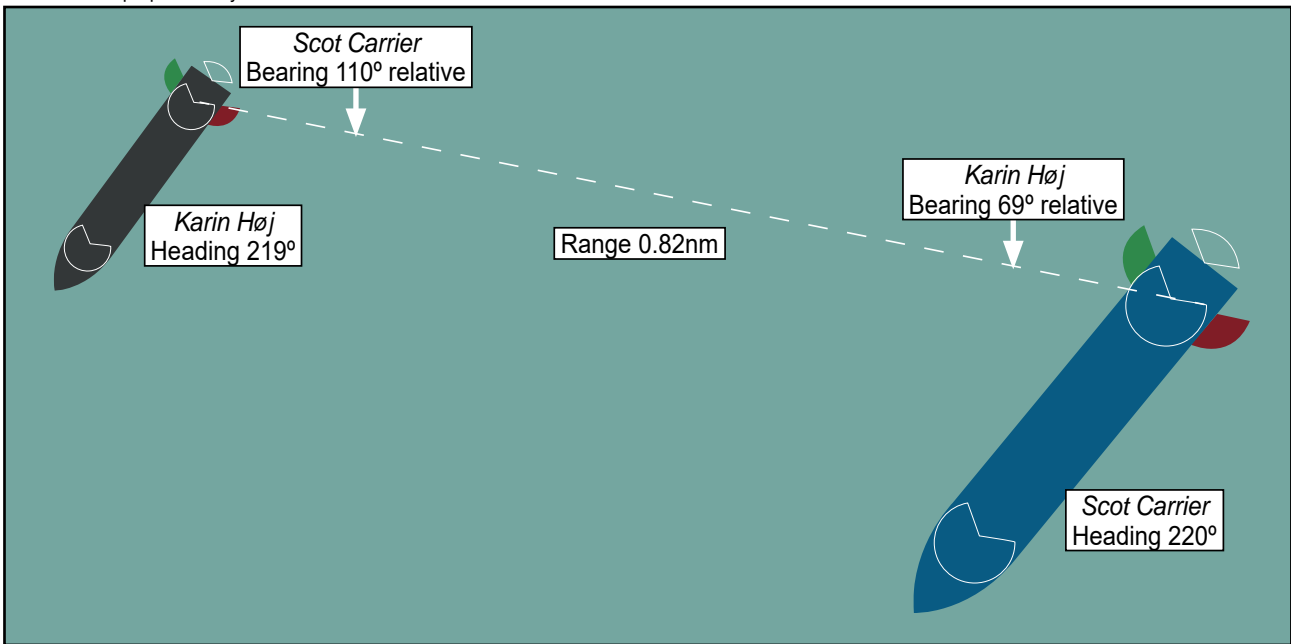
Figure 30: Relative positions of both ships at 0321, shortly before *Scot Carrier* altered course from 220° to 270°

Prudent seamanship required early and substantial action to be taken in order to make any intentions clear. The alteration of *Scot Carrier's* course close to *Karin Høj* left barely 3 minutes for its watchkeeper to identify the collision risk and take action, assuming that he was actively monitoring the situation.
