MIR-23-16

Collision between Cargo Ship *Damgracht* and Cargo Ship *AP Revelin*

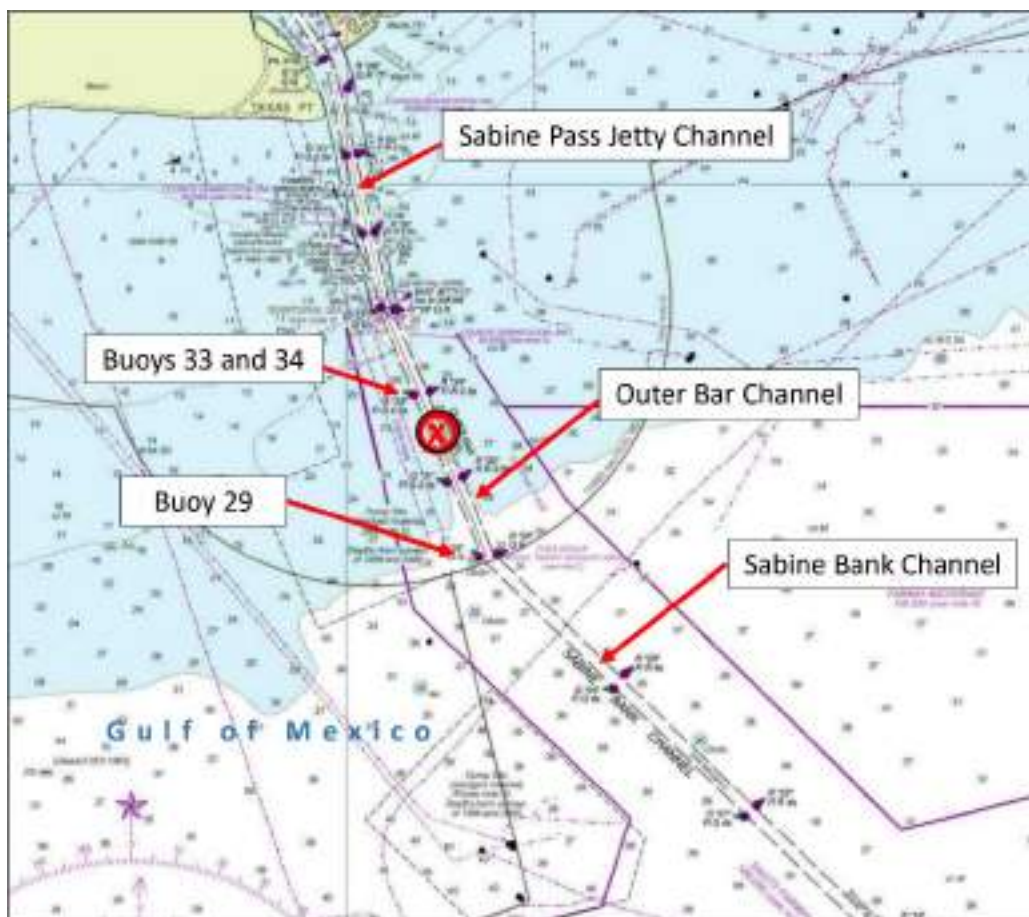
At 1030, the *Damgracht* got underway, heading inbound up the Sabine Bank Channel approaching the Outer Bar Channel. The pilots of the *Damgracht* and *AP Revelin* communicated over VHF radio and made arrangements to meet port-to-port in the Outer Bar Channel near buoys 33 and 34, about a mile seaward of the jetty entrance. The width of the channel in this area was about 800 feet.

Figure 3. Area where the *Damgracht* and the *AP Revelin* transited and where their pilots planned to meet at buoys 33 and 34. (Background source: NOAA Chart 11341)

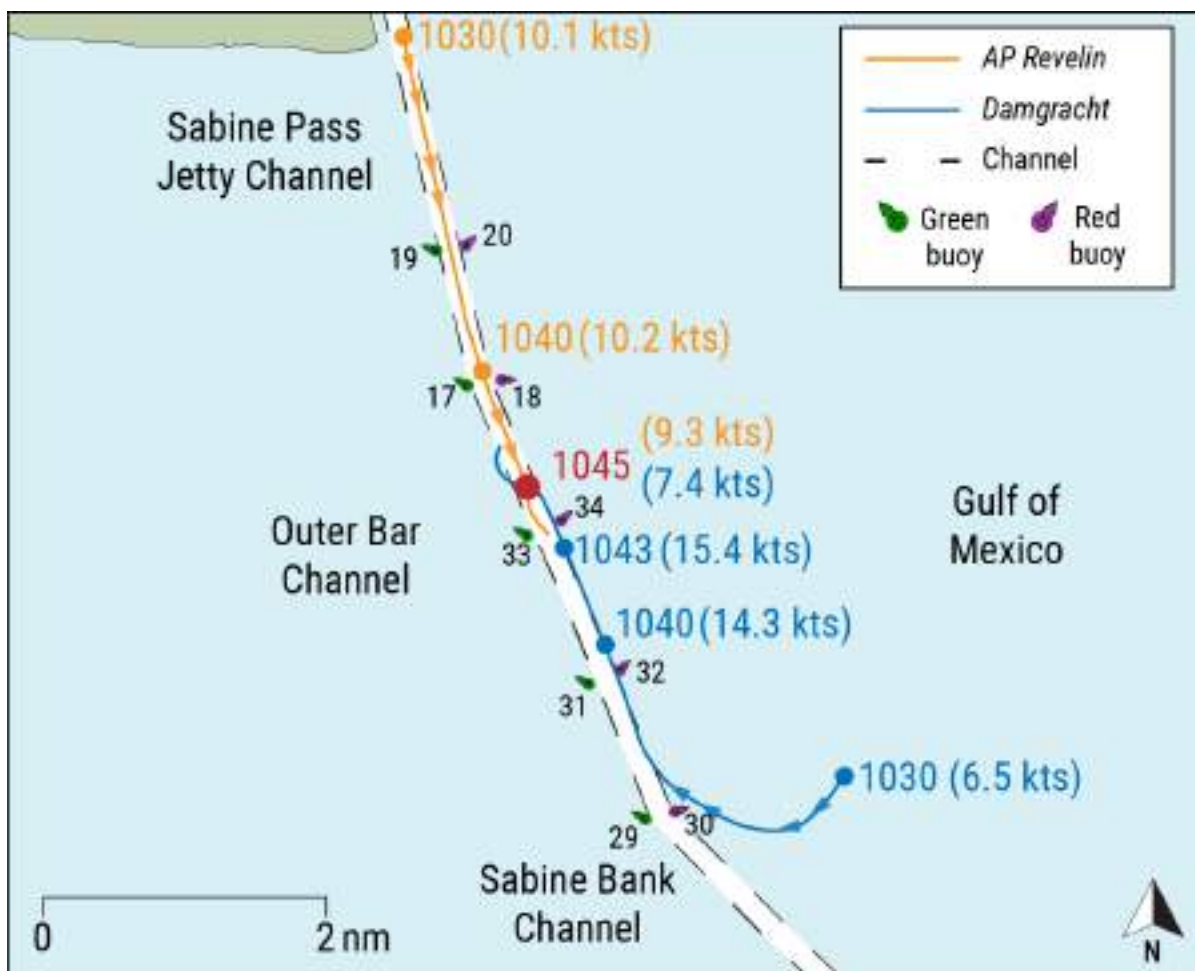
About 1043, when the two vessels were about a half mile apart, the oil mist detector (OMD) on the *Damgracht*'s main engine sensed "high oil mist density," activating the alarm and immediately shutting the engine down, thus causing the *Damgracht* to lose propulsion. The engine shaft-driven electrical power take-off generator, which had been online and powering the bow thruster, stopped producing power, and therefore, the thruster stopped as well. The vessel's other

The *Damgracht* continued to head toward the *AP Revelin*, and, about 1045, with the *Damgracht* moving at a speed of 7.4 knots and the *AP Revelin* at 9.3 knots, the bow of the *Damgracht* struck the port quarter of the *AP Revelin*, peeling back about 40 feet of the *AP Revelin*’s hull plating forward of the transom and wrapping it around the stern. About the same time, the chief engineer of the *Damgracht* verified that the main engine bearing temperatures and crankcase pressures were normal, opened the cover of the OMD measuring chamber, wiped the area of the infrared lights, and reset the OMD. The chief engineer did not notice any abnormalities when wiping the

Figure 4. Area where the *Damgracht* lost propulsion (1043) and collided with the *AP Revelin* (1045), as indicated by a red circle. (Background source: NOAA chart 11341)
