# SAFETY DIGEST

Lessons from Marine Accident Reports

2/2023

# MARINE ACCIDENT INVESTIGATION BRANCH

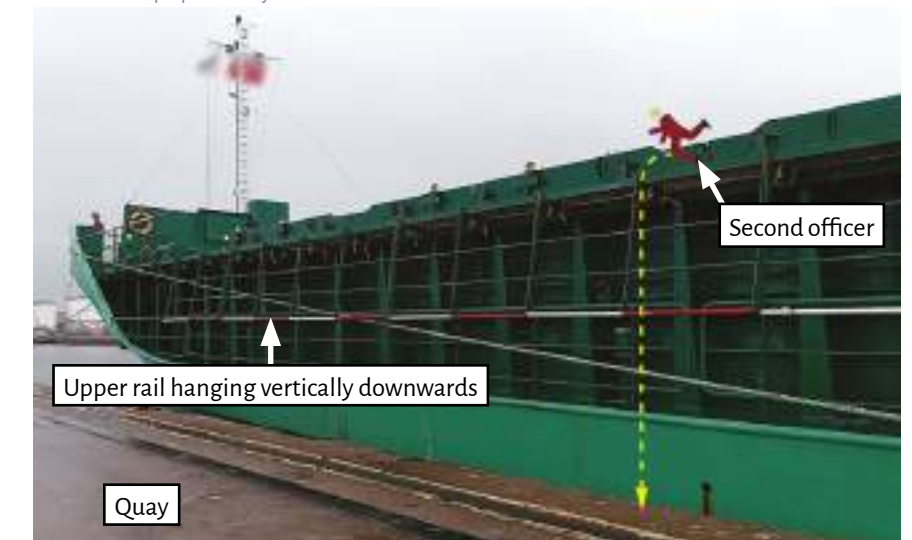
The 2/O was leaning towards the unsecured rail when it suddenly started to fall outboard. The 2/O, who was not wearing a safety harness fixed to the catwalk, lost their balance (Figure 2) and fell about 3.5m to the concrete quay below. The 2/O was in hospital for more than 10 days, having broken both legs in an attempt to land on their feet.

Figure 2: Illustration of the second officer falling to the concrete quay

1. **Procedure** → The shipboard risk assessment for this task required anyone working aloft or over the ship's side to wear a fall arrester. Following safety procedures increases the opportunity to identify hazards and determine what equipment or control measures are needed to mitigate them and keep people safe.
2. **Equipment** → A safety harness and appropriate restraint tether would have prevented the fall. Personal protective equipment (PPE) may be deemed uncomfortable to wear and will likely require adjusting to allow you to work effectively, but it is essential when carrying out high-risk tasks such as working at height.

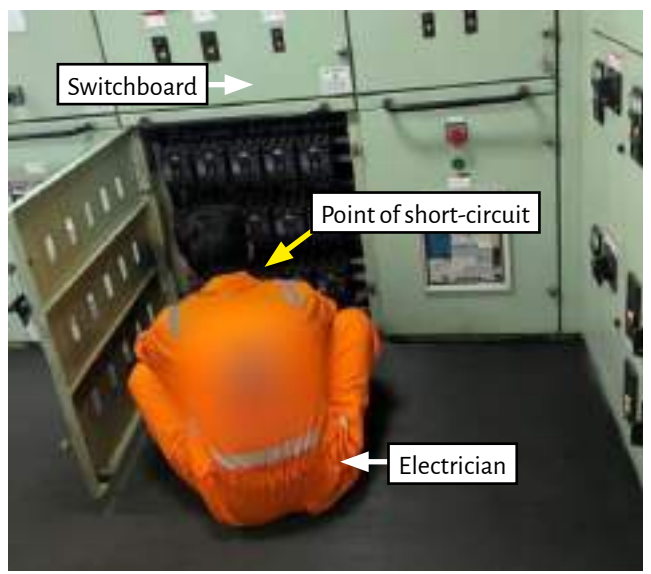
heat and blinding light. A burst of hot gas and molten metal exploded from the panel onto the electrician's face and chest (Figure 4).

Figure 4: Position of the electrician

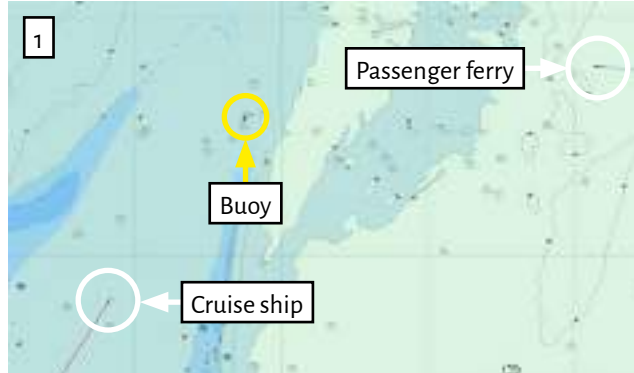
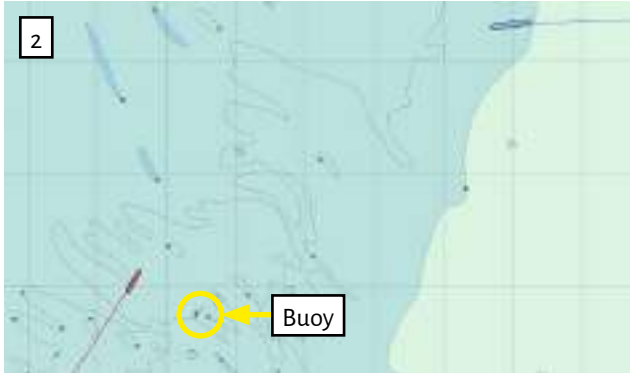
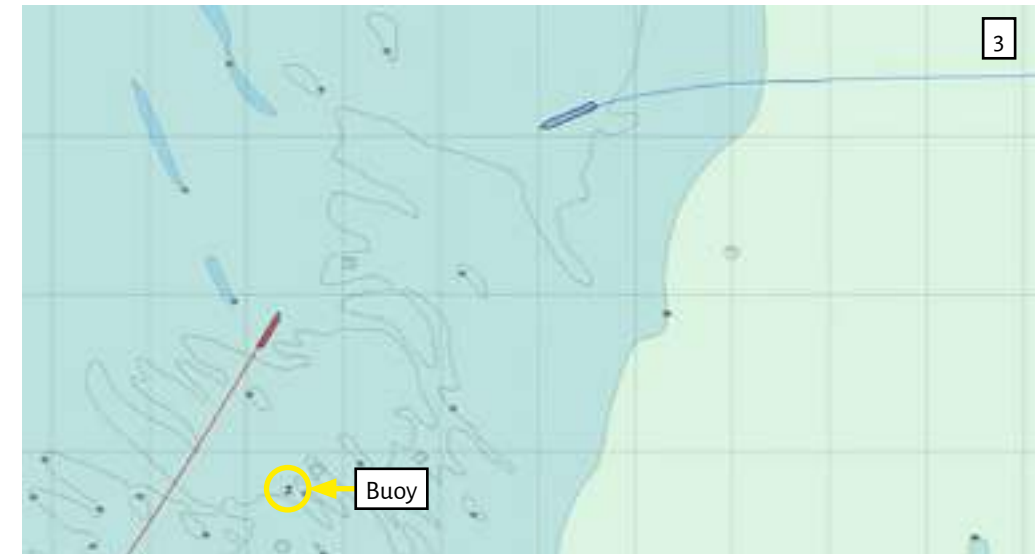
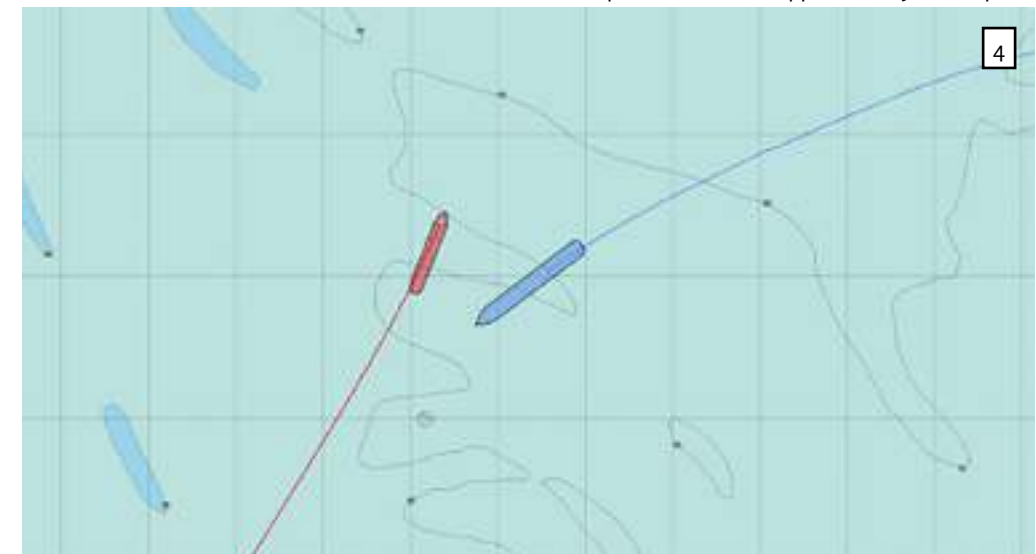
Figures: The near miss sequence

The vessels approach the buoy and the ferry alters to the north

Expecting the cruise ship to alter course to starboard as it passed the north cardinal buoy, the ferry's OOW altered their own course to port to approach the channel. Confused by this, the cruise ship's OOW attempted to call VTS several times on VHF radio to request them to ask the ferry to come further to port and pass the cruise ship's stern. However, the first three VHF radio calls did not transmit due to a faulty call button on the radio handset.

The cruise ship's OOW eventually transmitted the message to VTS as the two vessels moved ever closer to each other. VTS passed the cruise ship's message to the ferry, which altered further to port in response. The cruise ship's OOW also made an alteration of course to port and passed closely ahead of the ferry.

The cruise ship passes the buoy

The ferry alters to port expecting the cruise ship to alter to starboard now it is clear of the buoy

The vessels pass each other at approximately 100m apart

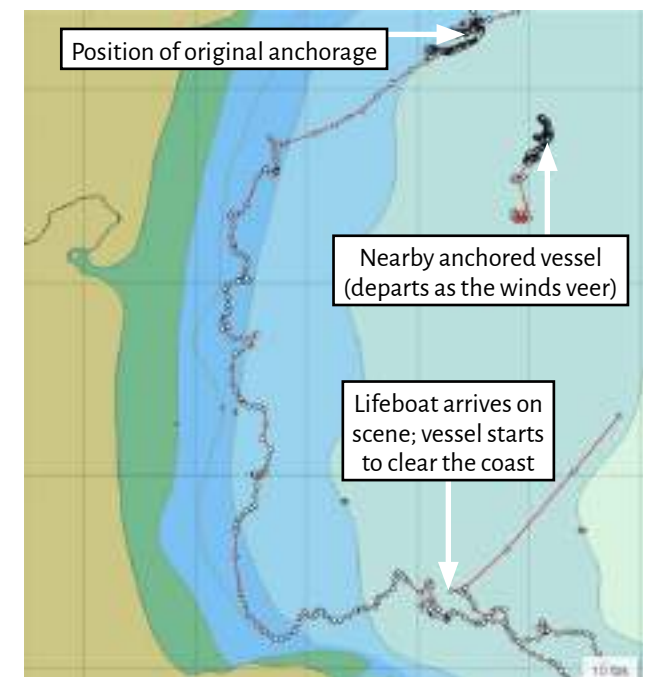
As the storm winds veered to the north-east the cargo vessel lost all shelter; it started to drag anchor and, 25 minutes later, was dangerously close to land on a lee shore. The master and crew fought hard for 2 hours to recover their anchor and proceed out to sea, during which the ship dragged southwards along the coast (see figure) and was within a few metres of grounding on several occasions.

Figure: Plot showing the track of the cargo vessel as it dragged anchor along the shoreline

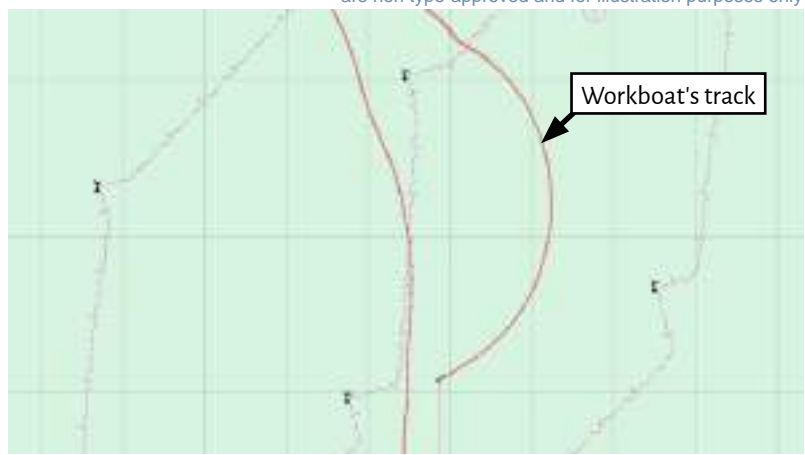
The master was shocked to see one of the wind turbine towers looming ahead when they looked up and turned to face forward. The collision happened before there was chance to react.

Figure 1: The navigational track of the workboat, showing its slow turn to starboard

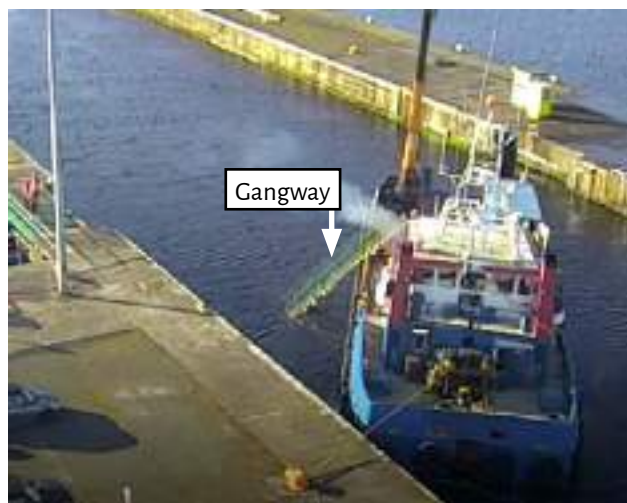
Figure 1: The workboat loses control of the gangway

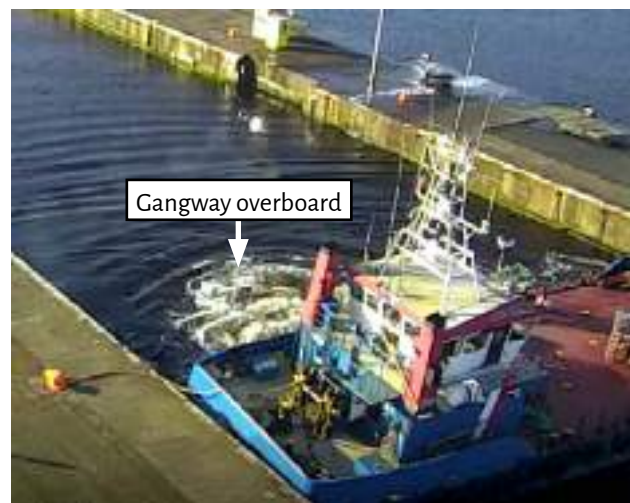
Figure 2: The workboat loses its gangway overboard

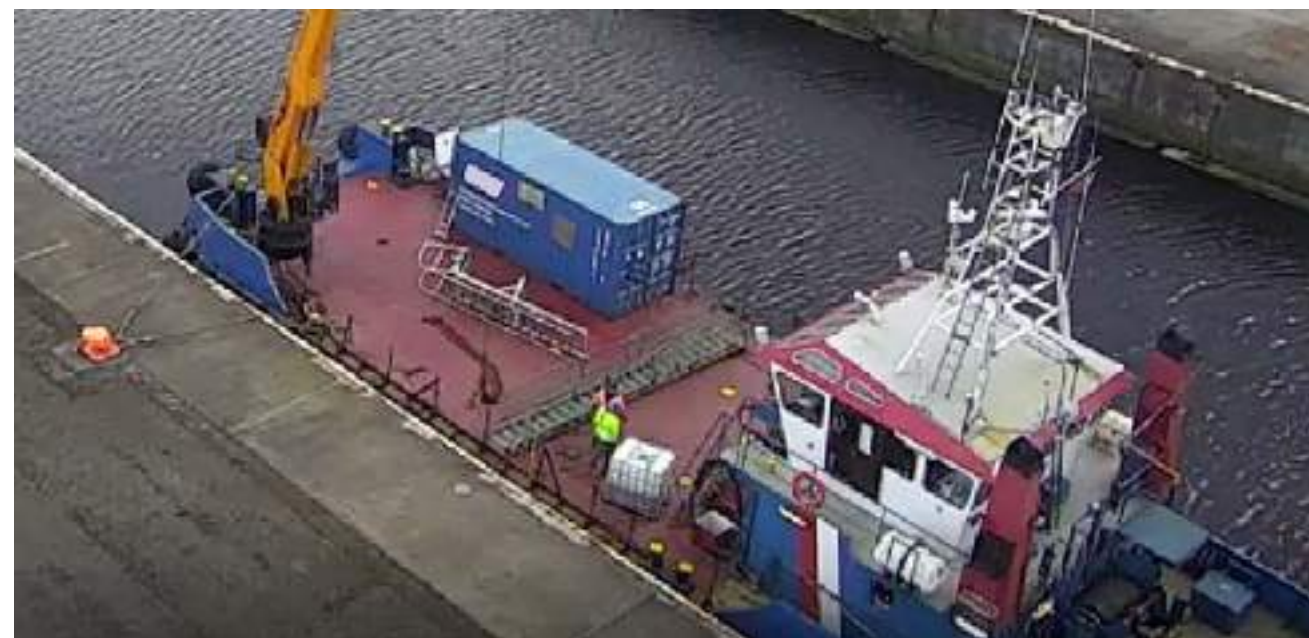
the water level in the lock (Figure 3). Language difficulties hindered the communication but, after several attempts, the lock operator received a positive acknowledgement from the master that they understood these intentions. However, the workboat's mooring lines were not adjusted as the water levels in the lock started to reduce and the workboat momentarily listed to starboard as some of the mooring lines became rigid (Figure 4). A deckhand used a knife to cut one of the breast lines to release the tension, causing the line to whip out and the vessel to jolt back onto an even keel (Figure 5). Luckily no one was hurt, either on the lock or on board.

Figure 3: Locking out at the end of the day's work

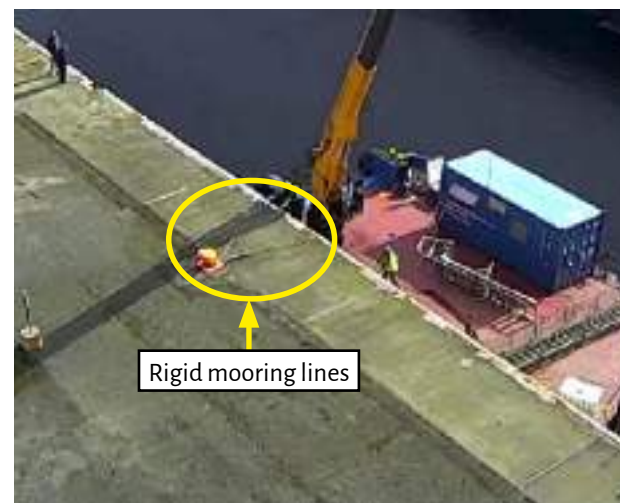
Figure 4: The workboat dropped in the lock and heeling over by 10°

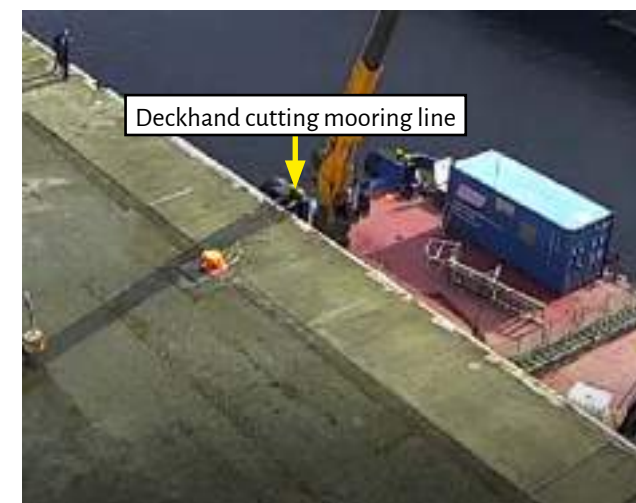
Figure 5: A deckhand cuts the forward mooring line, returning the vessel upright

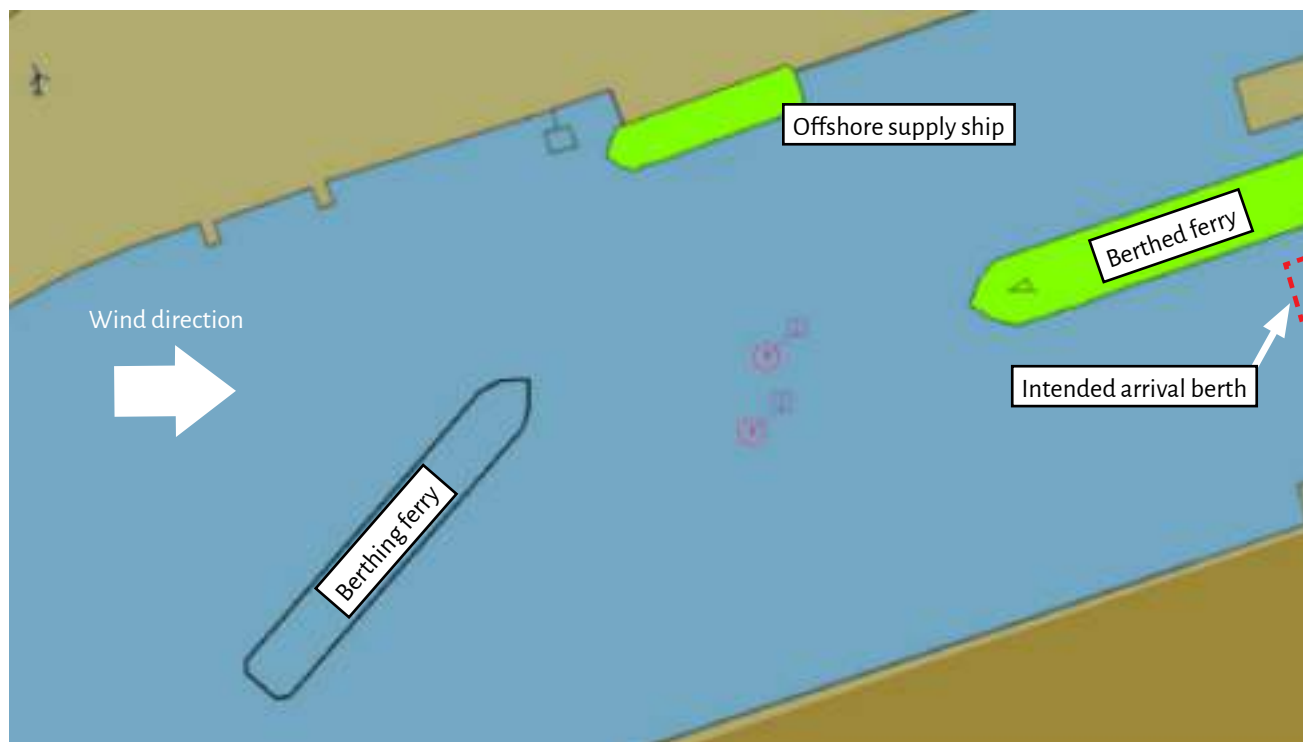
A ro-ro ferry was attempting to berth in a small northern European port at night in high winds. The three operational linkspans at the ferry port required vessels to moor stern to and another ferry occupied the middle linkspan (Figure 1). As the ferry entered the harbour the wind was

Figure 1: The ferry on approach to its intended linkspan

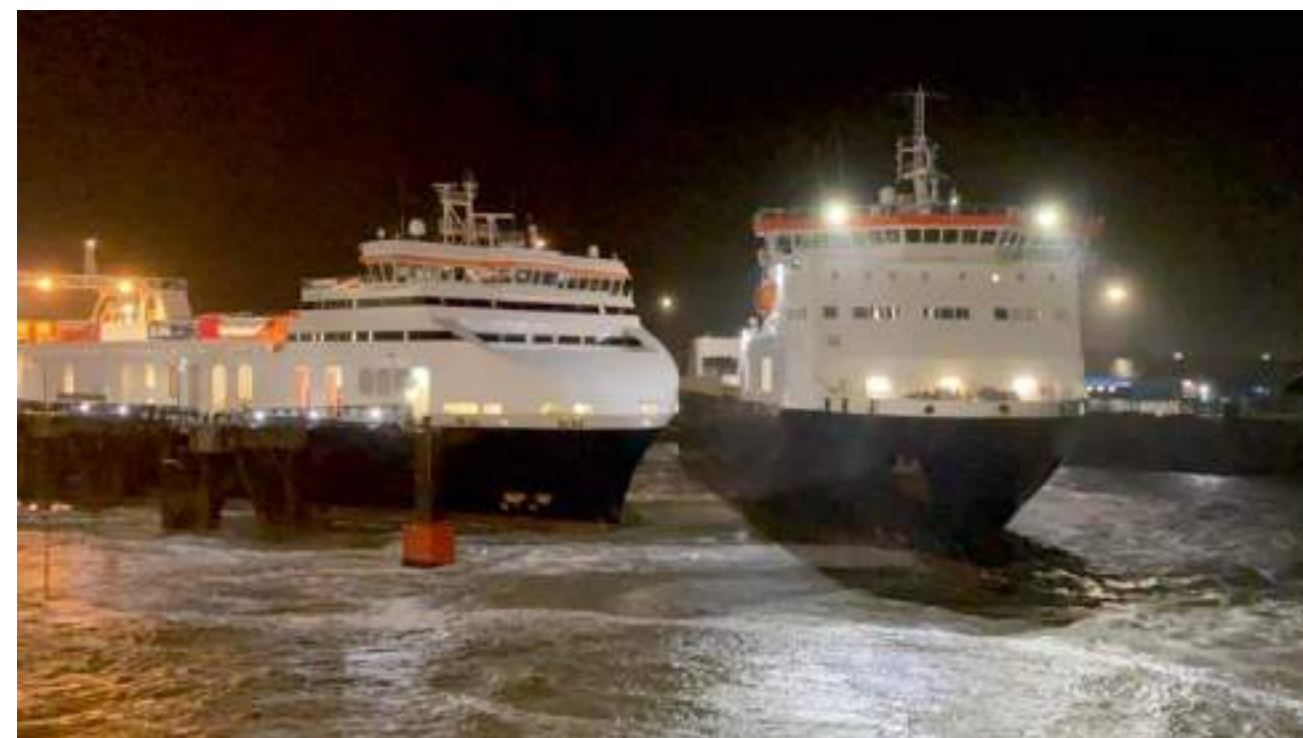
The wind increased to around 60kts as the ferry began to turn, pushing it very close to an offshore supply ship berthed on the northern breakwater inside the harbour. The crew of the ferry used the bow thruster and main engines to hold the vessel up into the wind, but the force was too strong for the vessel to hold position while positioned fully beam on to it. The ferry was blown eastward

toward the ferry already berthed in the middle linkspan and the two vessels collided, the moving ferry hitting the bow of the stationary ferry with its starboard shoulder (Figure 2).

Figure 2: The two ferries just before the collision

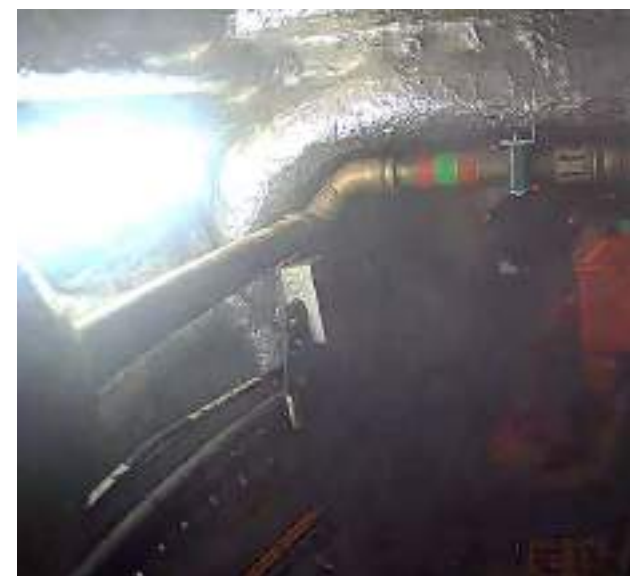
Figure 1: CCTV still showing smoke in engine space

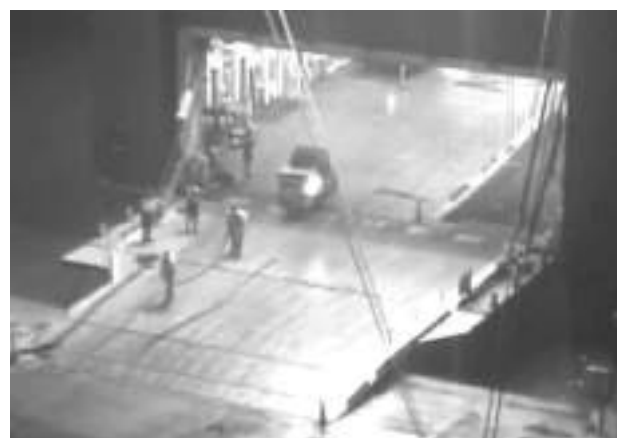
The ferry's staff were responsible for simultaneously supervising the offloading of cars and palletised cargo, which was undertaken using forklift trucks driven by stevedores. After the cars had been offloaded the crew prepared to back load excavators onto the ro-ro's deck, a process that required the positioning of lengths of heavy rope on the stern ramp. At the same time as two stevedores lifted the first length of rope and were moving it across the centre of the stern ramp, a forklift truck with a pallet of slate was being driven off the ferry (see figure).

The forklift truck driver did not see the stevedores on the stern ramp and the stevedore nearest to the approaching forklift truck was standing with their back to the ferry and did not see the oncoming forklift truck. The forklift truck driver was wearing ear defenders and did not hear a

Figure: Forklift truck and stevedores on ramp

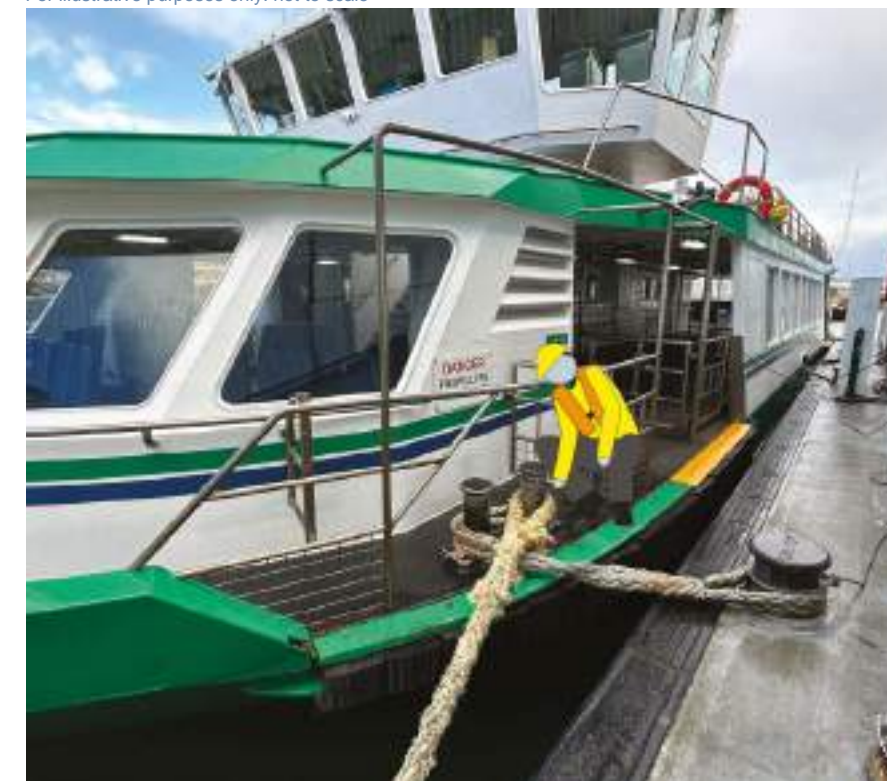
The ferry's crew quickly raised the alarm and the master regained control of the vessel, which allowed the crew member to release their hand. The casualty was taken to hospital for treatment and subsequently was signed off work for several weeks.

Figure: Trainee crew member releases the mooring rope

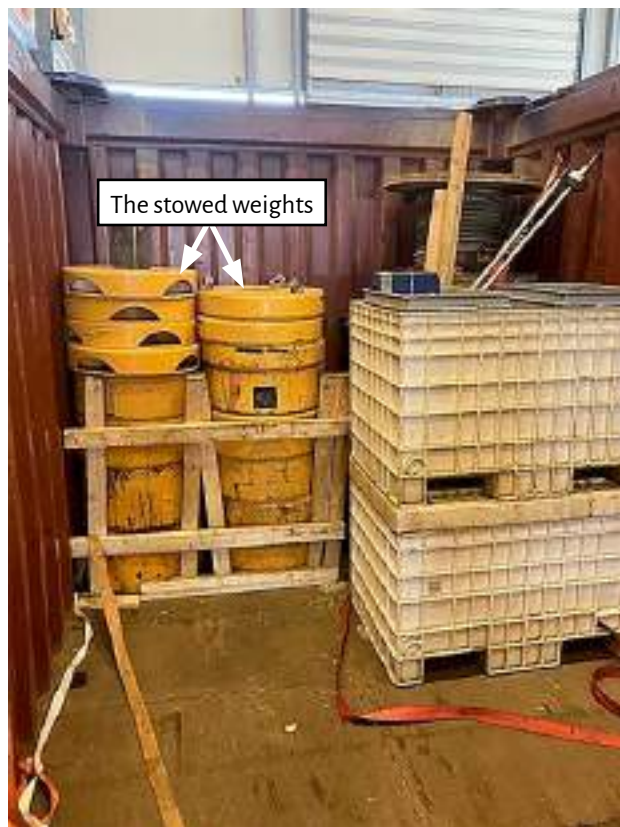
Nearly 8 tonnes (t) of weights had been stacked in the back corner of the container when the equipment was originally loaded into the container (Figure 1).

Figure 1: Weights loaded in container

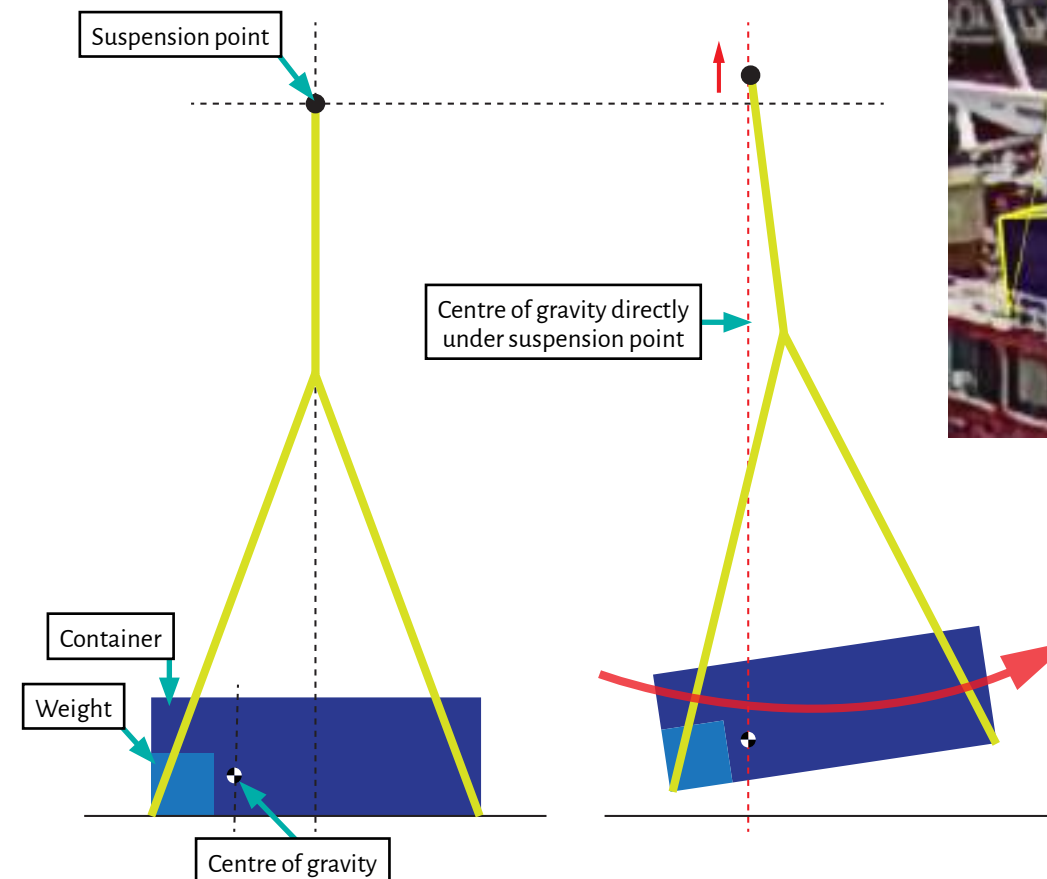
lifting gear bears. In this case, the imbalance from the stowed weights caused the container, which weighed more than 16t in total, to swing towards the banksman. There was nothing the crew could do to stop its movement (Figure 2).

Figure 2: Effect of unbalanced load on lifting operation and (inset) CCTV still, showing container position following lift

3. **Equipment** → There are occasions when an unbalanced load will need to be lifted. To facilitate this, you can either use slings of different lengths to lift the load directly above its centre of gravity or a spreader beam to evenly distribute the weight and make sure the load is lifted vertically.

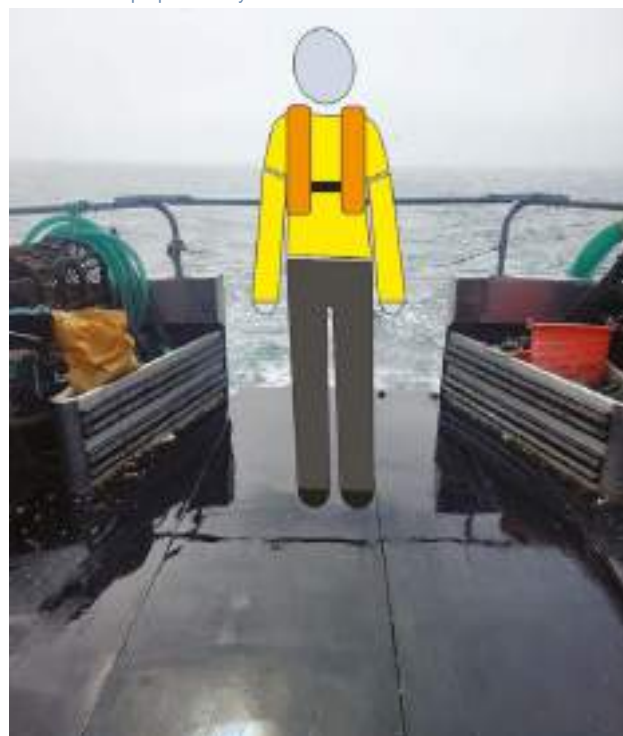
the second deckhand to recover their crewmate back on board through the shooting hatch opening. The casualty spent 2 minutes in the water and fortunately suffered no ill effects.

Figure: Deckhand's position at the shooting hatch

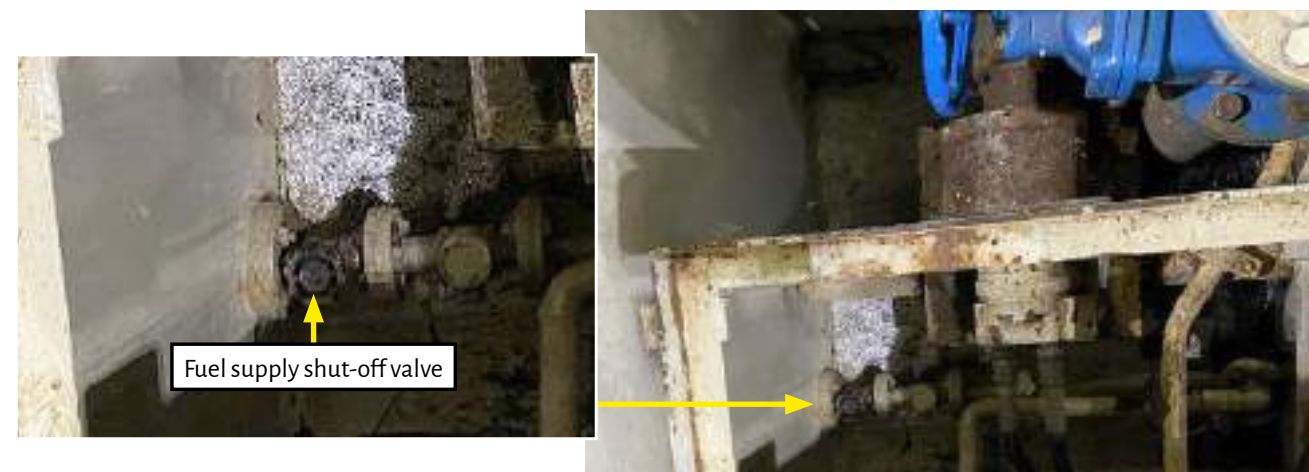
Figure: Fuel supply shut-off valve

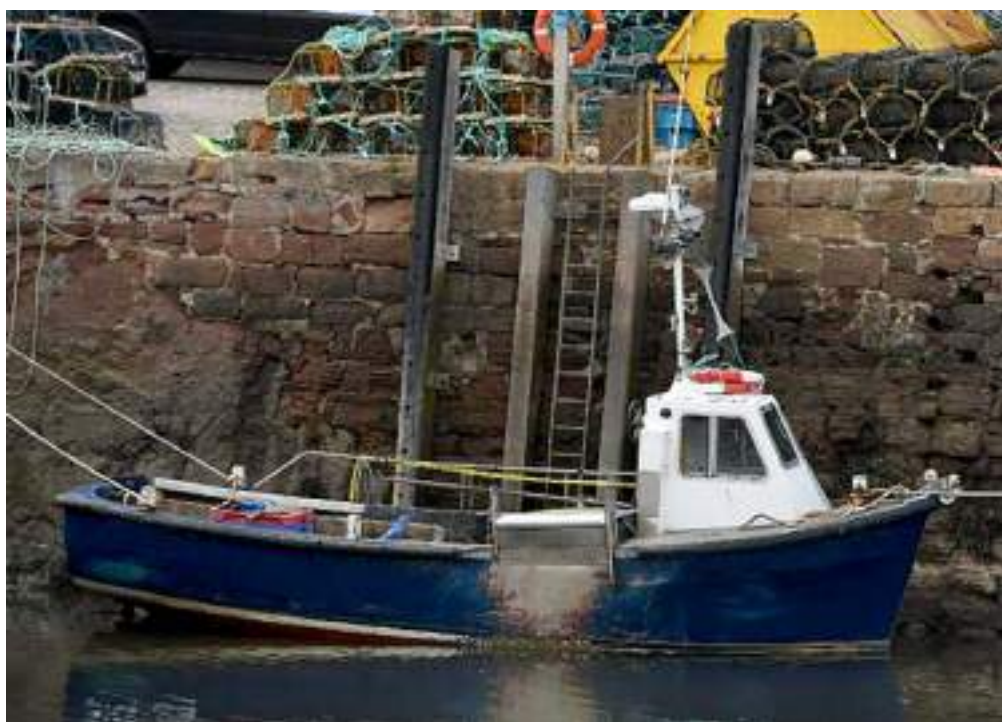
Figure 1: The single-handed creel vessel

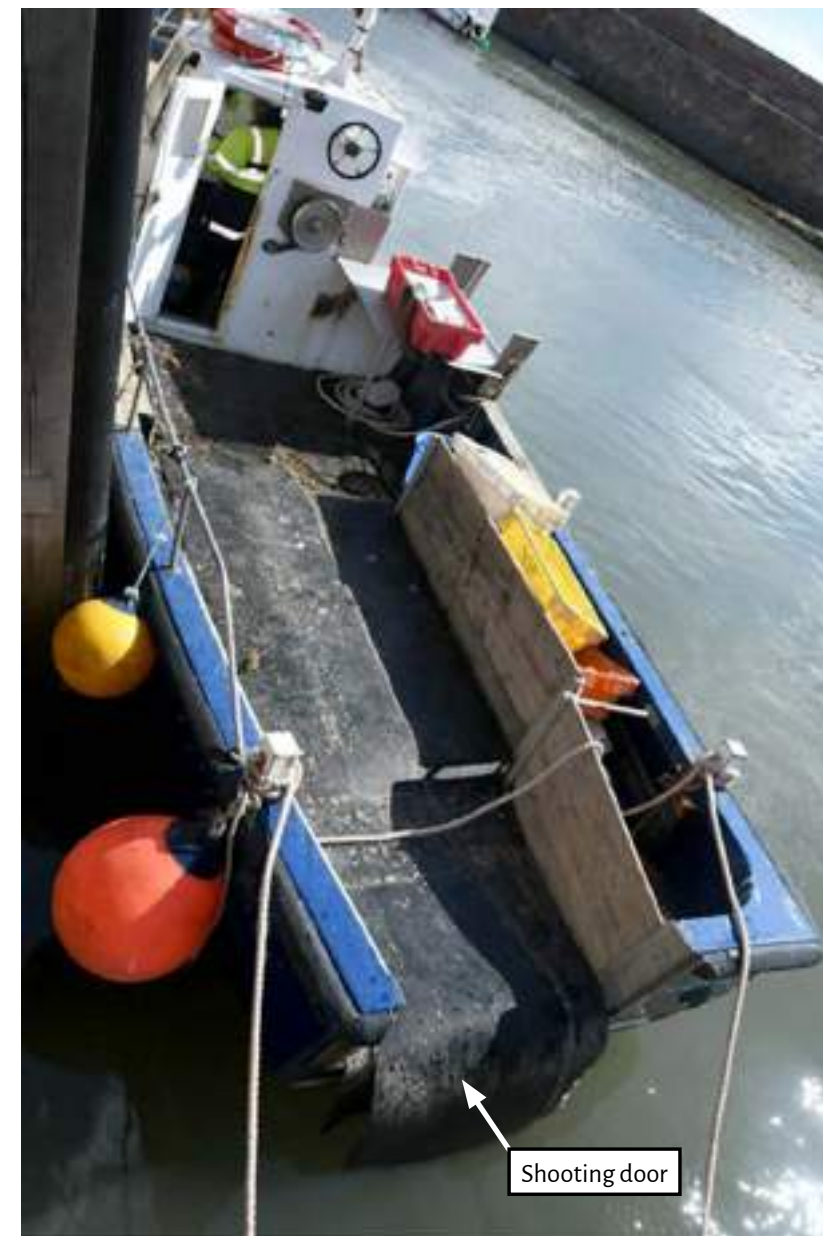
shooting door (Figure 2). The skipper's personal flotation device (PFD) automatically inflated on contact with the water, keeping them afloat and their face clear of the water. However, the skipper did not have an easy means by which to reboard their vessel and no method to raise the alarm while in the water and they succumbed to cold water immersion.

Figure 2: The shooting door (drop-in closing board removed)

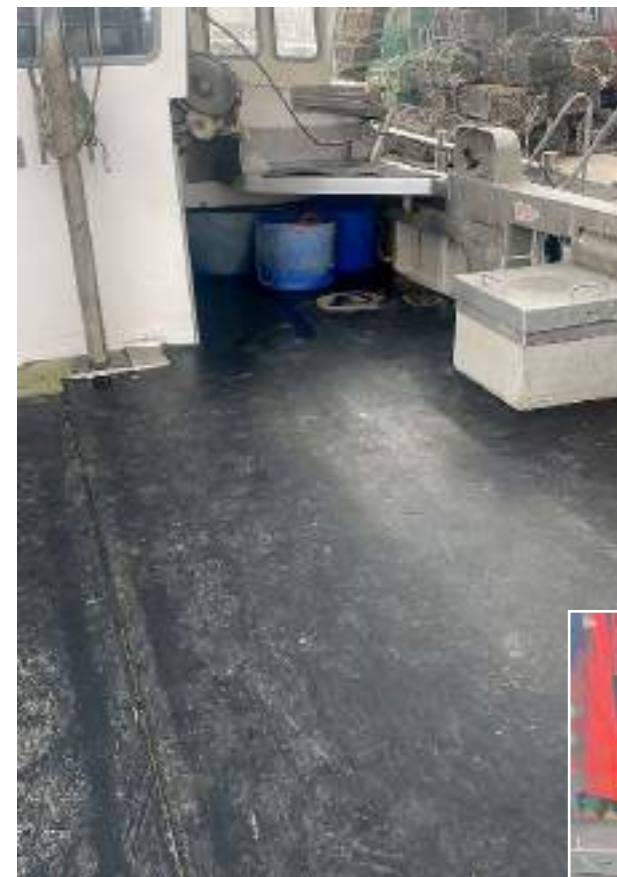
On a clear spring morning in smooth seas and with light winds, the three crew of a potting vessel were starting to shoot the gear after rebaiting the pots. The usual practice on board was for the crew to stand at the side of the working deck as the back rope and pots payed out through the coverless shooting hatch in the stern (Figure 1). However, on this occasion, one crew member was standing in the fish bay area (Figure 2) where the float line was coiled (Figure 3). As the line payed out, the crew member's leg became entangled in a bight of float line and they were pulled overboard after the last pot.

Figure 2: The fish bay area where the crew member was standing

1. **Procedure** → The usual working procedure on board the vessel was for the crew to stand aside when the vessel was shooting pots, to avoid becoming entangled in any lines or being struck by moving equipment. In this case, the crew member deviated from the usual procedure and was standing in an area where coiled lines were attached to the fleet of pots that were being shot.
2. **Observe** → The crew member did not observe their surroundings and therefore failed to identify the risk of standing near the coiled lines. Conversely, the skipper was observing the shooting operation closely from their position inside the wheelhouse, which meant that the skipper and other crew member were able to react quickly when they saw their crewmate being dragged overboard.

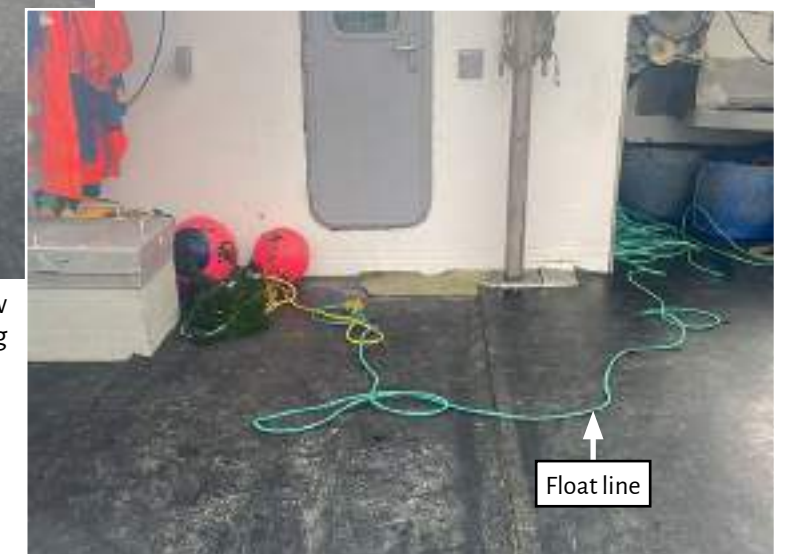
Figure 3: The float line coiled on the working deck

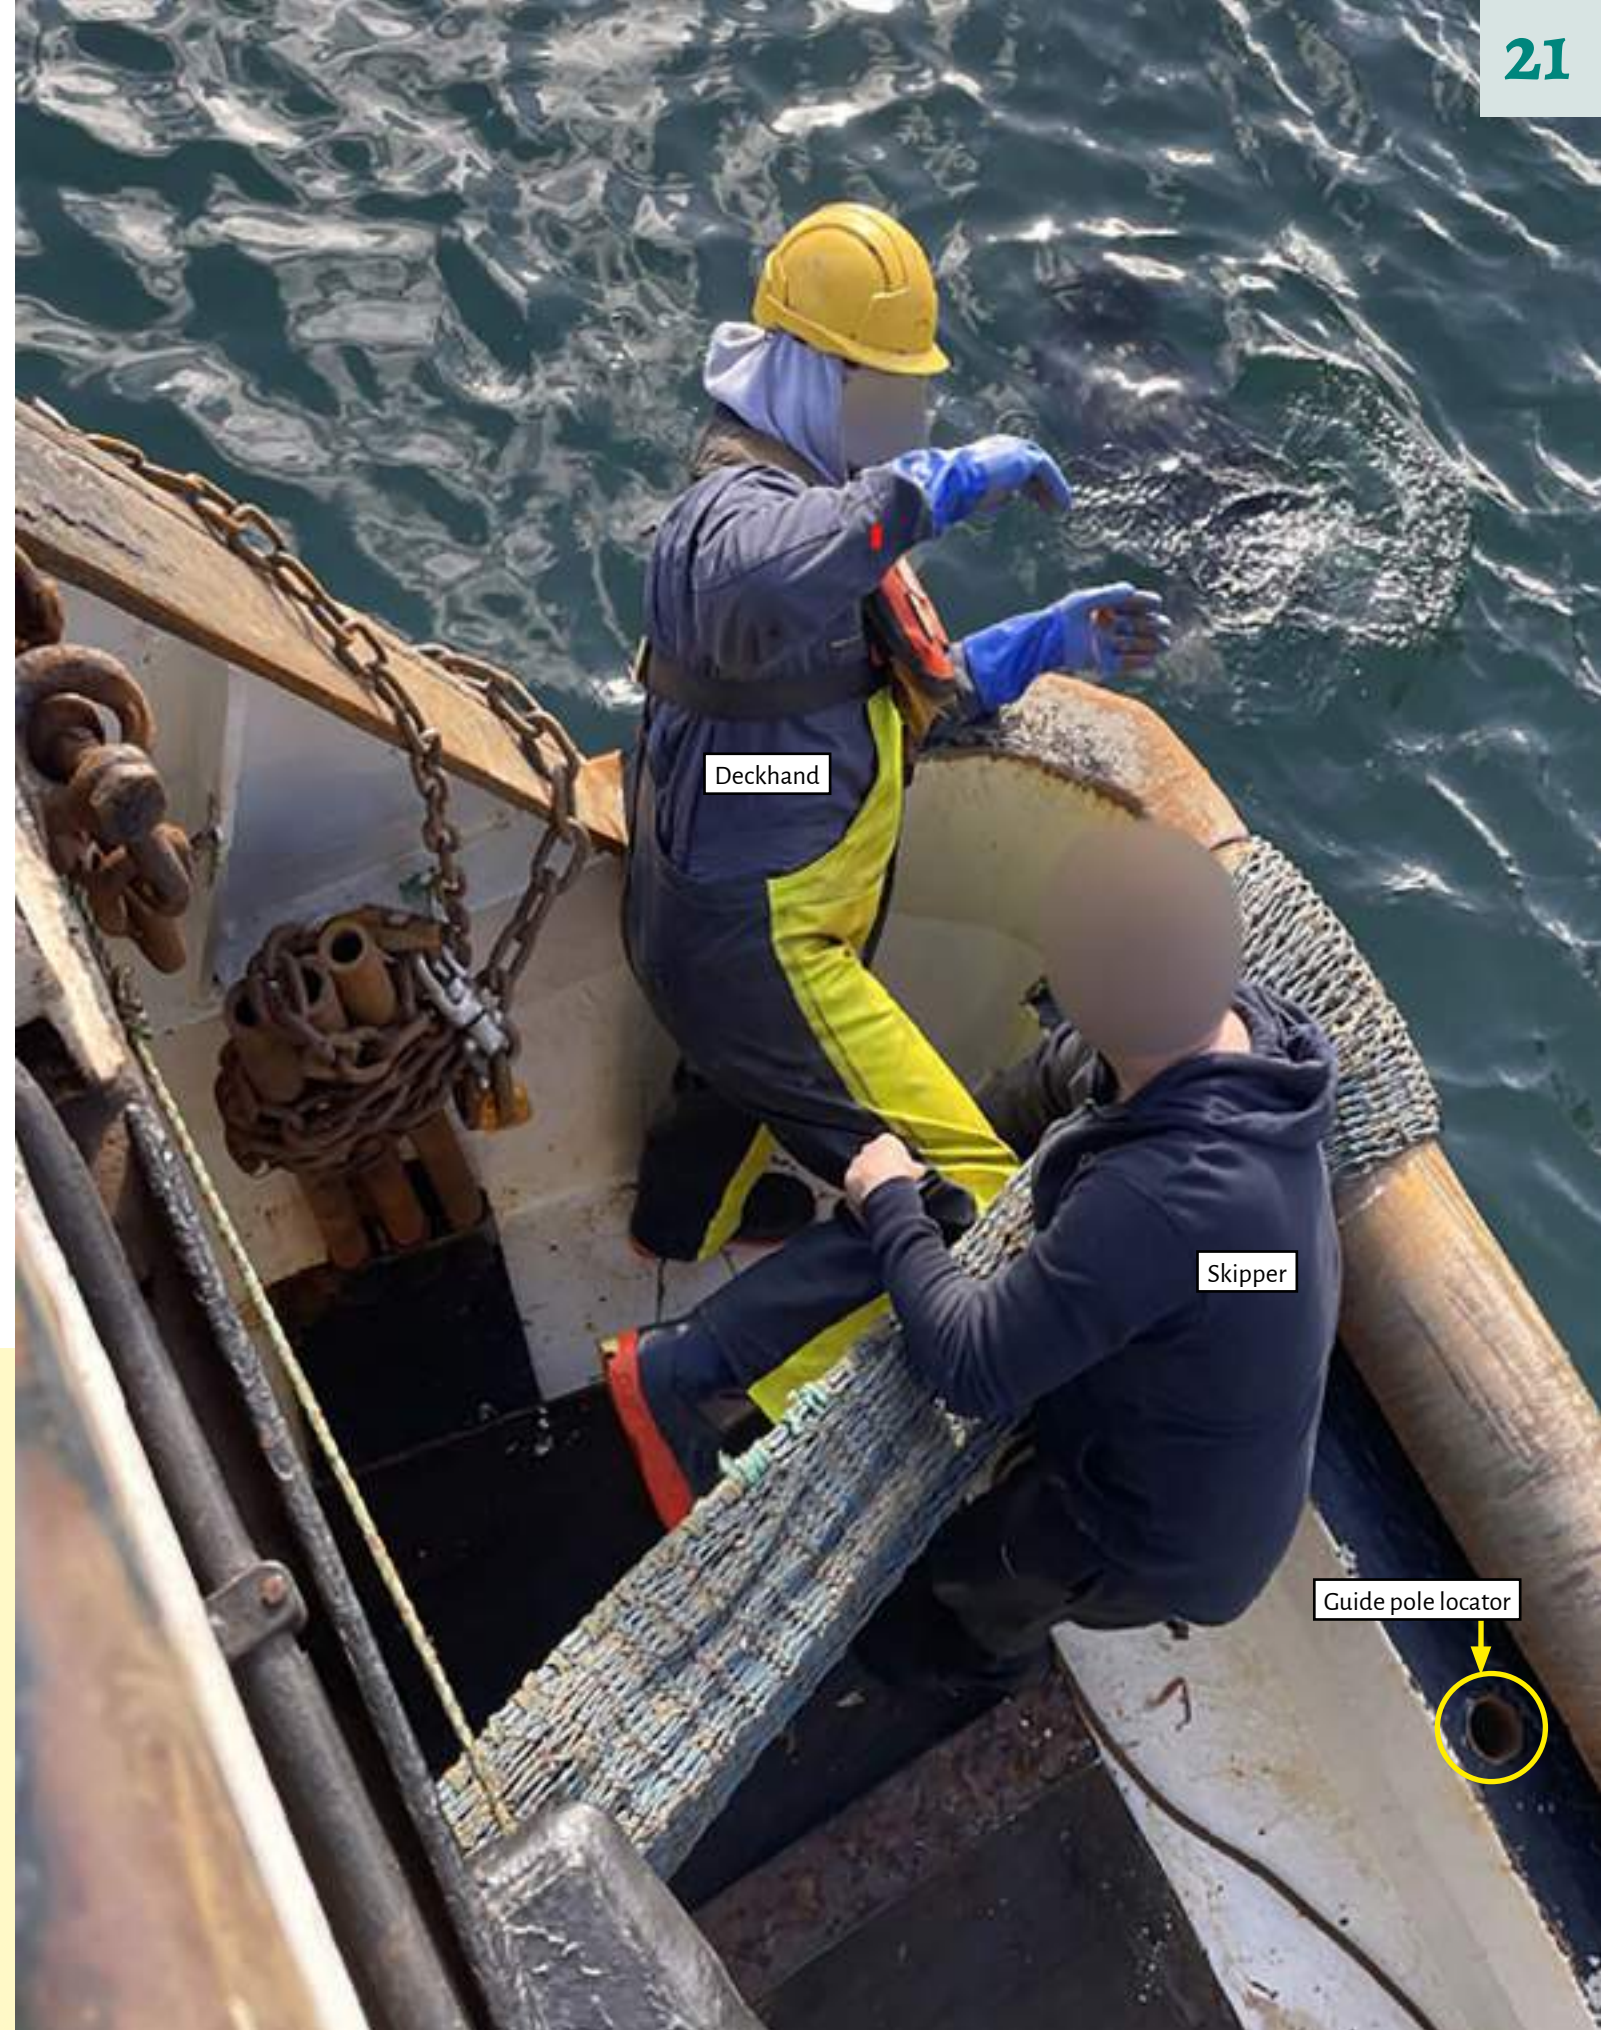
The deckhand was subsequently airlifted to hospital and later discharged with broken ribs and significant bruising.

Figure: Reconstruction, showing the deckhand standing in working position between the bulwark and net

3. **Hazard** → An unconstrained net during hauling is a significant hazard in anything other than the most benign conditions. The operation requires careful monitoring to prevent shortcuts being taken or complacency creeping in. Reminding crew of the hazards before they start working the net is advised.

4. **Observe** → The quick actions of the skipper in this case prevented a much more serious situation developing. Close observation of the crew and their activities during high-risk operational tasks ensures full awareness of the situation and enables swift action to be taken in the event of an emergency.

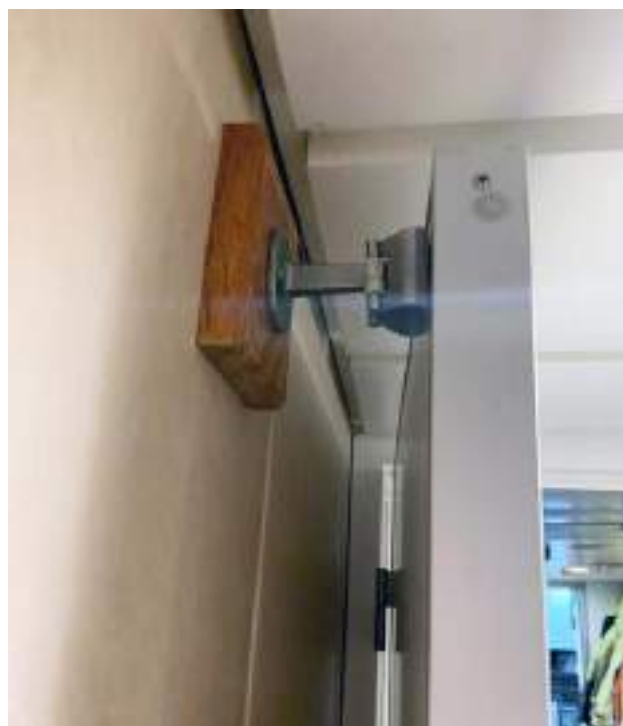
environmentally challenging conditions for about 10 hours, the injured crew member was airlifted from the fishing trawler and transferred to hospital where they underwent surgery. Fortunately, the surgeon managed to save the little finger.

Figure 1: The hold-open mechanism on the door

- Aware** → Take care when moving around any vessel, particularly in rough seas. Entrapment of hands in doors is a common hazard and you should exercise caution when walking through or standing near to a doorway. Keep hands and fingers clear of the doorframe to prevent accidents occurring due to the unexpected release of a hold-open door mechanism, which can cause self-closing doors to shut quickly and with force. The fitting of pneumatic door closers can reduce the force with which the door is pulled shut.

- Check** → Regular inspections of door mechanisms helps prevent accidents caused by doors unexpectedly opening or closing while the vessel is moving. Make sure doors are securely retained in their open and closed positions and that the mechanisms for doing so function correctly. The fitting of pneumatic door closers can reduce the force with which doors operate.

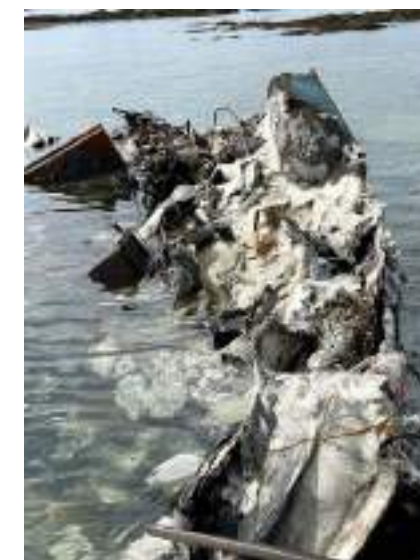
A fire had started near the electronic devices that had been left to charge. The skipper considered using one of the handheld fire extinguishers on board but the fire appeared to be spreading rapidly and, recognising the gravity of the situation, they

Figure: The remains of the vessel

The skipper used the VHF radio to transmit a “Mayday” call and was picked up by another sailing vessel and taken ashore. Fortunately, they had not sustained serious injuries and were treated for smoke inhalation and emotional shock; however, the sailing vessel burned down to the bilges and sank, eventually coming to rest on a sandbank (see figure).

- Hazard** → Lithium-ion (Li-ion) batteries present a fire hazard and should be used with this in mind, particularly when they are being recharged. Ensure that associated equipment such as charging cables and plugs are both compatible with Li-ion devices and undamaged before use. Never attempt to charge potentially damaged batteries. Items containing Li-ion batteries should be stored in a non-combustible area maintained at a temperature of 4°C to 26°C. Consider the consequences of activities that pose a combustion risk on board sailing vessels, which are often constructed of wood, plastic and fibreglass, and take steps to mitigate this by installing appropriate equipment such as fire extinguishers and fire blankets. The London Fire Brigade provides useful fire safety guidance on Li-ion chargers and batteries: <https://www.london-fire.gov.uk/safety/the-home/electrical-items/batteries-and-chargers/>

- Plan** → The skipper was unable to fight the fire due to the speed and ferocity with which it progressed. However, the readiness of their personal belongings packed in a single bag and a handheld VHF meant they were able to evacuate the area quickly and with the equipment needed to improve their chances of rescue. The skipper was also already wearing their lifejacket so were prepared to enter the water had they not had time to launch the tender.

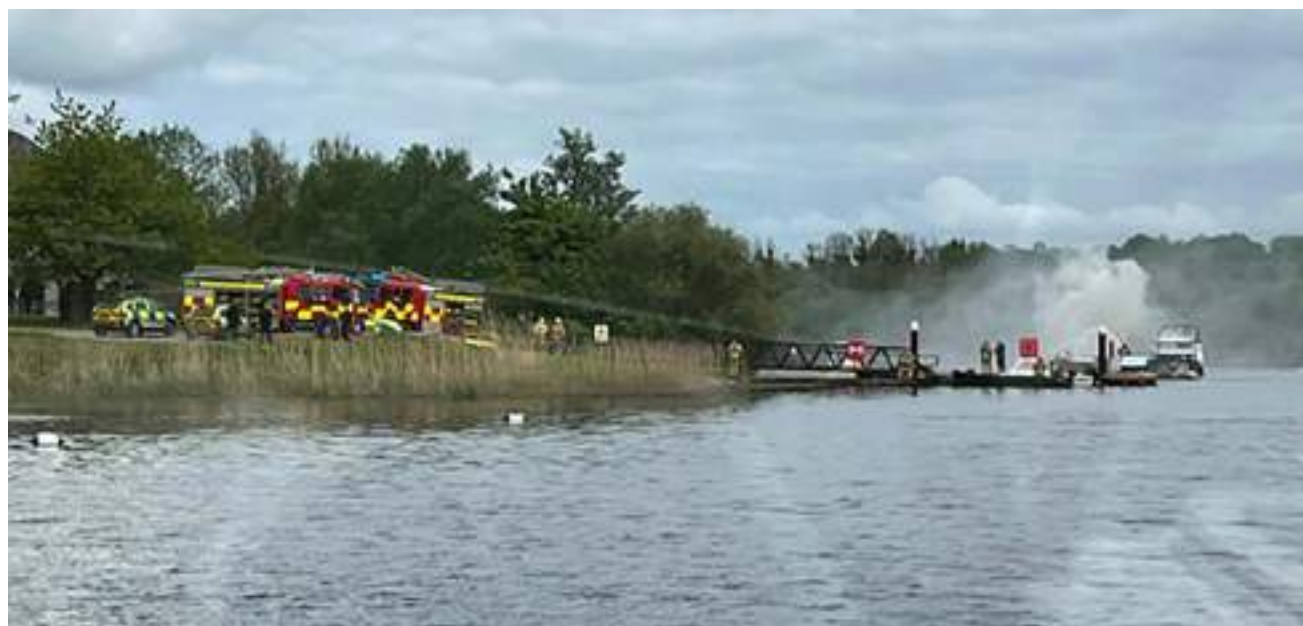
The emergency services arrived on the scene, having been called by marina staff. The fire brigade doused the yacht with water to extinguish the flames (Figure 1). The owner was recovered from the loch by police and medics

Figure 1: Emergency services attending the scene
