# SAFETY DIGEST

Lessons from Marine Accident Reports

2/2023

# MARINE ACCIDENT INVESTIGATION BRANCH

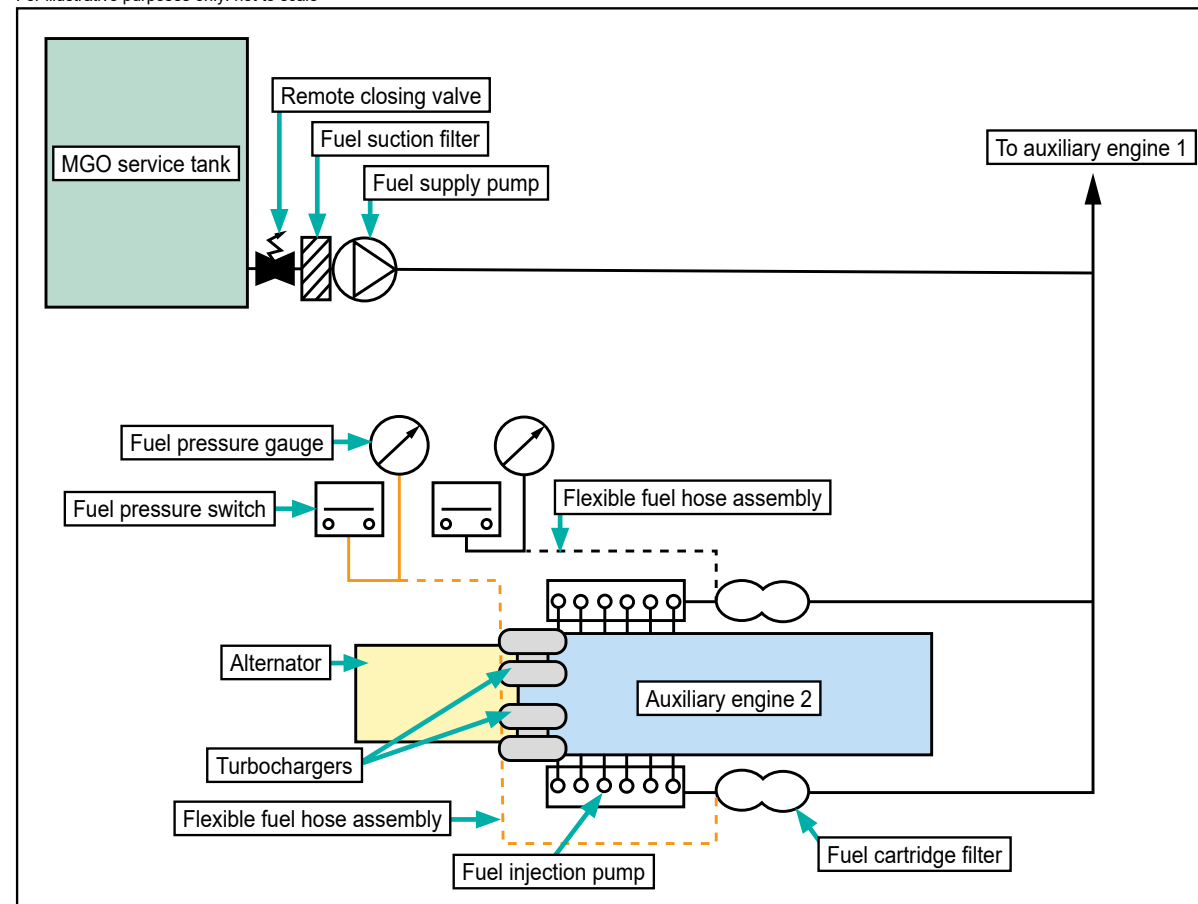
**Figure 2:** Schematic diagram of auxiliary engine fuel supply system

The flexible fuel hose that failed in the accident was connected to the outlet from the inboard set of AE2 cartridge filters (**Figure 3a**); the hose was routed aft along the engine and passed over the top of the flywheel cover under the turbochargers (**Figures 3b and 3c**). It then connected to a pressure sensor on an instrument panel mounted outboard of the AE2 alternator. Both this hose and the matching hose on AE1 were 3.4m in length. No isolation valve was installed at the connection to the cartridge filters.

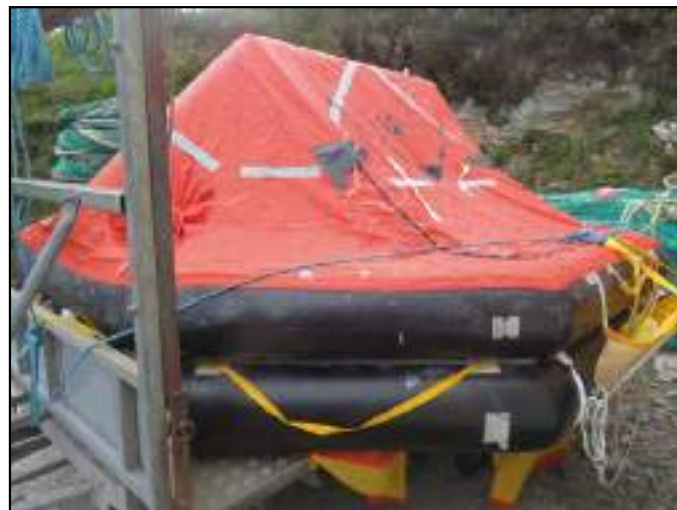
**Potential failure of**  
**Deutsche Schlauchboot GmbH (DSB) liferafts**  
**serviced by Comfer Marin SL, Marin, Spain**  
**identified following the foundering of the fishing vessel**  
***Piedras* (FD 528)**  
**south-west of Mizen Head, the Republic of Ireland**  
**on 1 June 2022**

Recovered *Piedras* starboard liferaft
