Report on the investigation of the falling of  
a lifeboat into the sea during  
a launching exercise on board the  
polar research vessel

***RRS Sir David Attenborough***

on Loch Buie, Isle of Mull, Scotland

on 4 March 2021

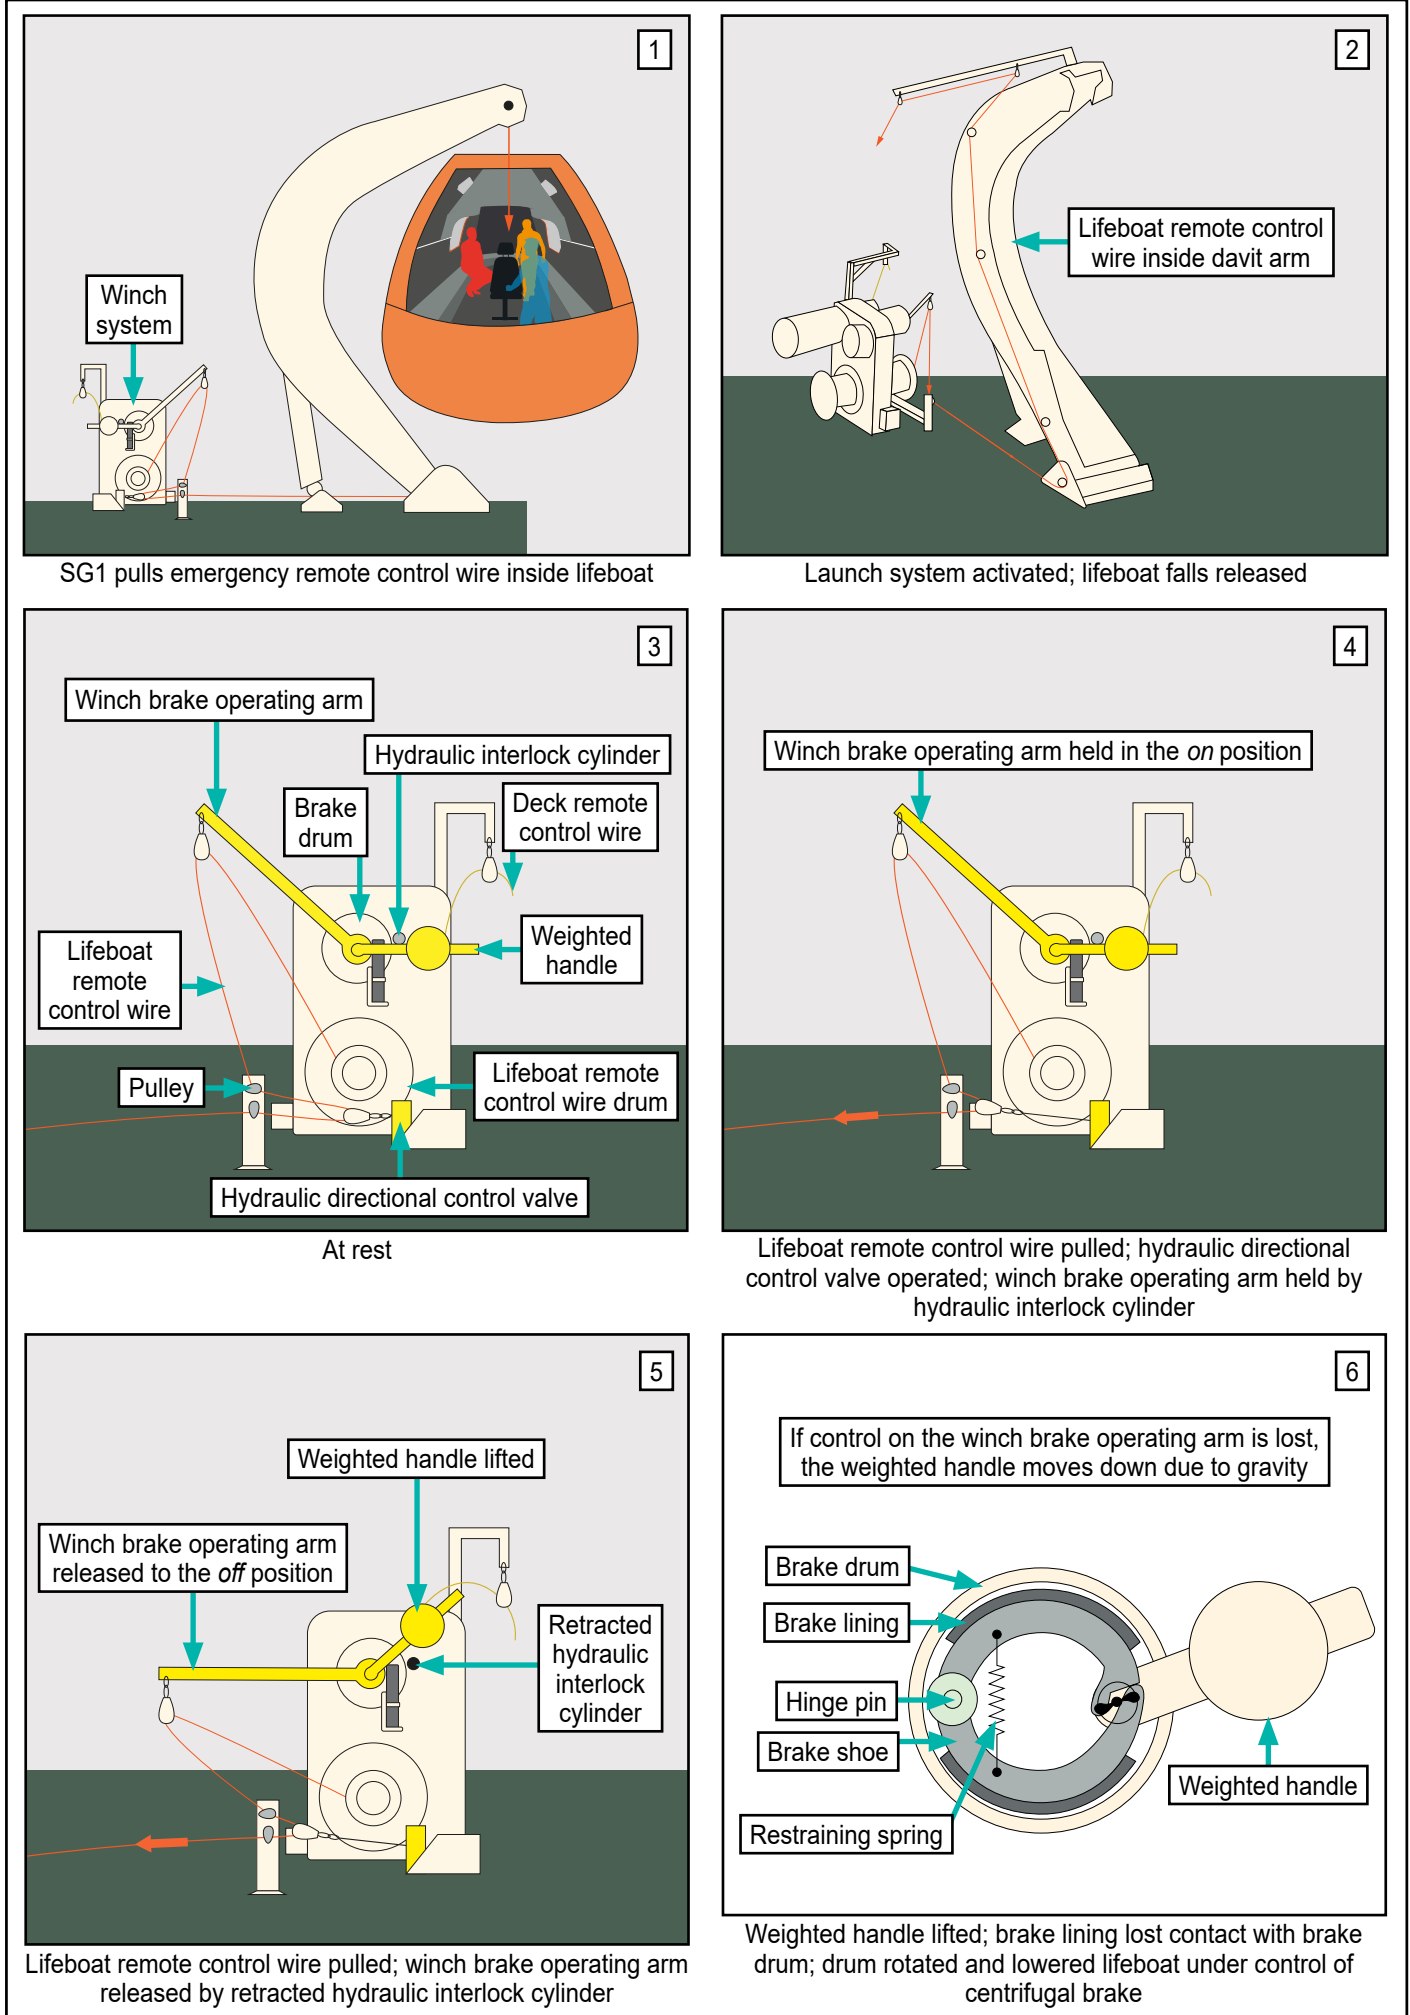
**Figure 4:** Davit system launch remote control method

The electric push button controller was fitted with an emergency stop button that cut all electric power to the davit system when pressed. This did not affect the launching of the lifeboat in either dead ship launch mode or training mode when the hydraulic directional control valve was operated by the attached wires.

In the event of total power failure and abandonment of the ship, the lifeboat was launched using the emergency remote control wire from inside the lifeboat following embarkation (**Figure 4**). The tension on the remote control wire operated the hydraulic directional control valve and stored hydraulic pressure moved the davit arms to the fully turned out position. The winch brake arm was prevented from lifting by the locking pin (**Figure 5**). When the davit arms were fully turned out the hydraulic proximity switches activated, retracting the winch brake arm locking pin. Tension on the remote control wire lifted the winch brake arm and the lifeboat was lowered to the water.

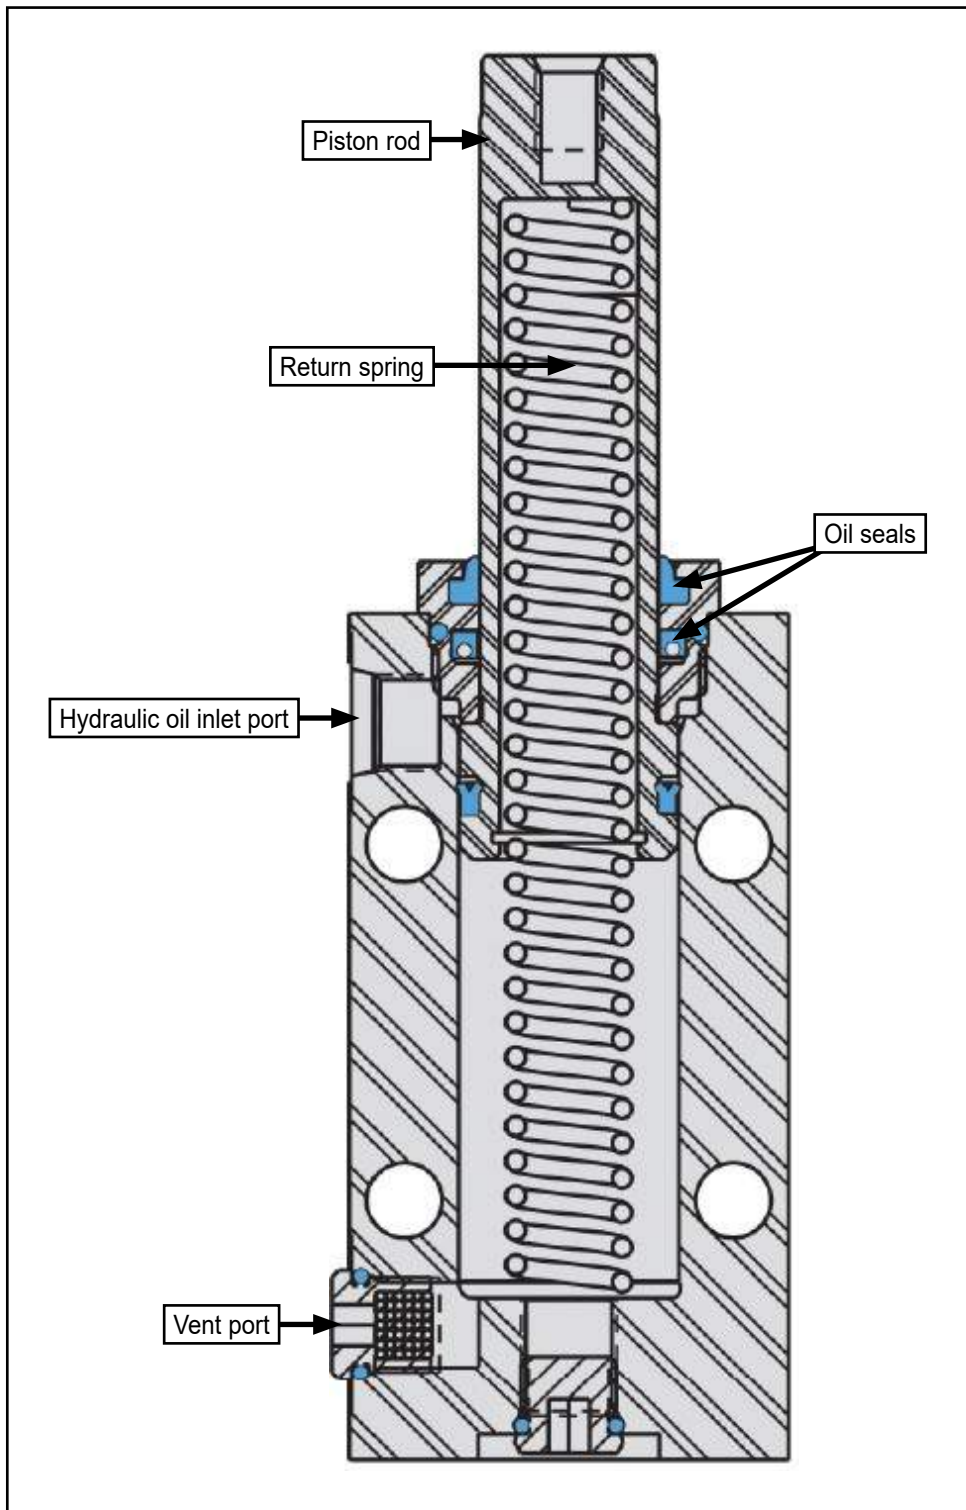
**Figure 6:** Cross-section of the hydraulic interlock cylinder

The interlock cylinder piston rod was retracted by applying hydraulic pressure through the hydraulic oil inlet port that acted against a piston, the other side of which was vented to atmosphere via a sintered bronze filter. When hydraulic pressure was removed the piston rod and its locking pin were extended outwards by means of a return spring (**Figure 6**).
