NATIONAL TRANSPORTATION SAFETY BOARD

2022

SAFER SEAS Digest

Lessons Learned from
Marine Investigations

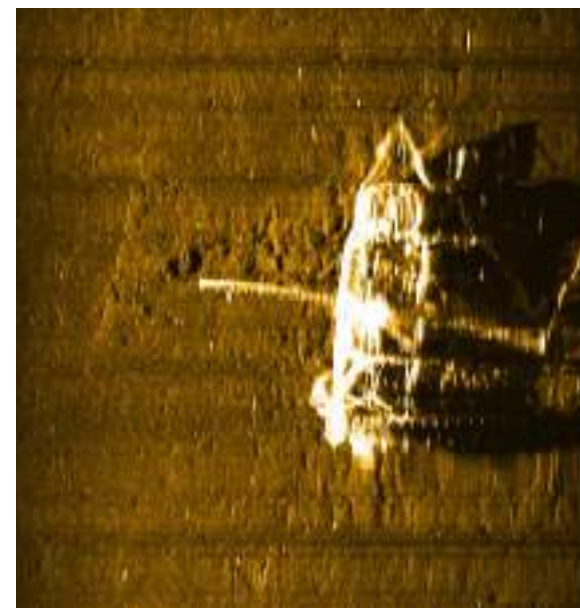
Figure 4. Side scan sonar image of *Emmy Rose* from 246 feet above at 600 kilohertz.

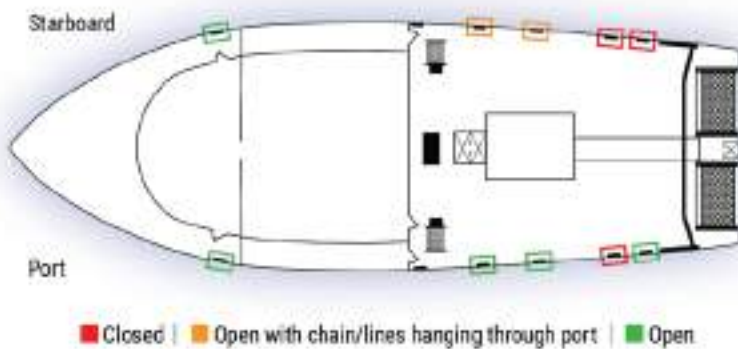
Figure 6. Status of *Emmy Rose* freeing ports during ROV survey.

We found that at the time of the sinking, the *Emmy Rose*'s freeing ports did not meet regulatory requirements for freeing port area and freeing port cover design, thus making the vessel more susceptible to accumulating water on deck. Additionally, we found that the vessel's lazarette hatch had a nonwatertight cover that had no securing mechanism, which meant the *Emmy Rose* was not being operated in accordance with its stability instructions and fishing vessel regulations, and water likely began flooding the vessel through the hatch that was likely opened by the sloshing seawater on the stern. As a result, we **recommended** that the Coast Guard increase the scope of commercial fishing vessel safety examinations to include inspections of freeing port covers and hatch covers.

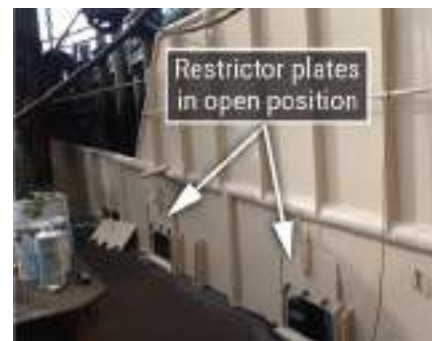
Figure 7. Freeing ports on portside bulwarks.

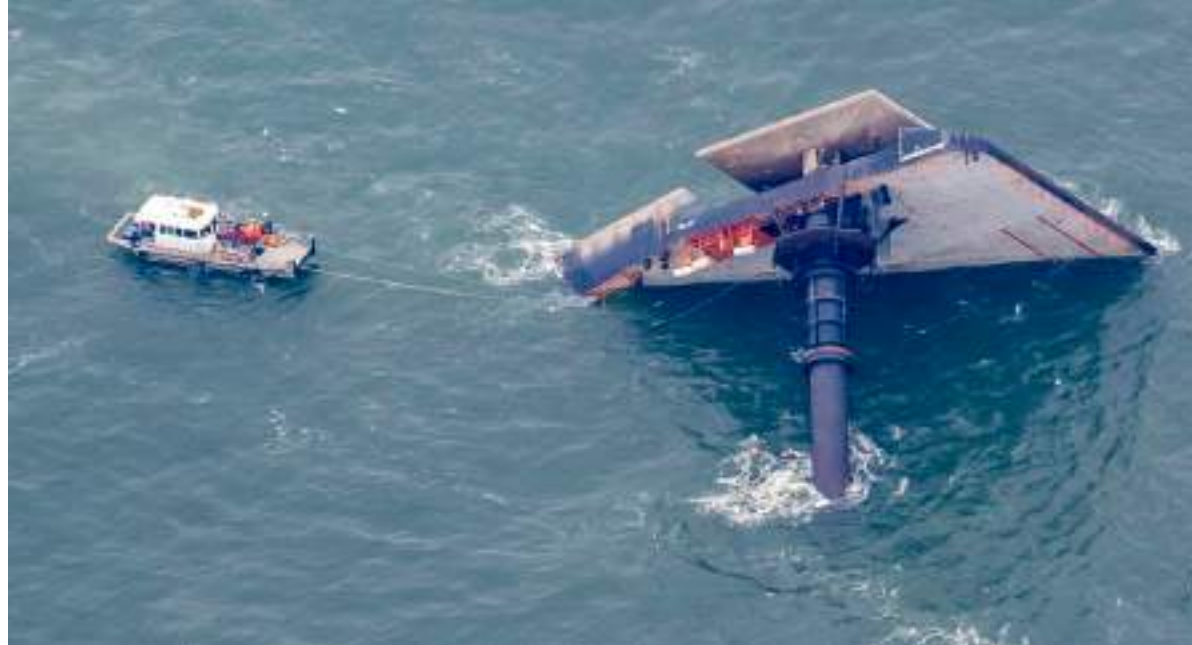
Figure 10. *SEACOR Power* after capsizing in the Gulf of Mexico when struck by severe thunderstorm winds.

THE PROBABLE CAUSE of the capsizing of the liftboat *SEACOR Power* was a loss of stability that occurred when the vessel was struck by severe thunderstorm winds, which exceeded the vessel's operational wind speed limits. Contributing to the loss of life on the vessel were the speed at which the vessel capsized and the angle at which it came to rest, which made egress difficult, and the high winds and seas in the aftermath of the capsizing, which hampered rescue efforts.

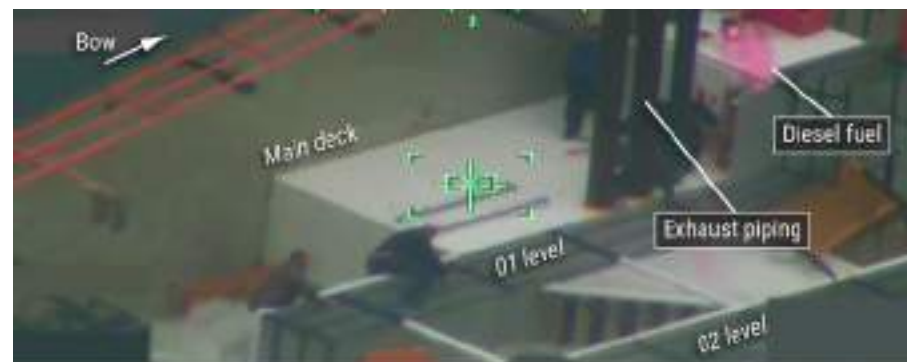
Figure 13. Left: Port side of the capsized hull about 1755. Some personnel are visible.

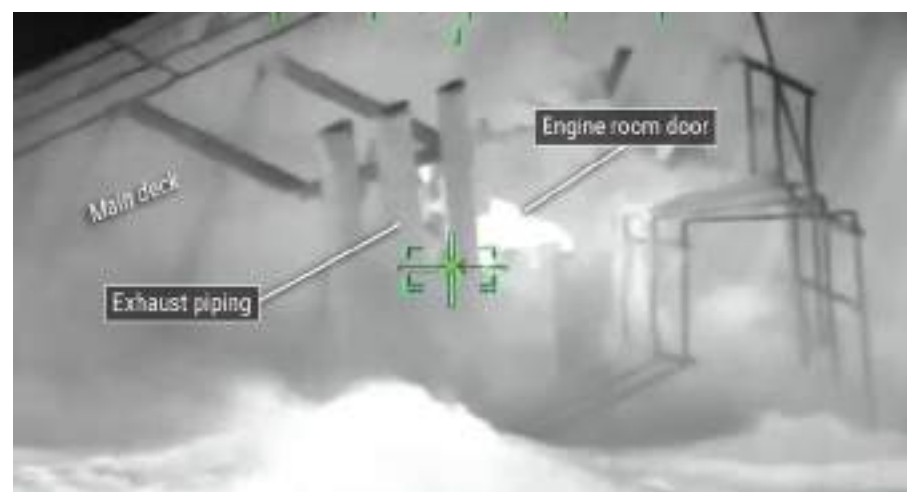
Figure 14. Door to engine room as it was opened at 2153, as seen by the Glen Harris.

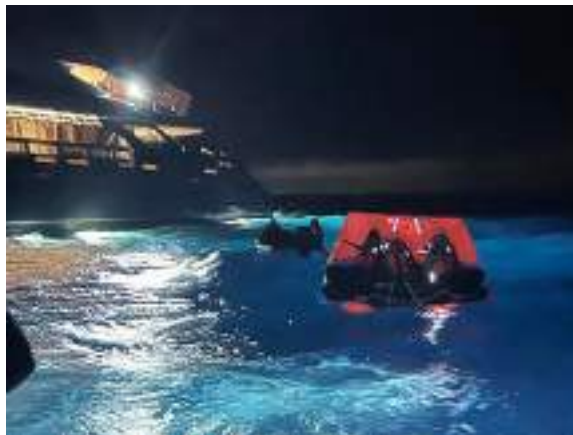
Figure 30. *Tropic Breeze* crew wearing lifejackets in the liferaft and rescue boat before rescue. The *Utopia IV* is in the background. SOURCE: AMARA

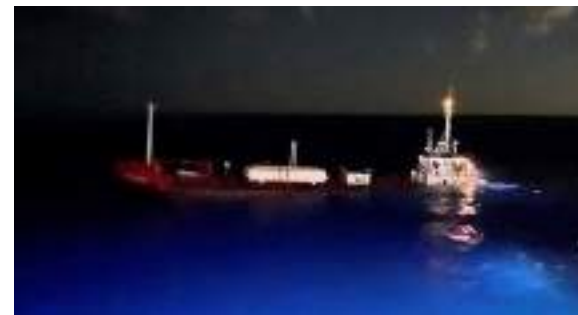
Figure 31. *Tropic Breeze* sinking by its stern about 15 minutes after the collision. SOURCE: AMARA

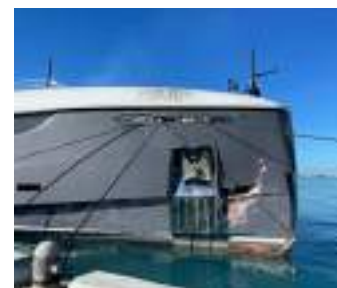
Figure 32. Damage to *Utopia IV*'s bow. SOURCE: COAST GUARD

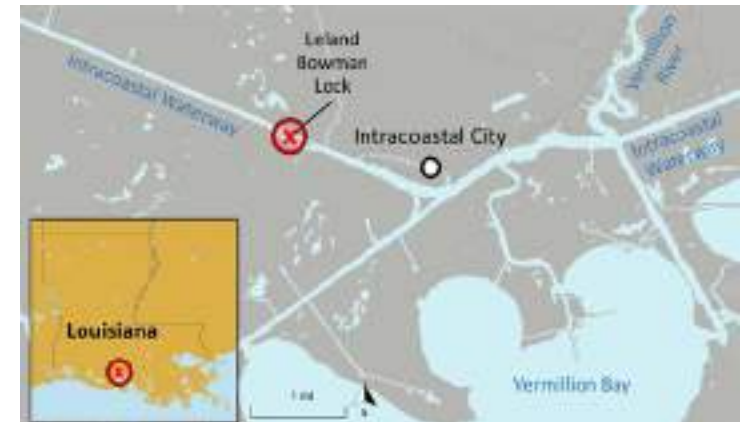
Figure 35. Area where the *Ava Claire* tow contacted the Leland Bowman Lock gate, as indicated by the red X.

When the tow was about 200 feet from the gates, the captain put the engines at full astern. The tow continued to slow but did not fully stop before the starboard bow of the *HFL 439* struck gate no. 3 on the northwest side of the lock at 0522. The tow's speed when it contacted the gate was 1.2 mph.

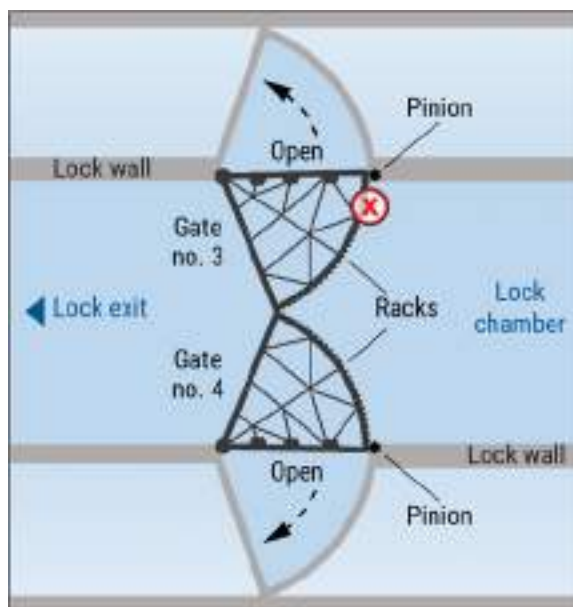
Figure 37. Left: Simplified illustration of Leland Bowman Lock western gates showing the point of contact by barge *HFL 439*, as indicated by the red X.

Figure 38. Below: Damaged steel plating and rack on gate.

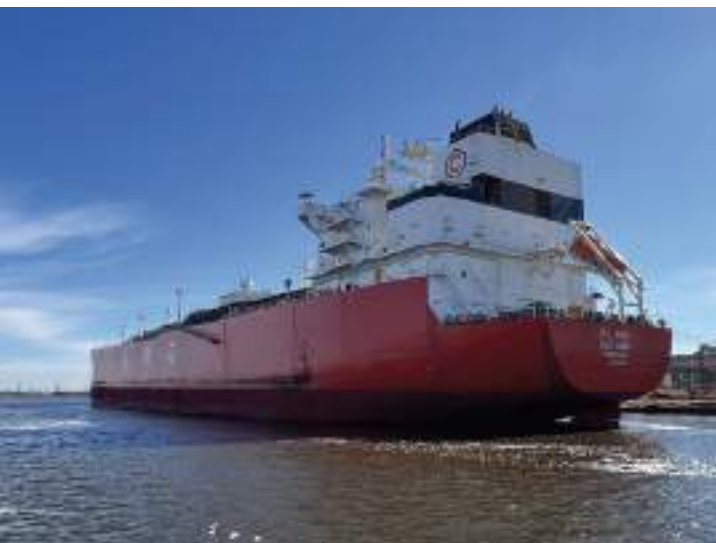
Figure 39. *Gas Ares* after the casualty.

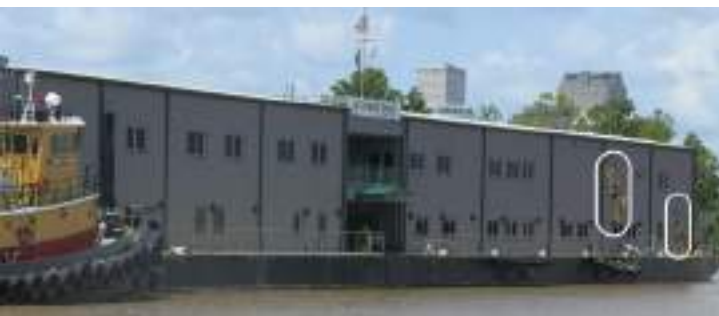
As the two dispatchers aboard the office barge were attempting to evacuate, one dispatcher heard the blast of the ship's whistle, and shortly after, the bulbous bow of the *Jalma Topic* struck the downriver corner of the office barge at 0322:40, at a speed of 6.2 knots, breaching the *Jalma Topic*'s bulbous bow and breaking the barge from its permanent moorings. The two dispatchers and a cleaner were later able to exit the barge to the shore.

Figure 47. Office barge with detached mooring apparatus and structural penetrations (outlined in white).

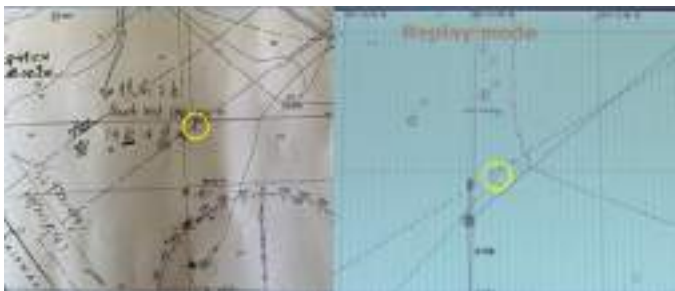
Although SP-83A was depicted on the British Admiralty paper chart on the bridge, it nor other nearby platforms were marked as obstacles as required by the company's SMS. The mate was aware of the platform when he plotted fixes on the paper chart nearly an hour before the casualty but did not think it was of concern. He also did not tell the master about the platform on the chart and assumed the master was aware of it.

Figure 56. Navigation aids used by the *Ocean Princess* bridge team, with the location of platform SP-83A shown annotated by NTSB with a yellow circle (images are at different scales). The British Admiralty chart 3857 (left) and ECDIS screenshot from the *Ocean Princess* fed by NOAA ENCs (right), which were up to date at the time of the casualty. The British Admiralty chart shows SP-83A while the ECDIS image does not.

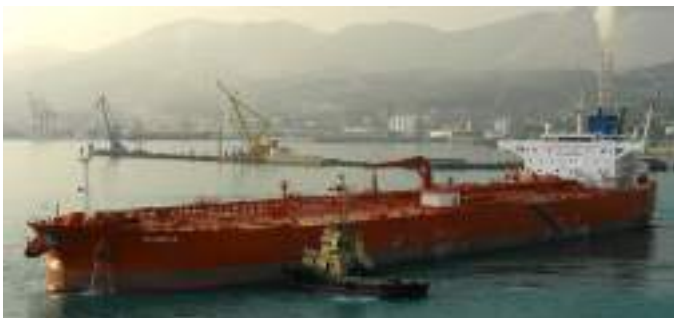
Figure 58. Damage to the no. 4 Moda dock catwalk (left) and the *Riverside* (right, circled). SOURCE: COAST GUARD

The captain informed pilot 2 that they had "lost the engine." Pilot 2 contacted a nearby tug, *Honor*, which pushed against the *Riverside*'s port bow and affected the vessel's direction back toward the channel. Pilot 2 ordered dead slow astern, and the chief engineer tried to start the engine astern locally, but it failed to start. At 1302, the *Riverside*'s port bow struck the mooring dolphin and catwalk at the end of the no. 4 Moda dock at 5 knots.

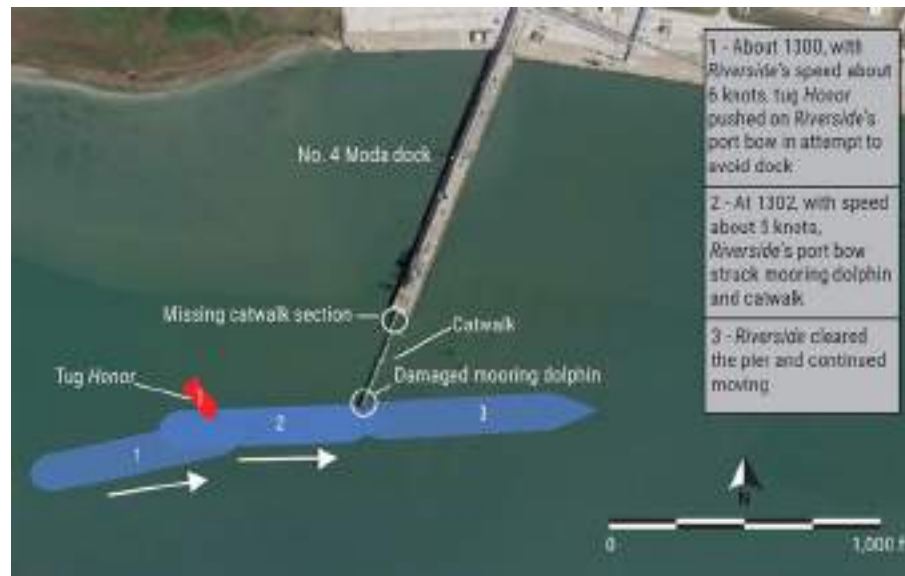
Figure 60. Final events surrounding the *Riverside*'s contact with the no. 4 Moda dock. BACKGROUND SOURCE: GOOGLE EARTH

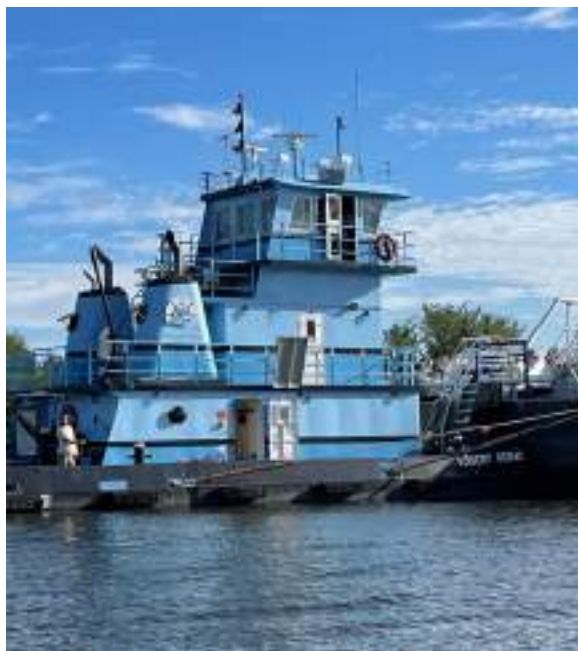
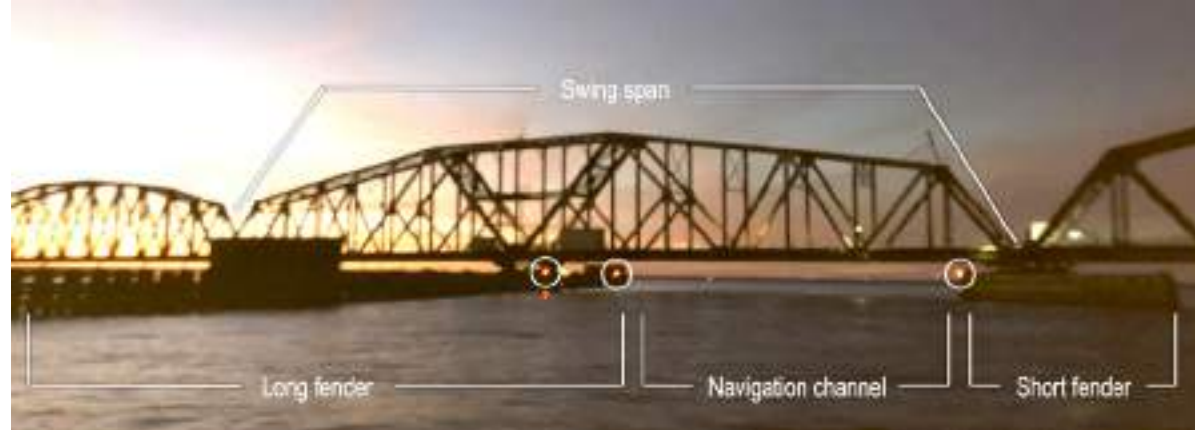
Figure 62. January 29, 2021, post-casualty photo of the Rigolets Bridge (*in the closed position*), as it would have been approached from the south, heading north. Red navigation lights on the long and short fenders are circled. Note there are no navigation lights at the top of and each end of the swing span, and there are no red navigation lights at either end of the short or long fenders, nor anywhere on the south side of the bridge on the short or long fenders.

The captain and pilot stated it was difficult to see the channel through the bridge fenders, and investigators determined that required navigation lights were not located at the fender ends. Investigators also found that the swing span was not fitted with any navigation lighting, as required by regulation, to indicate that it was in the open or closed position. Had the swing span been lighted as required, the captain would likely have been able to visually determine the position of the swing span throughout its opening sequence.

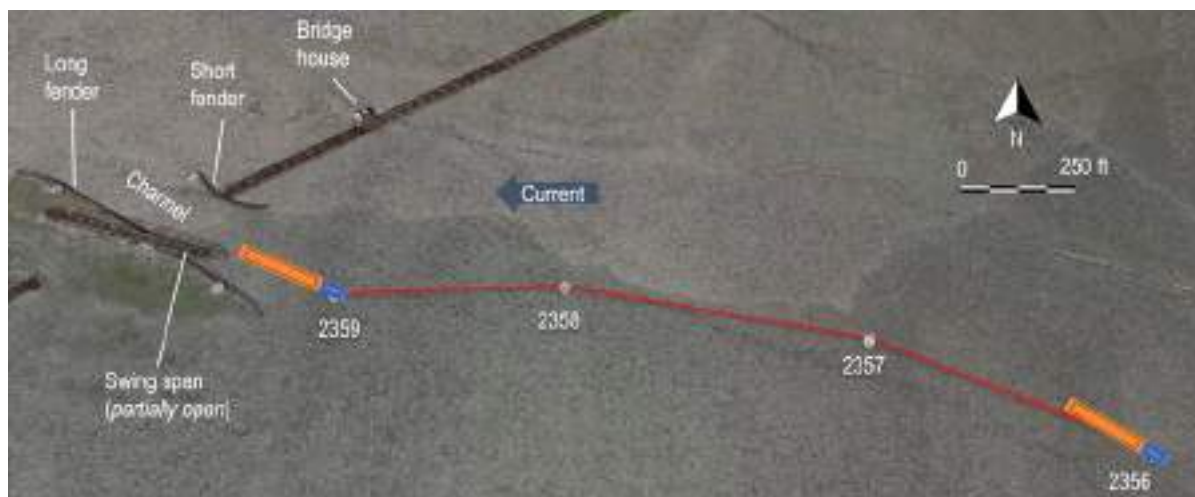
Figure 63. (Above) Trackline of the *Robert Cenac*, based on AIS course over ground data and the approximate position of the tow upon its contact with the Rigolets Bridge. Bridge position in the photo is about three-quarters of the way open. Tow headings are estimated. BACKGROUND SOURCE: GOOGLE EARTH

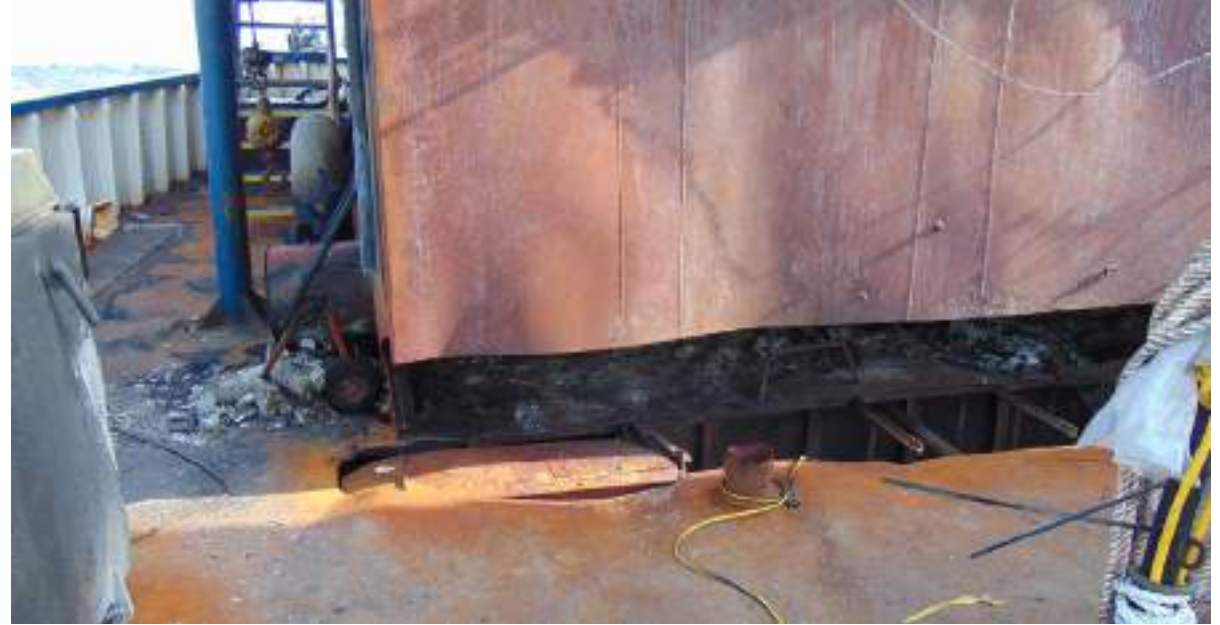
Figure 66. *Aleutian Falcon* bridge deck post-fire, depicting hot work area on the day of the casualty.

On February 17, 2021, workers planned to continue ongoing hot work by removing corroded steel deck plating located on the bridge deck above the pantry, dry stores area, and walk-in refrigerator. Because the work was in an area that adjoined foam insulation below, a marine chemist had previously been brought

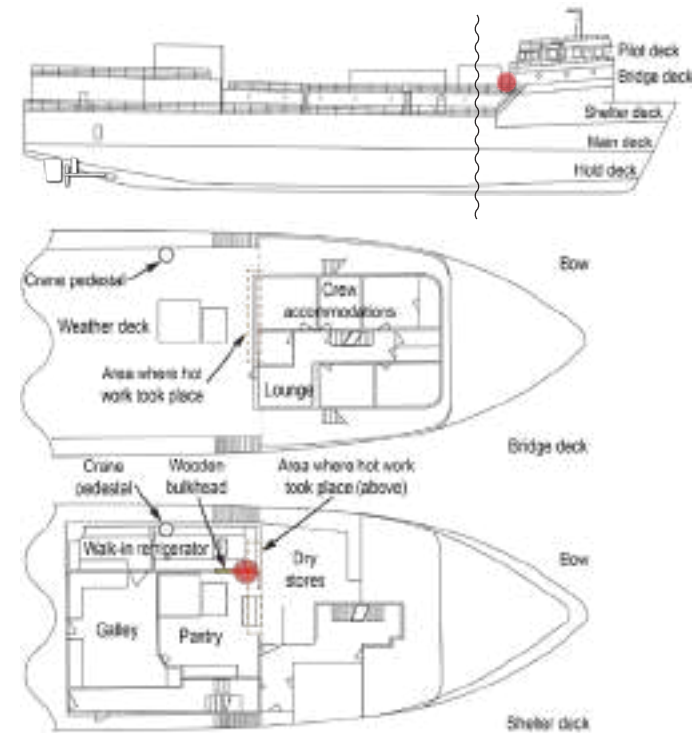
Figure 67. Profile (top) and bridge and shelter deck arrangements (bottom) of *Aleutian Falcon*. The area where the fire began on the shelter deck is indicated by a red circle. The area of the bridge deck where the deck was being cut is highlighted with orange dashed lines.

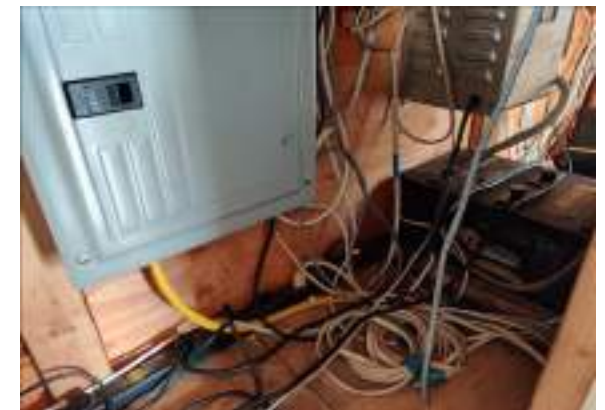
(*Blue Dragon II*) and found wiring that did not meet typical marine standards (improper connections, loose, disorganized, and bare wires) under the wooden wheelhouse console, as well as computer equipment and batteries. Such substandard electrical outfitting can result in an electrical fault, which can serve as a source of ignition for a fire. Given that both vessels were owned and operated by the same company and were designed with similar console equipment, the condition of the *Blue Dragon's* wiring was likely comparable to the *Blue Dragon II's*. Additionally, because there was similar electrical equipment stowed under both consoles, it is likely the fire started from an electrical source.

Figure 72. *Blue Dragon II* pilothouse console wiring.

Substandard electrical installation and outfitting—including bare wires, unsecured wire nuts, overloaded circuits, loose wiring, and household wiring not designed for marine use—is a common cause of electrical fires. Additionally, batteries have been identified as ignition sources of fires in multiple modes of transportation. Vessel operators should ensure electrical systems are adequately designed, installed, and maintained in accordance with established marine standards to prevent fires.

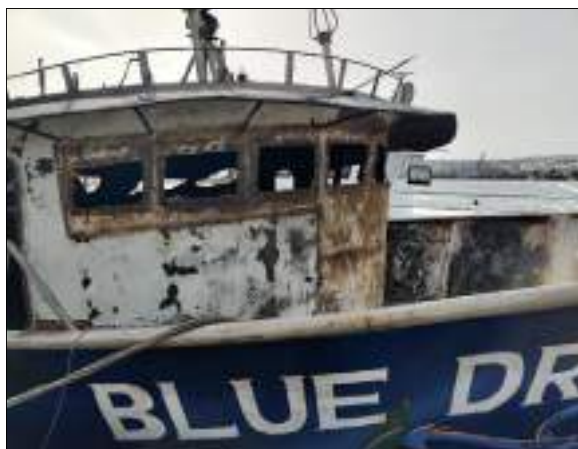
Figure 73. *Blue Dragon* wheelhouse exterior (top) and interior looking forward (bottom), following the fire. The framing of the false deck below indicates the location of what was the wheelhouse deck. SOURCE: COAST GUARD

THE PROBABLE CAUSE of the fire aboard the fishing vessel *Blue Dragon* was from an unknown source, likely electrical in nature, which ignited the wooden wheelhouse console. Contributing to the extent of the fire damage was the substantial use of combustible materials in the joinery, outfitting, and furnishings in the wheelhouse and accommodation spaces.

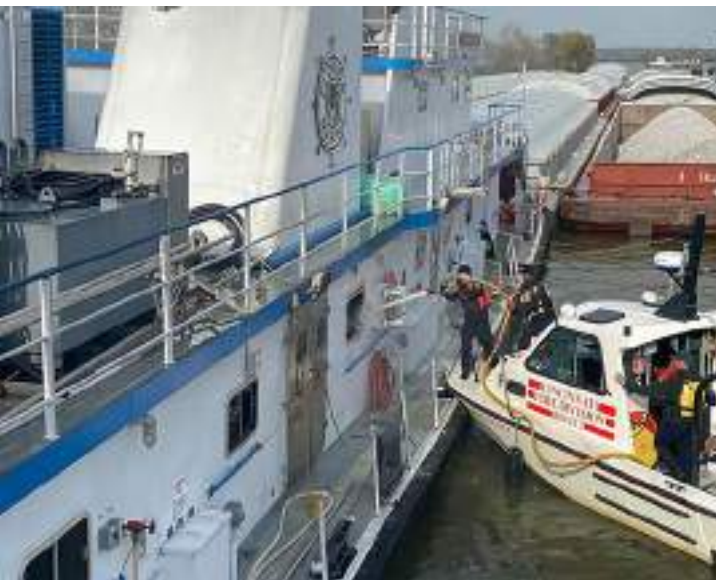
Figure 75. Firefighters deploying water into the engine room of the *Capt. Kirby Dupuis* through an open window.

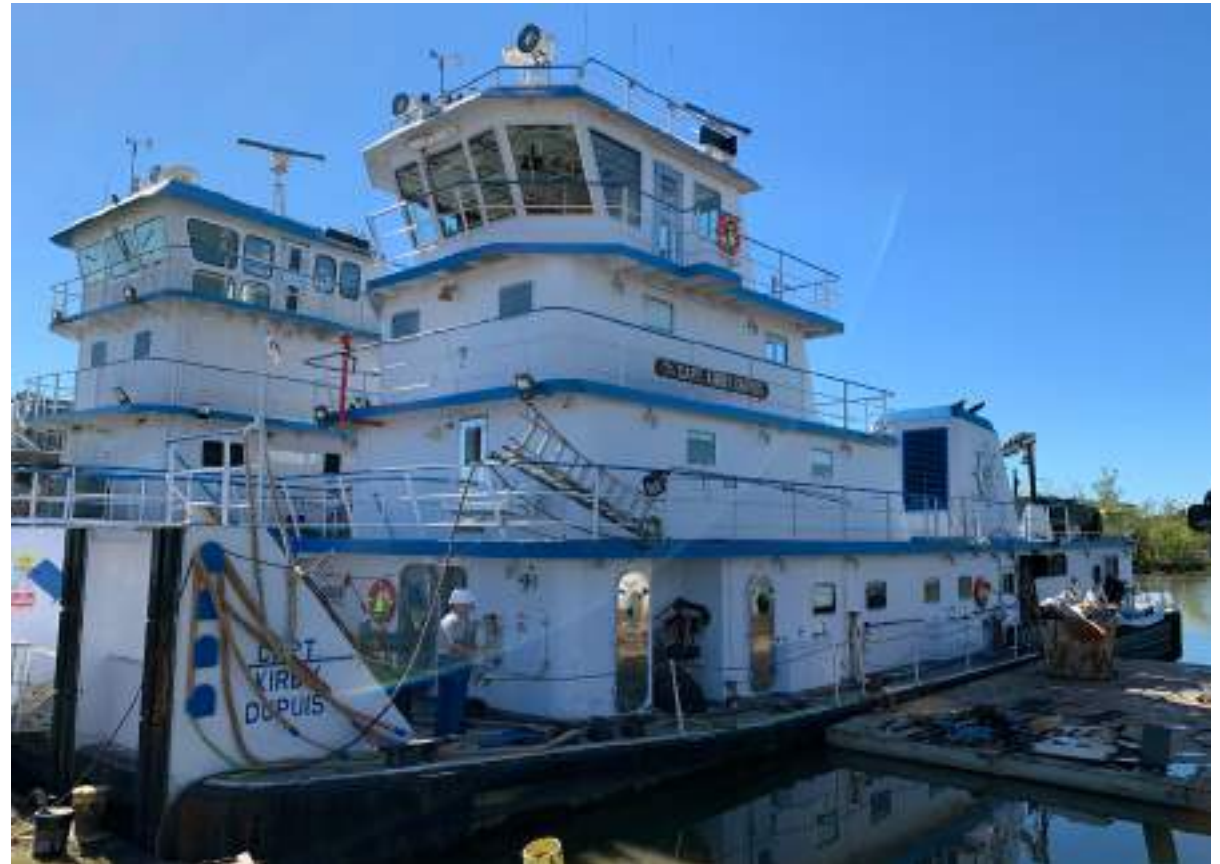
Figure 76. *Capt. Kirby Dupuis* docked following the casualty.

Post-casualty, a service manager from Louisiana Cat (Caterpillar) determined that a broken O-ring was missing from a lube oil tube on the port engine. The tube was also missing a retaining ring and supporting hardware. A sheared bolt indicated that the supporting clips and hardware had originally been installed on the engine but had failed at some point. Without the clips and hardware, the tube was unsupported and more susceptible to vibration and associated movement. It is unknown how long the engine had been operating without the retaining ring, supporting clips, and hardware on the lube oil tube. The technician concluded that the cause of the fire was "a severe oil leak" that sprayed onto the exhaust manifold and ignited.

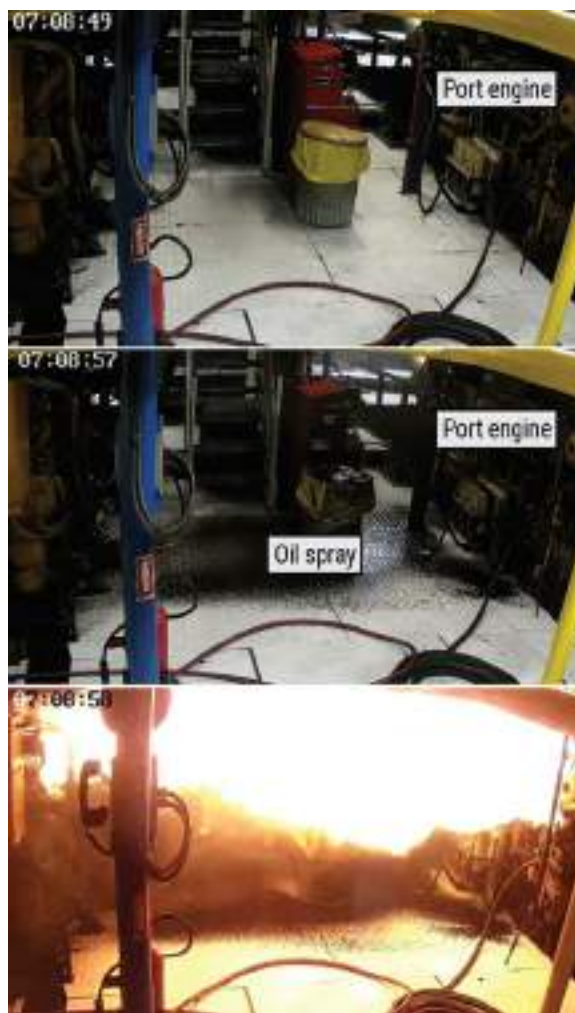
Figure 77. Screenshots from the *Capt. Kirby Dupuis* engine room video camera (looking aft).

However, investigators determined that the system was not activated during the fire. The deckineer did not hear the system's sirens nor product discharging into the engine room. After the fire, both suppression fluid cylinders were full, and the nitrogen pilot cylinder lever was found in the "set" position with its cylinder still fully charged.

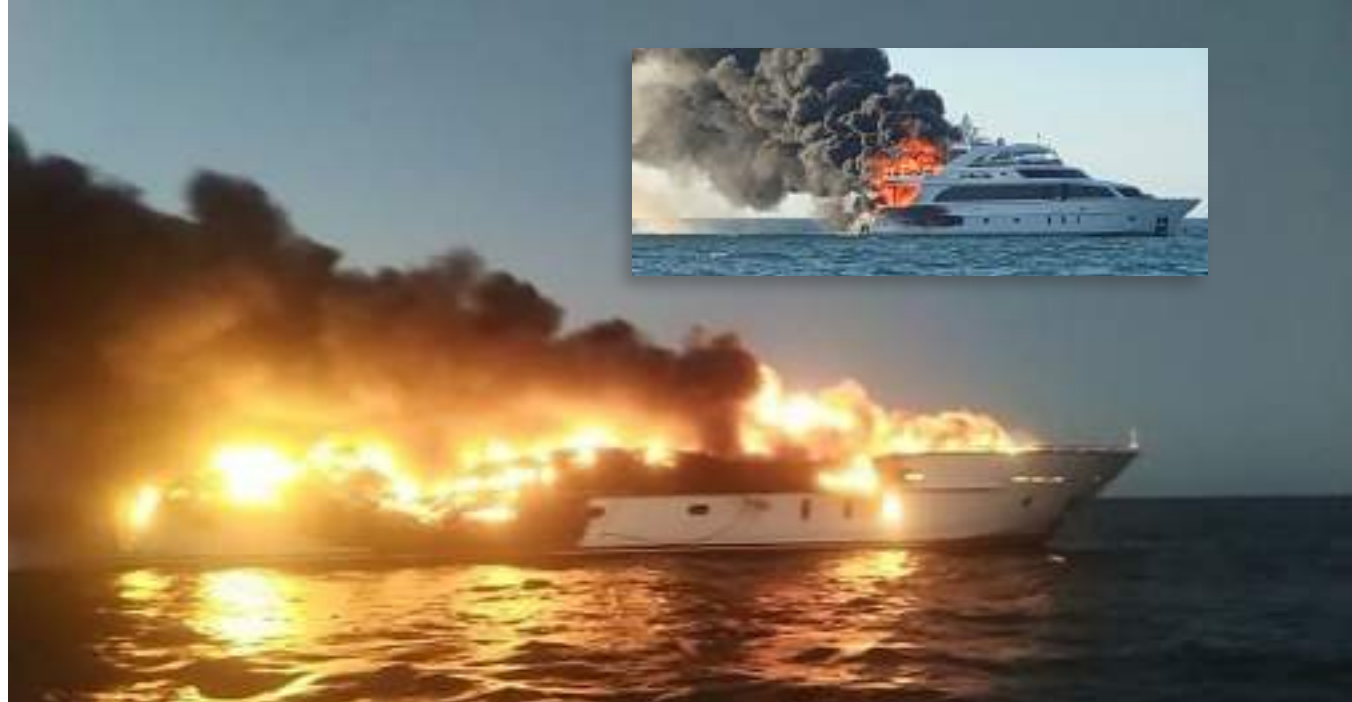
**Figure 79.** *La Dolce Vita* on fire shortly after passengers and crew abandoned the vessel (inset), and the yacht afire shortly after sunset on March 16. SOURCE: LINDSEY SCHULT, CAPTAIN OF *LA DOLCE VITA*

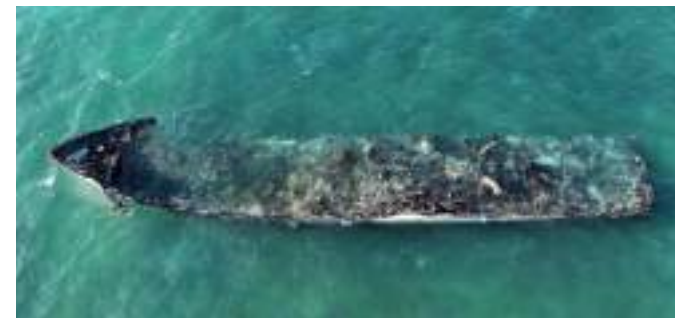
THE PROBABLE CAUSE of the engine room fire aboard the yacht *La Dolce Vita* was an undetermined electrical source within the sound enclosure for the starboard generator. Contributing to the severity of the fire and total loss of the vessel was the inability to secure ventilation to the engine room, which reduced the effectiveness of the yacht's fire extinguishing system and allowed the fire to spread beyond the engine room.

Figure 80. After-fire remains of *La Dolce Vita* before salvage operations. SOURCE: COAST GUARD

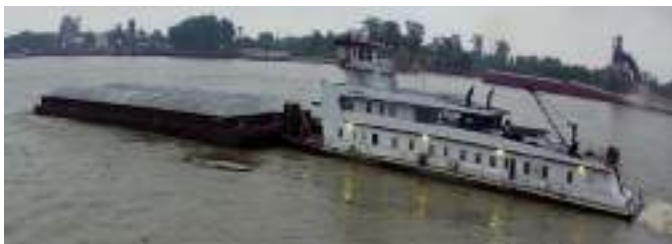
Figure 82. Above: *Mary Lynn* underway at 0652 on May 18, 2021, about a minute before the fire broke out. Below: *Mary Lynn* at 0652:40 (left) when the first open flame, circled in yellow, was visible on the second deck port side exhaust stack, and at 0652:45 (right).

The pressure increase caused the weakest part in the system, the fuel supply bypass sight glass bowl on the port main engine spinon fuel filter assembly, to fail, causing atomized fuel to spray and ignite. The design of the *Mary Lynn's* fuel system allowed for the potential pressurization of the day tank to exceed atmospheric pressure if a crewmember secured valves on other tanks. Had the *Mary Lynn's* day tank been fitted with its own vent line, even with the fuel return lines inadvertently left closed, the overpressurization of the return line would have not occurred.

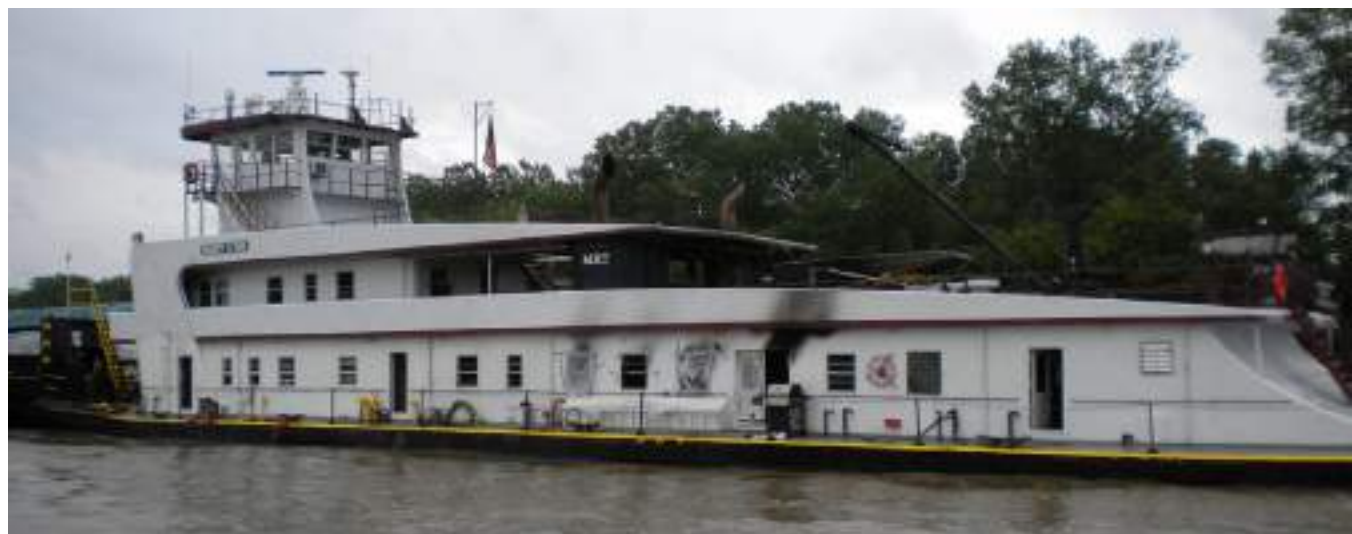
Figure 83. *Mary Lynn*'s port side, postcasualty, with some of the plastic window coverings remaining over the engine room windows. SOURCE: COAST GUARD

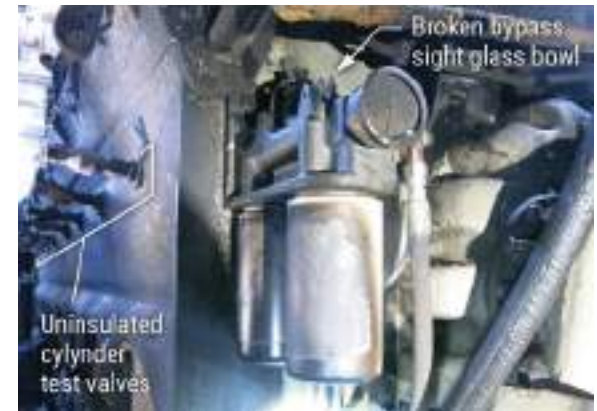
THE PROBABLE CAUSE of the engine room fire on board the towing vessel *Mary Lynn* was the overpressurization of the fuel day tank (which did not have an independent vent) and a main engine fuel return system when the fatigued chief engineer inadvertently left the day tank overflow valves to the storage tanks closed, which ultimately led to ignition of spraying diesel fuel from a main engine's fuel system onto an uninsulated engine component.

Figure 85. Inboard side of the port main engine showing the uninsulated cylinder test valves and their proximity to the broken sight glass bowl.

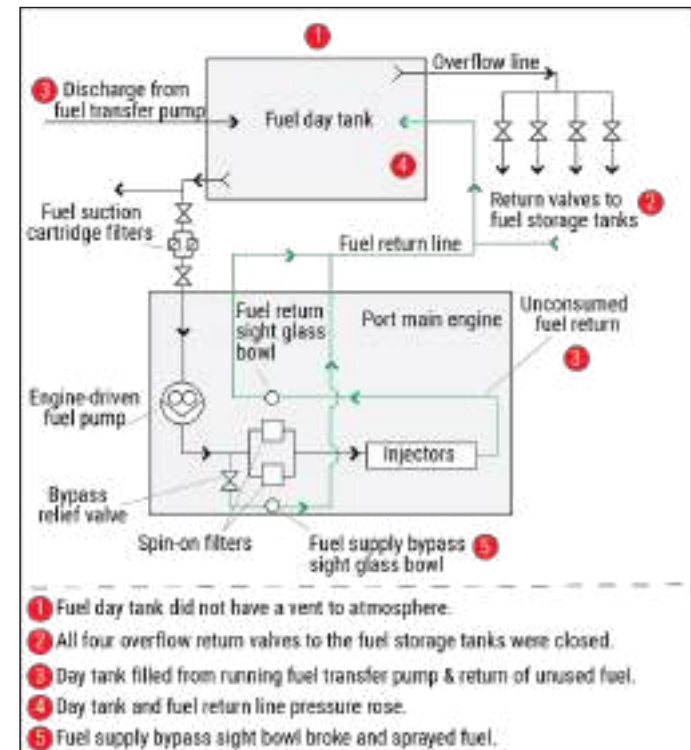
Figure 86. Simple main engine fuel supply/return system diagram for the *Mary Lynn* and sequence of events leading to the casualty.

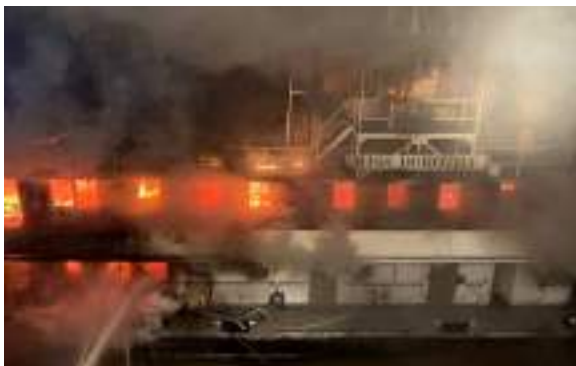
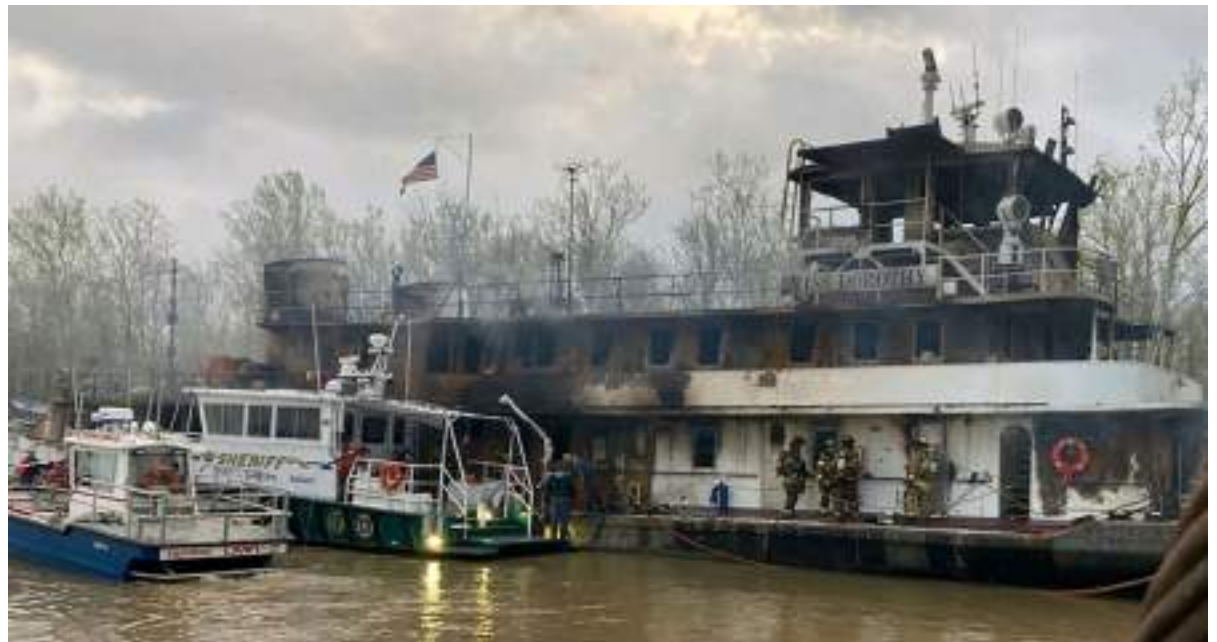
Figure 89. East Baton Rouge Sheriff's Office and ExxonMobil fire boats alongside the burned-out *Miss Dorothy* after the fire had been extinguished. SOURCE: WESTERN RIVERS BOAT MANAGEMENT INC.

THE PROBABLE CAUSE of the engine room fire aboard the towing vessel *Miss Dorothy* was the ignition of spraying diesel fuel from a main engine's fuel system onto an uninsulated section of the engine's exhaust system. Contributing to the severity of the fire and damage to the vessel was the inability to effectively secure ventilation to the space and fuel to the affected engine.

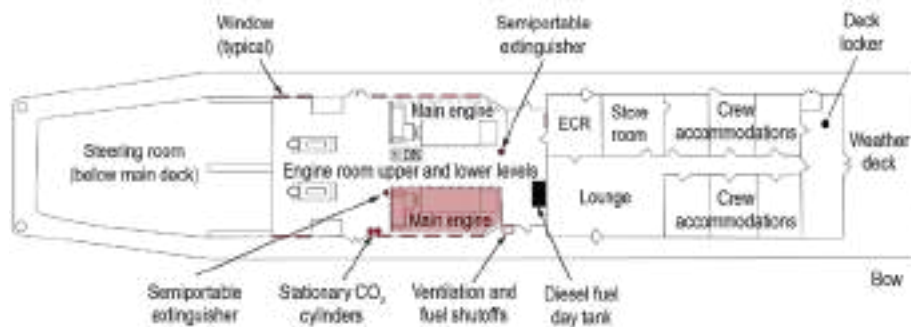
Figure 90. *Miss Dorothy* main deck layout. The area where the fire was discovered is highlighted in red.

In the area of the starboard main engine, investigators found a 0.5-inch fuel return line that had a joint that had de-brazed and separated. Temperatures exceeding 1,200°F would have been required to de-braze it and would have only been present in a well-established fire. Therefore, the return line likely separated because of the fire and the fuel likely came from another undetermined pressurized source (near the forward end of the engine) capable of spraying or atomizing fuel, such as a faulty flange connection, gauge line, pressure gauge, or pump seal. If the engine continued to operate after the fire, the de-brazed joint would have caused fuel to leak from the joint while the engine was running, which likely contributed considerably to the severity of the fire. Additionally, throughout the fire, up until the point when the electrical system ceased to operate, the automatic electric fuel oil transfer pump would have continued to fill the 500-gallon diesel fuel day tank when the low-level switch was activated. This perpetual supply of fuel would have contributed to the size and duration of the fire.

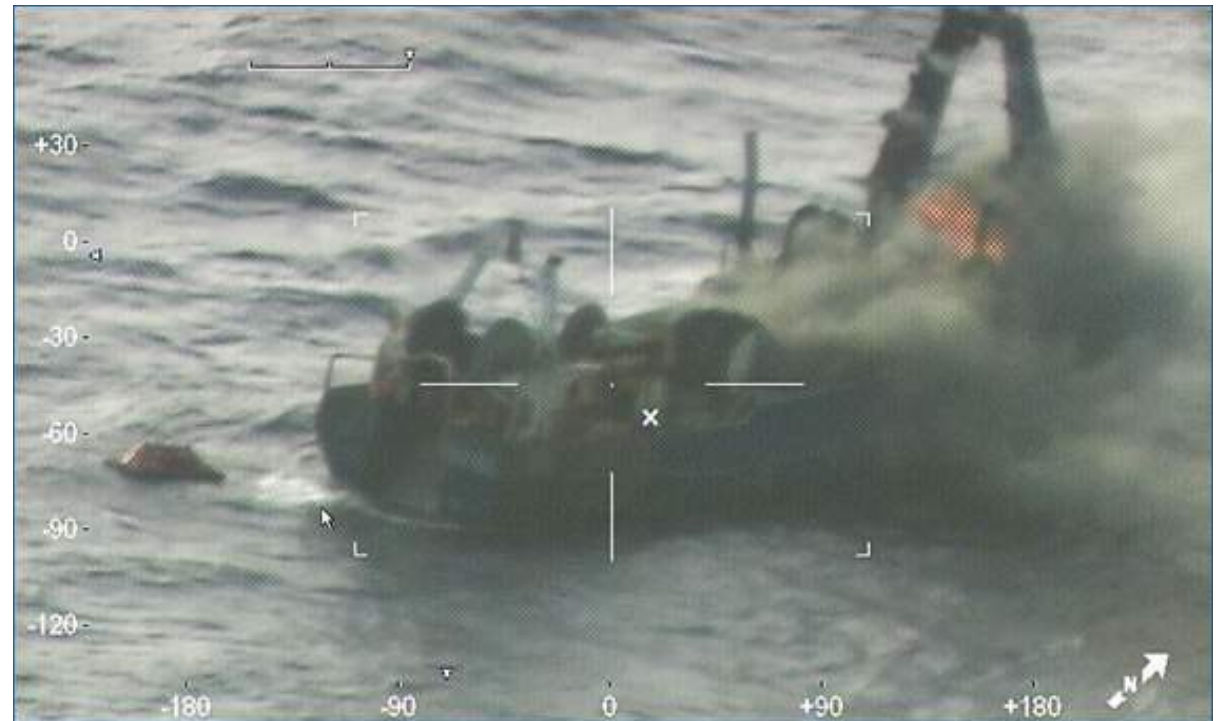
Figure 93. Photo taken from the Coast Guard HC-144 aircraft at 1827 shows the bow of the *Nobska* on fire before the rescue. The deployed liferaft appears on the left. SOURCE: COAST GUARD

THE PROBABLE CAUSE of the fire aboard the fishing vessel *Nobska* was a failure of a hydraulic hose within the engine room that allowed hydraulic fluid to spray onto a hot surface, likely the exposed main engine exhaust pipe. Contributing to the failure of the hydraulic hose was possible heat damage from a fire that occurred earlier in the day.

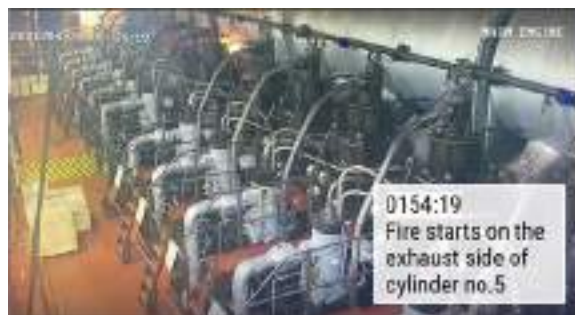
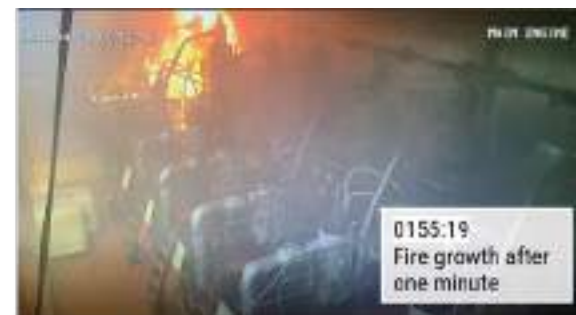
Figure 96. Top to bottom: CCTV screen captures of the main engine showing fuel spray in the area around the no. 5 cylinder the moment the fire started, and the progression (*time stamps are 4 hours ahead*). SOURCE: APL MARITIME

CCTV footage showed that about 0124, on April 28, ultra-low sulfur diesel fuel began spraying in the area around the main engine's no. 5 cylinder. The engine room was unattended at the time, and the leaking fuel went unnoticed. The *President Eisenhower* did not have CCTV video analytic technology integrated into the existing system to identify fuel mist in real time and alert the crew.

Investigators found that an exhaust valve compensator flange on the no. 5 cylinder—which was subject to internal engine exhaust temperatures greater than 428°F (often as high as 600°F)—near the disconnected fuel return tubing end was exposed and not insulated (as was required by SOLAS regulations). Therefore, it is likely that the unshielded and uninsulated exhaust valve compensator flange acted as an ignition source for the spraying diesel fuel.

THE PROBABLE CAUSE of the engine room fire aboard the containership *President Eisenhower* was a crewmember insufficiently swaging a compression fitting ferrule during the installation of fuel oil return tubing for a main engine's cylinder, allowing an end of the tubing to disconnect and spray fuel oil onto a nearby unshielded and uninsulated cylinder exhaust component.

Rapid oil leak-detection systems are a valuable tool that can be used to prevent fire in machinery spaces. Video analytic technology is designed to use standard CCTV video to detect fuel mist and spray in real time and alert the crew before any ignition and fire. This technology is supported by class societies as an acceptable method for identifying leaks and can be integrated with existing CCTV systems. Had this technology been in use aboard the *President Eisenhower*, the spraying fuel oil may have been detected well before the fire developed.

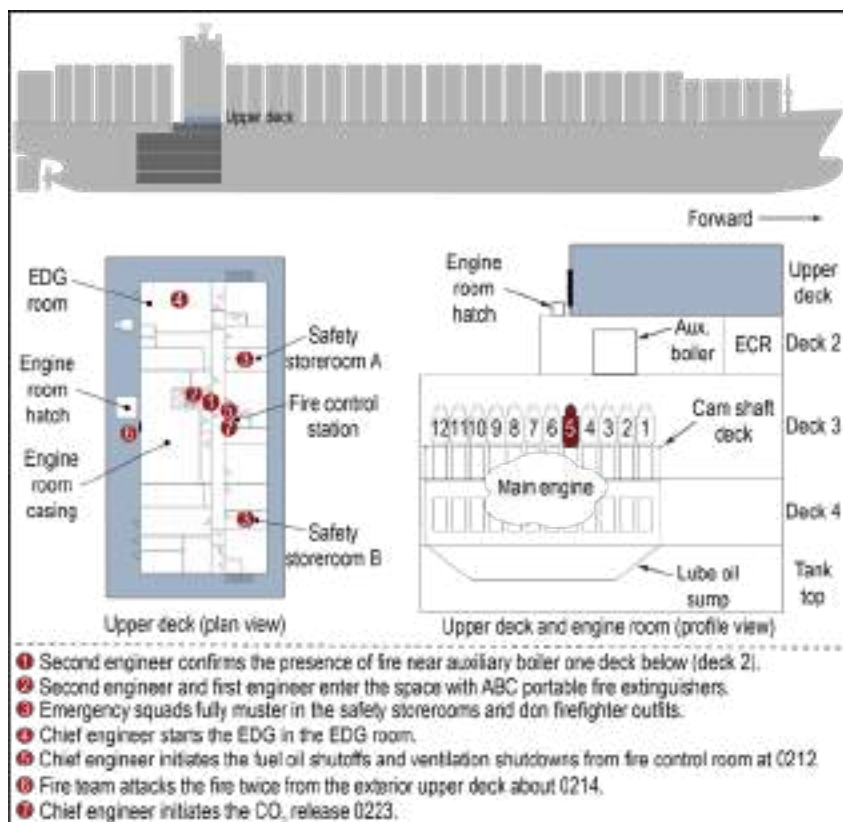
Figure 97. Profile view of the *President Eisenhower* (top). Plan view of the upper deck showing the sequence of events during the fire (left). Profile of the upper deck and engine room decks with the origin of fire highlighted (right).
