NATIONAL TRANSPORTATION SAFETY BOARD

2022

SAFER SEAS Digest

Lessons Learned from
Marine Investigations

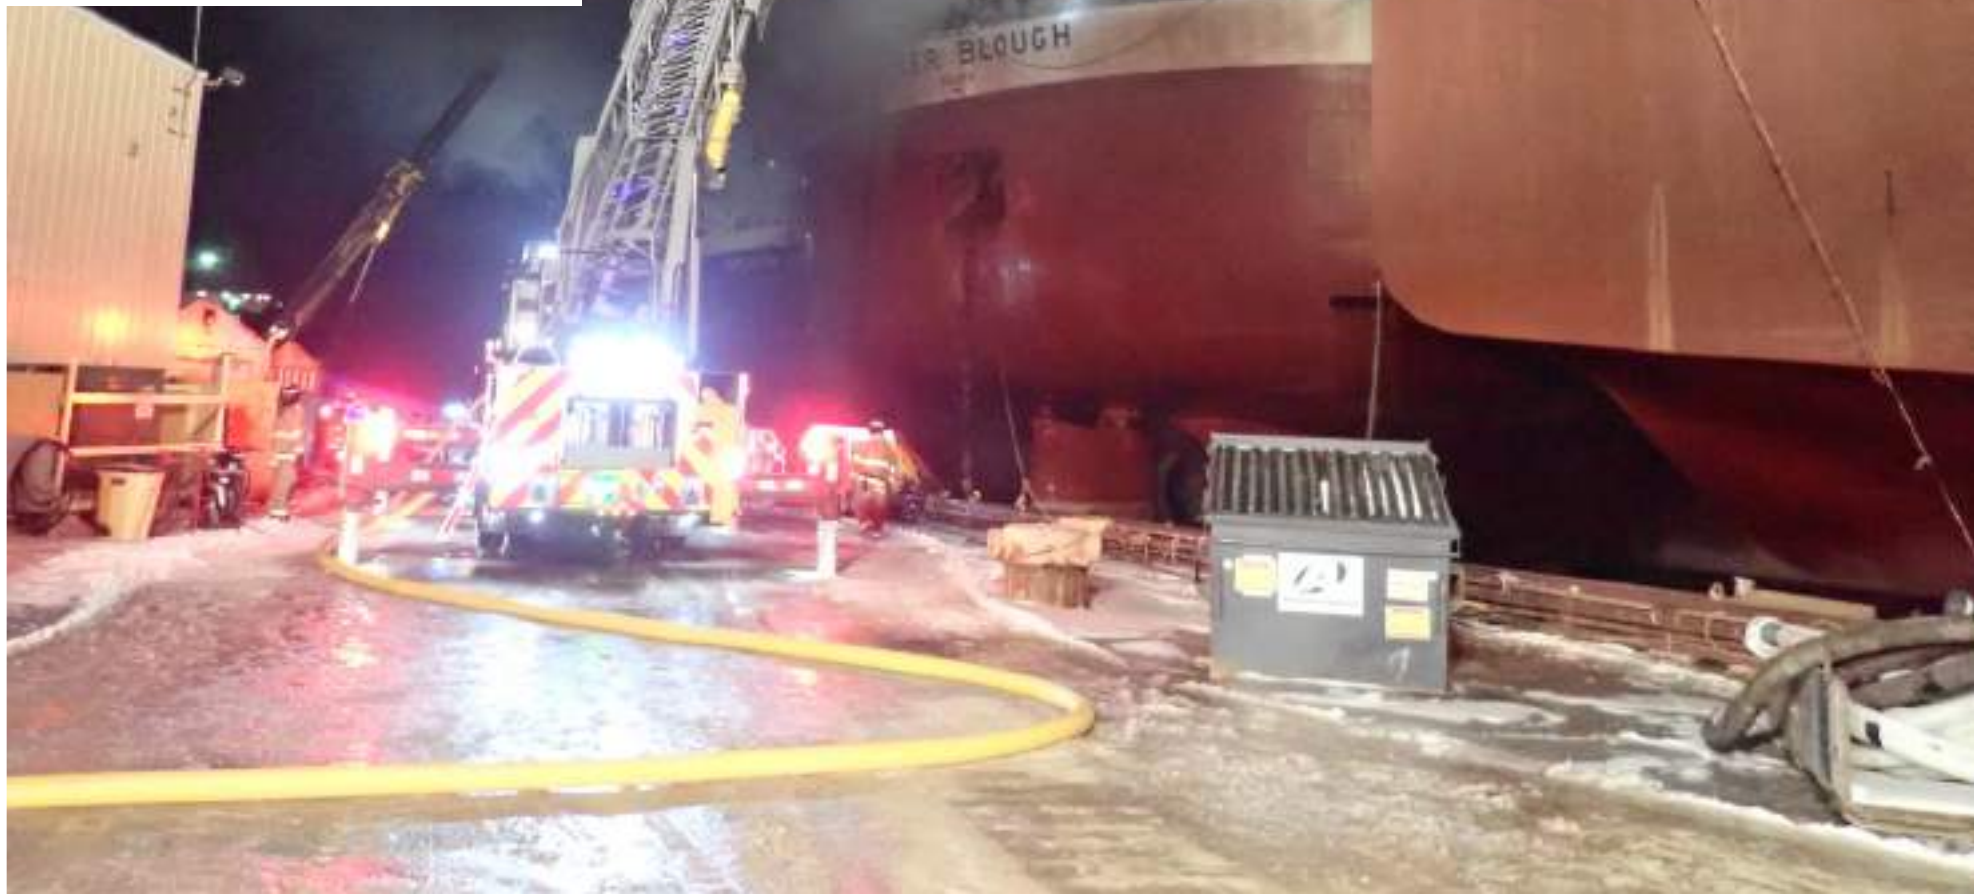
Figure 99. Stern of the *Roger Blough* during firefighting efforts. SOURCE: COAST GUARD

THE PROBABLE CAUSE of the engine room fire aboard the bulk carrier *Roger Blough* was likely the repeated removal and reinstallation of the furnace's burner that led to the failure of its mounting coupling, resulting in the operating burner dropping to the bottom of its enclosure and fracturing its fuel supply line, which allowed diesel fuel to ignite. Contributing to the casualty was the absence of a fire-activated automatic fuel oil shutoff valve on the fuel oil inlet piping before the burner, which would have stopped the fuel feeding the fire shortly after it started and limited the spread of the fire.

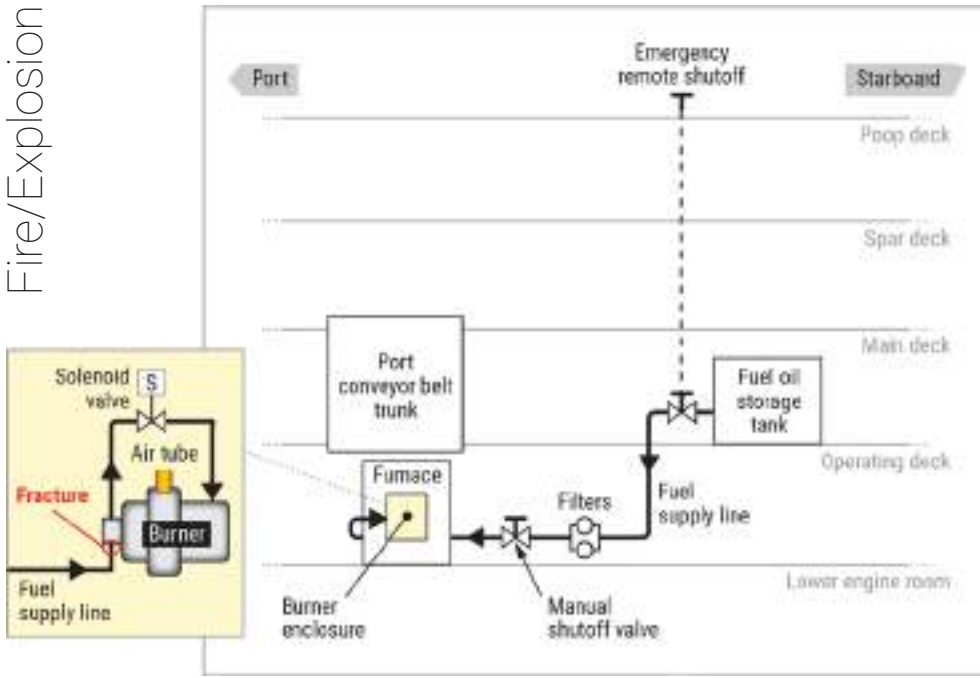
Figure 102. Simple section view of the *Roger Blough's* engine room with arrangement of the furnace's fuel supply (not to scale).

Figure 103. Diagram showing the 65-pound burner assembly within the enclosure as mounted on the furnace on board the *Roger Blough*.

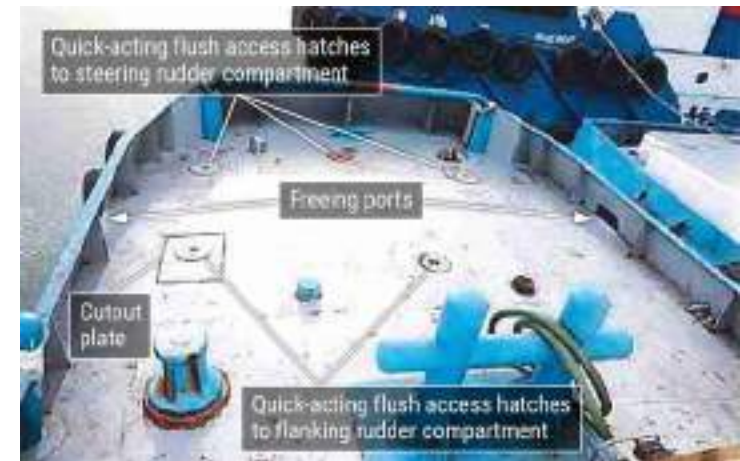
Figure 109. Main deck at the stern of the *Proassist III*.

Investigators found no structural hull defects that could have allowed for significant flooding; thus, the only other explanation would have been if a cover for one of the five aft main deck flush hatches were not in place. The crew told investigators that all deck hatches were closed when the vessel departed, but given the rate of flooding observed, at least one was likely not closed. With a reported 4–6 inches of water on deck, an open hatch would have allowed a significant amount of water to flood into the compartments below.

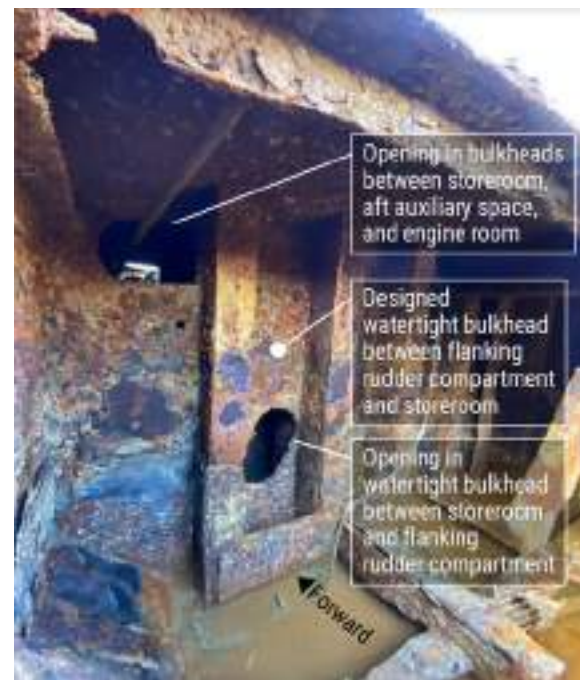
About 2.5 hours after departing, the crew noticed the vessel was down by the stern. They removed the flush access hatch to the flanking rudder compartment and found about 3 feet of water. A postcasualty examination of the vessel showed that portions of the transverse bulkhead between the flanking and steering rudder compartments were missing, and, therefore, the water that was found in the flanking rudder compartment would have also been in the steering rudder compartment at an equal level. Based on the approximate size of the two compartments, the volume of water accumulated in the spaces would have totaled roughly 36,500 gallons. Calculated from when the weather worsened, the average flooding rate would have been 304 gallons per minute.

Figure 112. Flanking rudder compartment after recovery. Openings in bulkhead shown are also typical of other bulkheads below the main deck separating compartments. BACKGROUND SOURCE: COAST GUARD

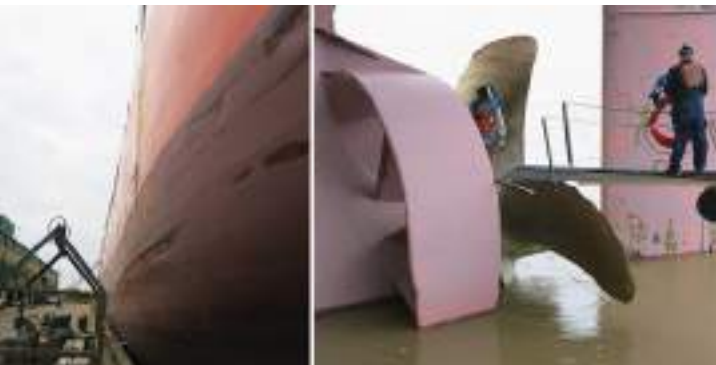
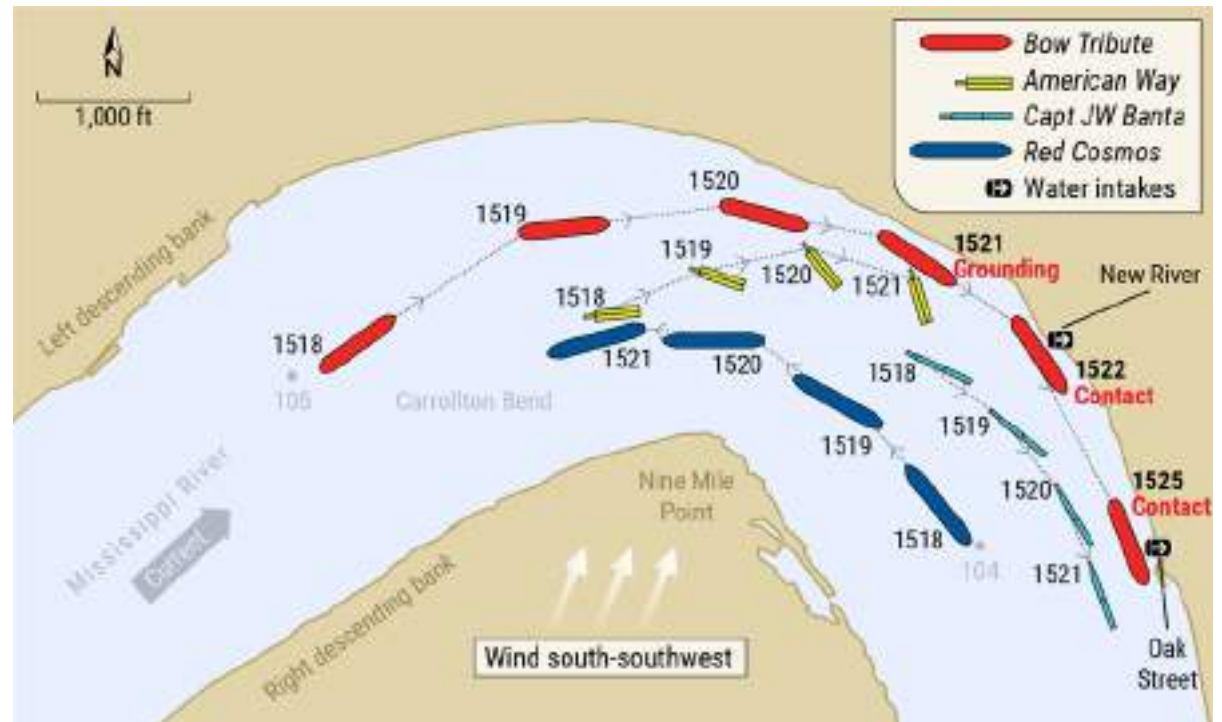
Figure 114. *Below, left to right:* Postcasualty damage to the *Bow Tribute's* portside aft hull and propeller.

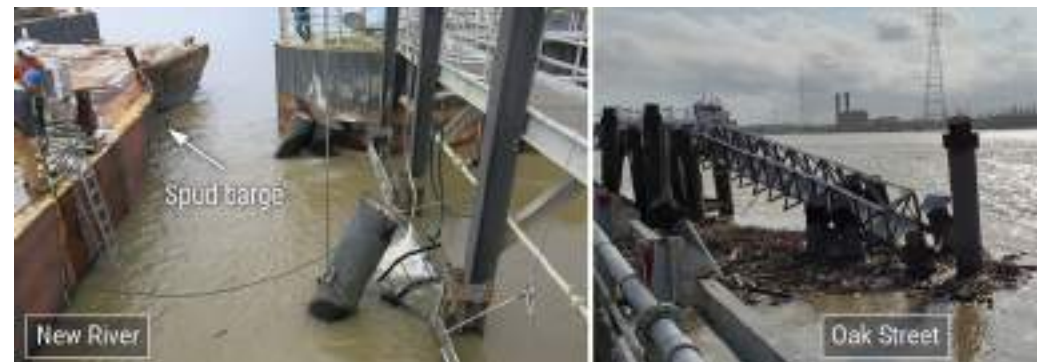
Figure 118. Left to right: Damage to the river intake fender systems: arrow shows damage to the spud barge at New River; damaged catwalk and dolphin piles at Oak Street.

At 1521:45, the stern of the *Bow Tribute* momentarily grounded on the left descending bank before it continued along the bank. Seconds later, at 1522:26, the port side of the *Bow Tribute* struck a spud barge, which was part of a fender system to protect the river intake pipes, moored at mile 104.1. After being struck, the barge broke free from its spuds and moorings and drifted downriver. At 1522:38, the pilot ordered the starboard anchor let go. At 1525, as the *Bow Tribute* slowed in the bend with its starboard anchor paying out, the tanker struck another protective spud barge for another set of river intake pipes, located at mile 103.8.

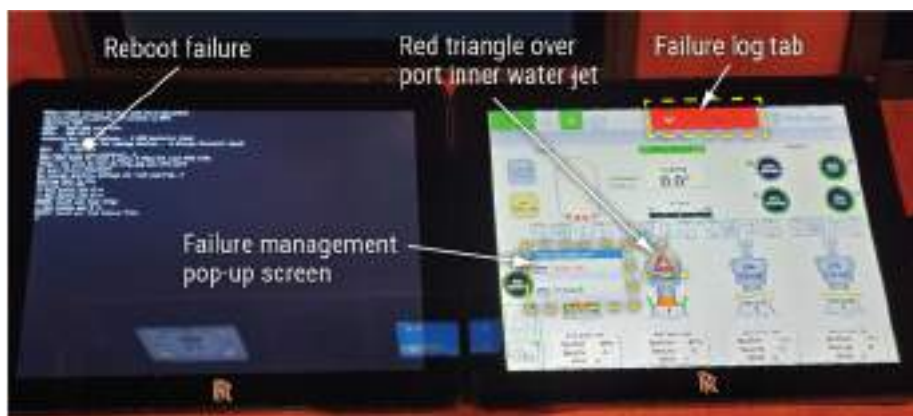
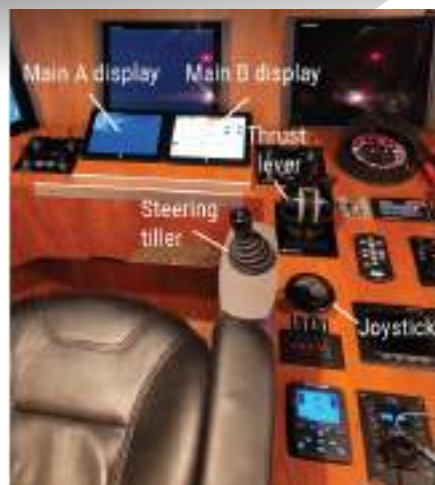
Figure 121. *Commodore's* main control station during postcasualty examination. Above: main A display screen's reboot failure (left) and the red failure log tab, red triangle over the port inner water jet icon, and the failure management pop-up screen on the main B display screen (right). Below: main control station's hand controls and water jet display screens.

The control system manufacturer concluded that a software problem led to a failed SD card for the touchscreen, causing a reboot failure, meaning that the touchscreen went blank and could not restart. This also resulted in the loss of the primary controls (thrust lever, joystick, and steering tiller) for the port hull's engines and water jets. The manufacturer later issued a service letter mandating that vessels with the same touch control system software receive an update.

The investigation found that the control system displays showed active failures for several days before the casualty. The vessel operating company's SMS

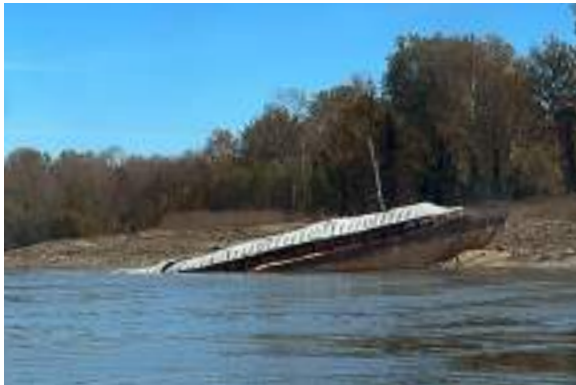
Figure 122. One of the *Marquette Warrior*'s barges that grounded and partially sank following the casualty.

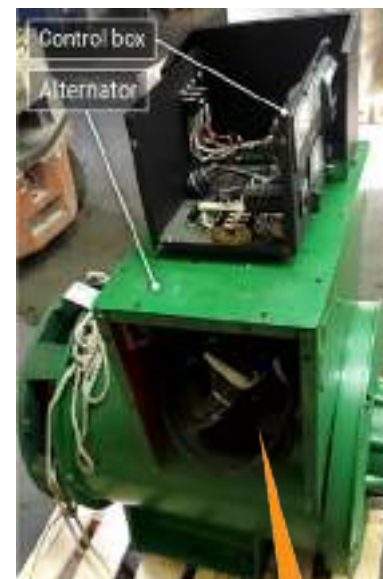
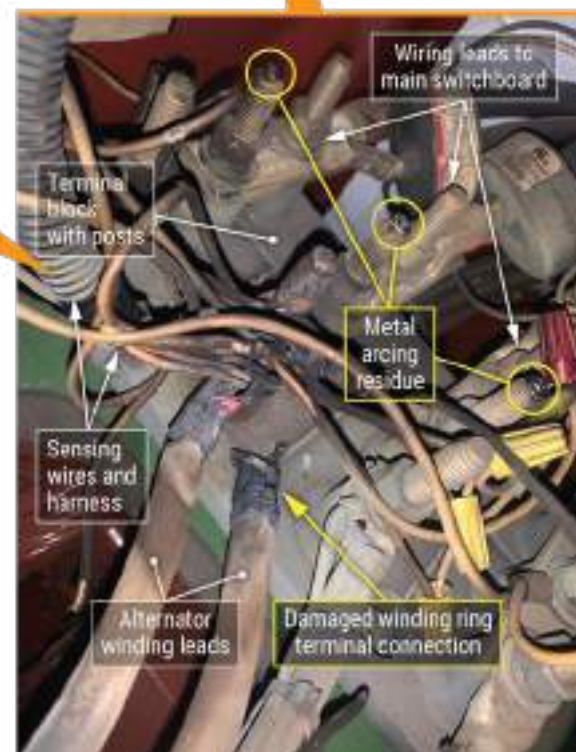
Following the grounding, the port genset's alternator was inspected by the towboat company's engineers and then a repair facility that had recently refurbished the unit. It was found that a ring terminal connection for one of the alternator's winding leads was burnt and had failed, causing the alternator to lose one of its phases—this would subsequently cause the towboat's steering pump motors (and all other 3-phase equipment) to stop due to a lack of available torque. Electricians also discovered arcing metal residue on three terminal block posts and a severed wiring harness. This indicated that the wiring harness had been lying across, rubbing against, and eventually arcing to the terminal block posts for a prolonged period. The way the alternator failed would have caused fluctuations in the alternator output voltage and amperage, and the vessel likely would have experienced flickering lights.

Recent preventive maintenance performed by the vessel's engineer required removing the genset alternator's cover panel to inspect all wires and connections for wire fray, chaffing, and loose connections. Electricians' analysis of the alternator following the casualty indicated that the most likely cause of the failure was rubbing or chaffing of the sensing wiring harness, which led to arcing between terminal block posts, heat buildup, insulation failure, and eventual winding ring terminal failure. Because the onboard engineer did not notice damage within the terminal box or to the sensing wiring harness during his inspection, it is likely the chaffing of the wiring harness took place over the 72 hours the genset ran between the November 7 maintenance inspection and the casualty on November 21. While the wiring harness could have shifted onto the terminal posts due to vessel vibrations, it is more likely that the wiring harness was inadvertently displaced during the vessel engineer's preventive maintenance inspection and went unnoticed during his reinstallation of the cover panel.

THE PROBABLE CAUSE of the grounding of the towing vessel *Marquette Warrior* was a loss of steering, likely due to a wiring harness within an electrical generator that was improperly positioned during a maintenance inspection, resulting in the harness contacting the terminal posts, eventually causing the loss of 3-phase electrical power to the steering pump motors.

Figure 125. Below: Close-up of port alternator terminal block showing damaged connection and metal arcing residue accumulated on terminal block posts. Detail shows the severed wiring harness.

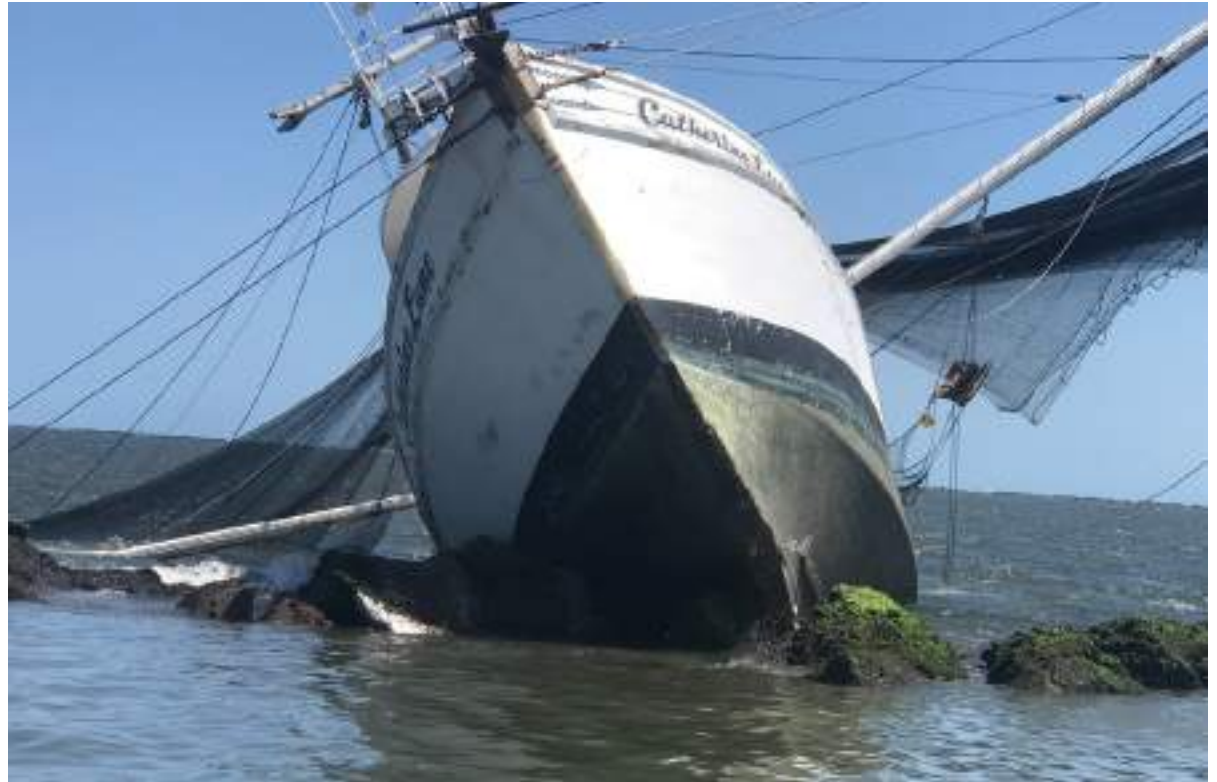
Figure 127. *Sage Catherine Lane* aground on the St. Marys Entrance north jetty. SOURCE: COAST GUARD

The vessel's reported sharp turn to port (about 90°) while on autopilot before grounding indicated that the autopilot system had failed. The sudden sharp turn likely resulted from the helm/autopilot receiving a signal that the vessel was far from its programmed heading and required significant rudder correction to return to the original heading. Based on the information provided to investigators (due to the sinking,

a postcasualty exam was not possible), this sudden change could have been caused by the loosening or detachment of the autopilot rudder angle sensor, which resulted in the transmission of incorrect rudder position data to the autopilot that subsequently commanded a large port rudder angle.

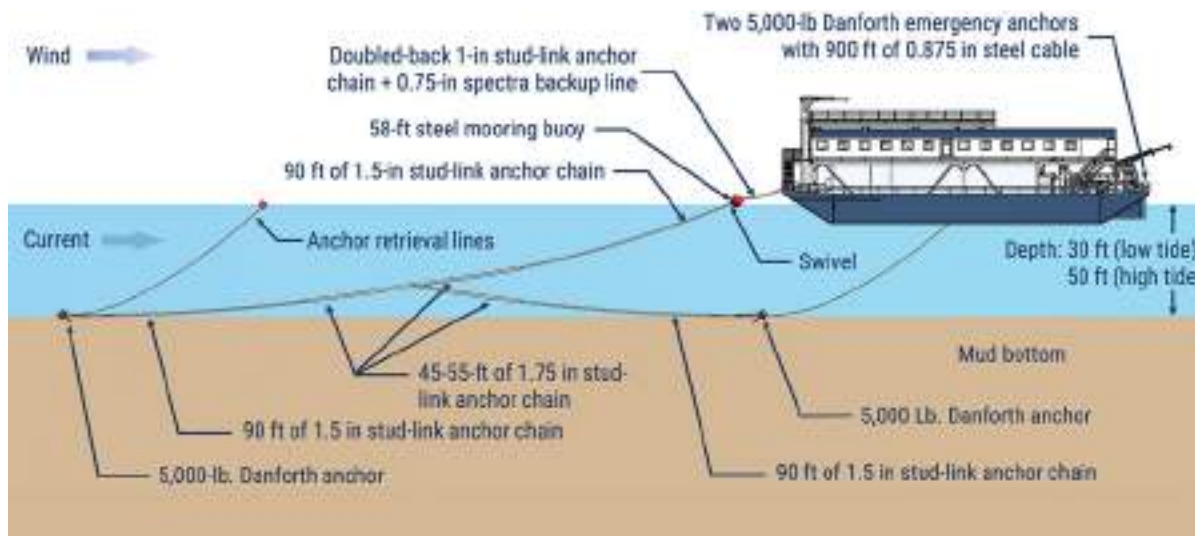
Figure 132. *SM-3* ground tackle system at the time of the casualty when the water depth was about 40 feet.

A postcasualty examination of the buoy showed that a 1.25-inch-wide fatigue crack had formed at the padeye's fillet weld, moving across nearly two-thirds of the weld before failing abruptly and tearing the cap plate it was welded to. Investigators were unable to determine whether the fatigue crack existed before the storm or developed because of it. If the crack was preexisting, it contributed to the failure of the buoy in the storm; if it was not preexisting, the forces on the buoy during the storm resulted in the fatigue crack and complete separation of the padeye and adjoining shell material from the buoy.

THE PROBABLE CAUSE of the grounding of the fishing tender barge *SM-3* was a fatigue crack in one of the mooring buoy's padeye welds, which resulted in the padeye separating from the buoy's spherical steel plating, causing the barge to break free from its buoy and anchors and drift ashore during a storm.

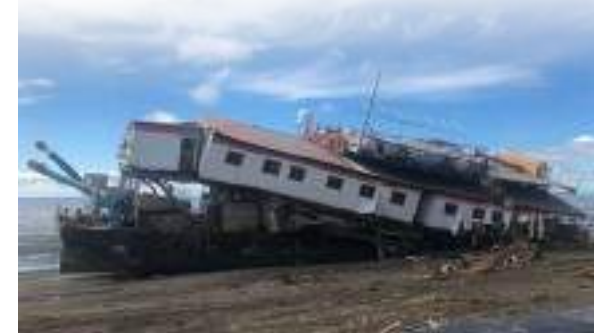
Figure 133. *SM-3* after the grounding.

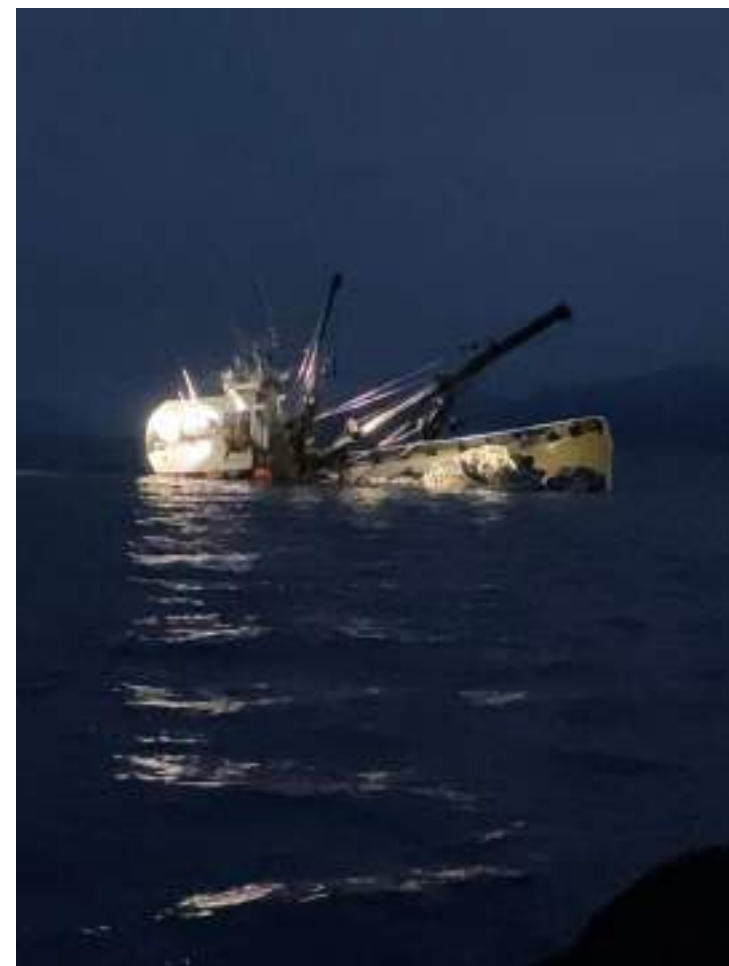
THE PROBABLE CAUSE of the grounding of the fishing vessel *Tenacious* was the captain's decision to get under way while fatigued. Contributing to the casualty was the decision not to use the navigation system's cross track error alarm and to operate with a non-functioning bridge watch alarm.

Figure 137. *Tenacious*, sinking by the bow, about 0345 on July 24. SOURCE: LUCAS BROCKMAN

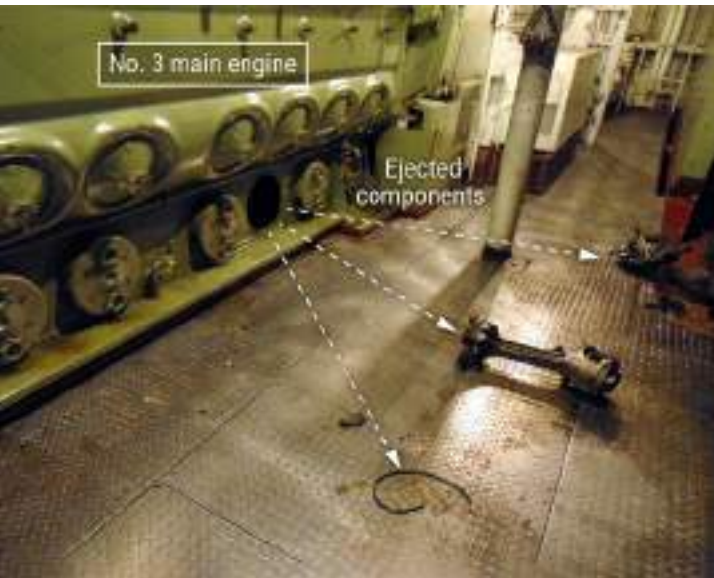
Figure 138. Ejected components from the no. 3 main engine. BACKGROUND SOURCE: COAST GUARD

An independent forensic analysis determined the root cause of the engine failure was an inadequately torqued bolt on the nos. 6 and 14 cylinder's fork and blade (connecting rods) lower basket assembly. The bolt unfastened while the engine was running, disrupted lubrication in this section of the crankshaft, and resulted in extremely high temperatures, which led to disassembly of the connecting rods and lower connecting basket assembly. After the broken engine parts were struck by rotating components in the engine, they were ejected from the crankcase through an inspection port.

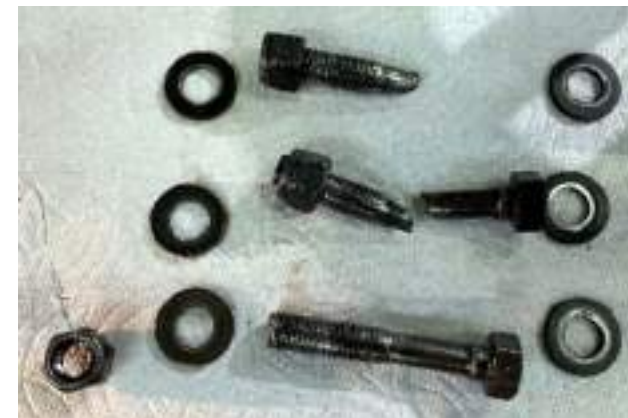
Based on the condition of the bolt, engineers determined that the nut had backed off (unfastened) while the engine was running. These nuts were required to be torqued to 75 foot-pounds during assembly using a torque wrench connected to a special extension tool that rotated the nut via a socket. Under magnification, engineers inspected the condition of the grooves on the lower basket nuts. Flattening was observed on properly torqued exemplar nuts but was not seen on the recovered nut that had unfastened from the no. 3 engine's lower basket assembly, indicating the nut had not been properly torqued.

Figure 141. Damaged lower basket bolts, washers, and nuts from no. 3 engine's nos. 6 and 14 connecting rod and piston pair. SOURCE: WASHINGTON STATE FERRIES

THE PROBABLE CAUSE of the mechanical failure of the no. 3 main engine aboard the passenger vessel *Wenatchee* was a connecting rod assembly that came loose and separated from the crankshaft due to insufficient tightening (torquing) of a lower basket bolt during the recent engine overhaul.

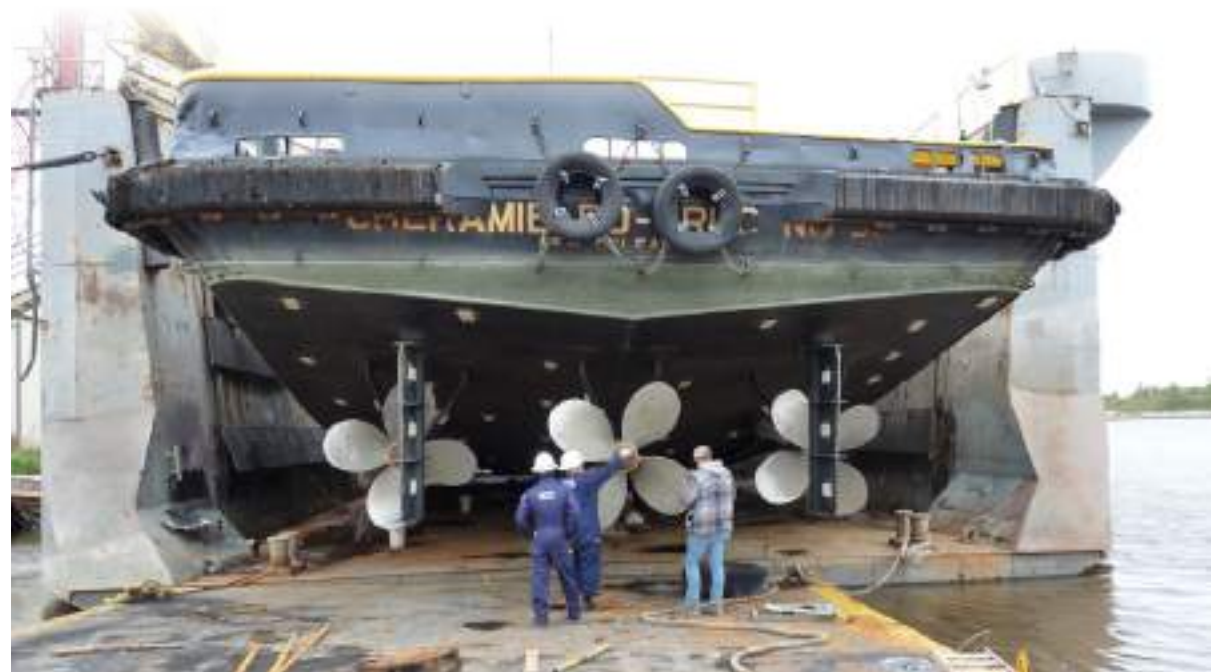
Figure 143. Coast Guard personnel inspecting the *Cheremie Bo-Truc* No. 33.

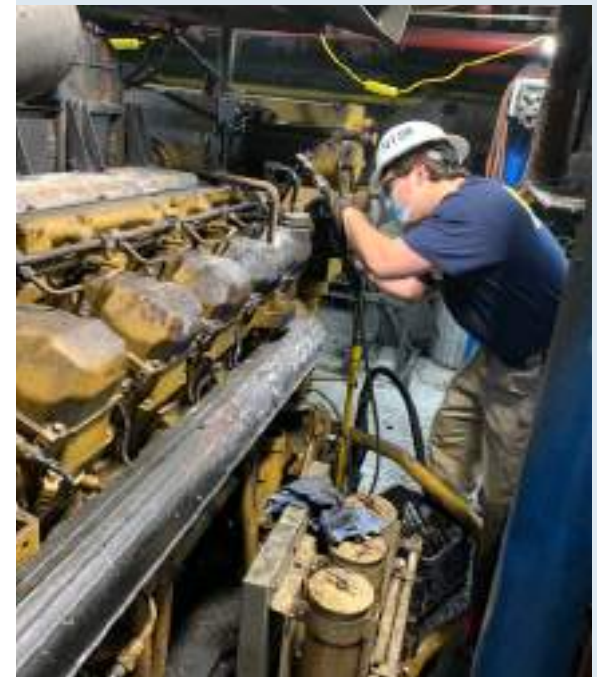
Figure 145. NTSB investigator Derek Johnston examines the main diesel engine during the *Capt. Kirby Dupuis* investigation.

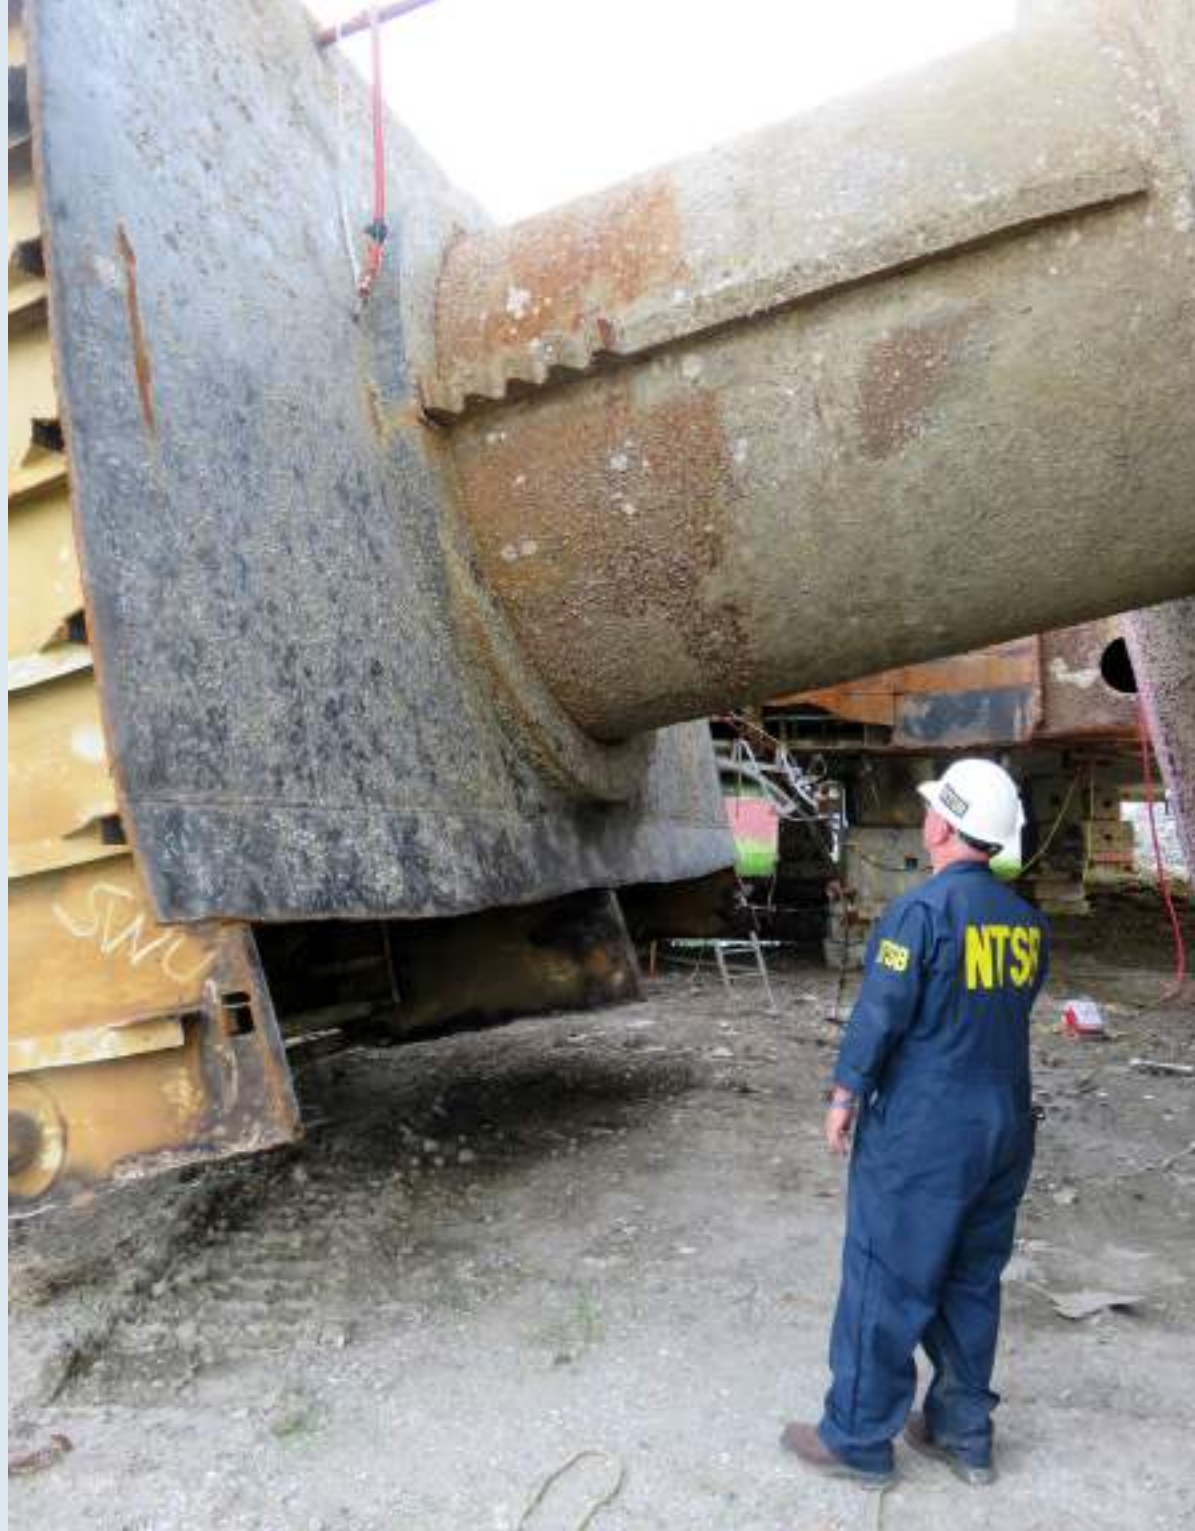
Figure 146. NTSB investigator Marcel Muise inspecting the *SEACOR Power*'s leg post-casualty.
