# STENA SCANDICA

Marine accident report on fire

29 AUGUST 2022

**MARINE ACCIDENT REPORT ON FIRE ON BOARD STENA SCANDICA  
ON 29 AUGUST 2023**

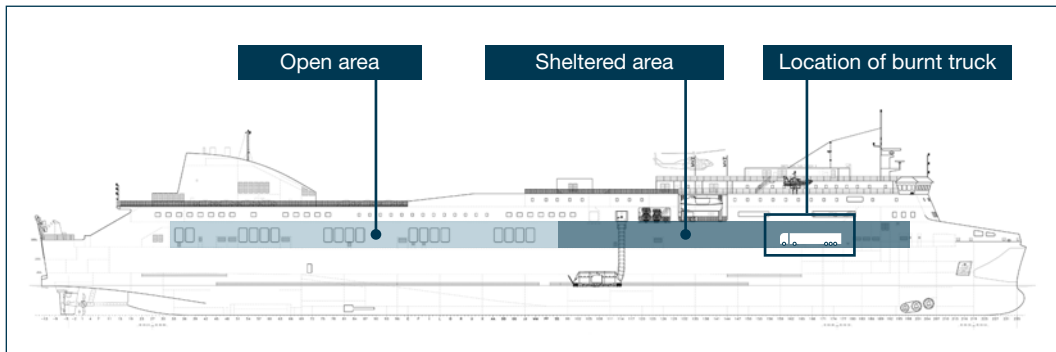
Vehicle Deck 4 was an open Ro-Ro space. On the aft part of the deck, the side plating had openings, while the forward part was sheltered. On the forward bulkhead, fire dampers were found open, with indications that they had been open during the fire. The various openings created a natural ventilation for the entire vehicle deck (Figure 13).

Figure 13: Open and sheltered area on Deck 4.  
Source: Stena Rederi A/S, modified by DMAIB

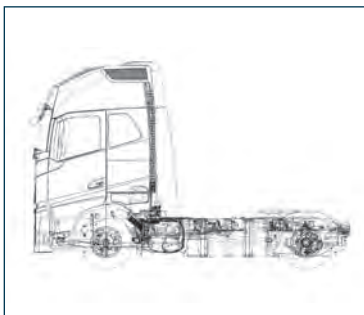
The burnt truck was manufactured by Volvo, of the type Volvo FH13, model FH13A42t, from 2017 (Figure 15). The truck was owned and operated by the Lithuanian transport company Vlantana. The last service was carried out on 25 October 2021 and was performed by an authorised Volvo service centre. The truck carried a refrigerated trailer built in 2021 by Schmitz Cargobull (Figure 16). The trailer's cooling system was manufactured by Thermo King, and the refrigerating unit was connected to STENA SCANDICA's power supply system by a 440V cable during the voyage. At the time of the fire, the trailer was loaded with berries.

Figure 15: VOLVO FH13.  
Source: VOLVO Denmark

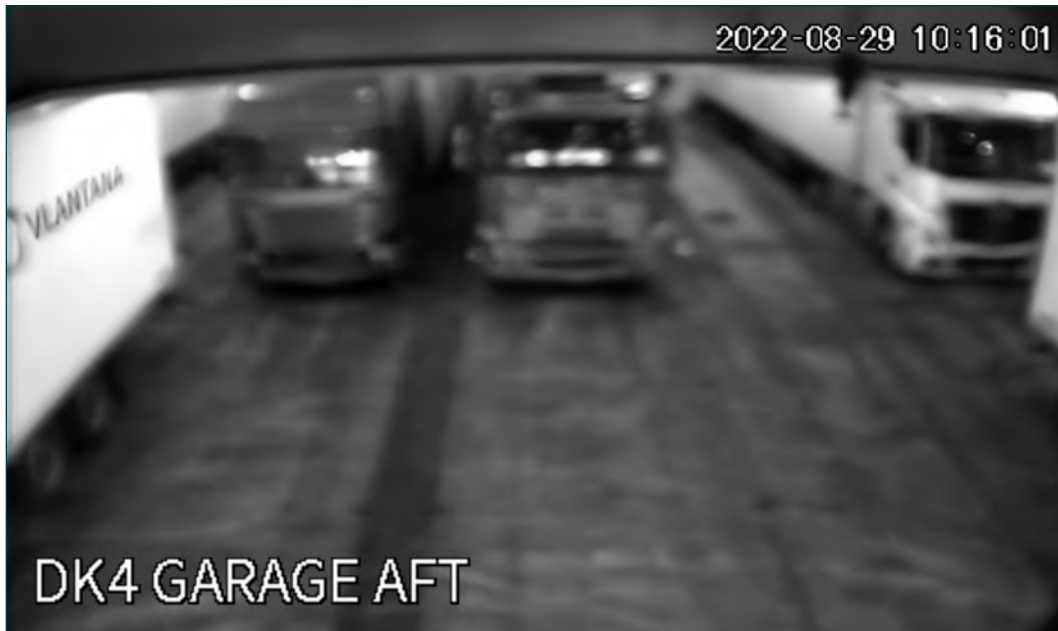
Deck 4 was covered by CCTV, which viewed the rear of the truck's trailer, and the footage did not capture the start of the fire. However, at 1216<sup>3</sup> smoke was recorded on the vehicle deck, indicating that combustible material had ignited, or was at least smouldering (Figures 32 and 33). Two minutes later, at 1218, the atmosphere filled with black smoke, indicating that the fire had spread and intensified (Figure 34).

Figure 32: Deck 4 at 12:13:01. No visible smoke.  
Source: DMAIB

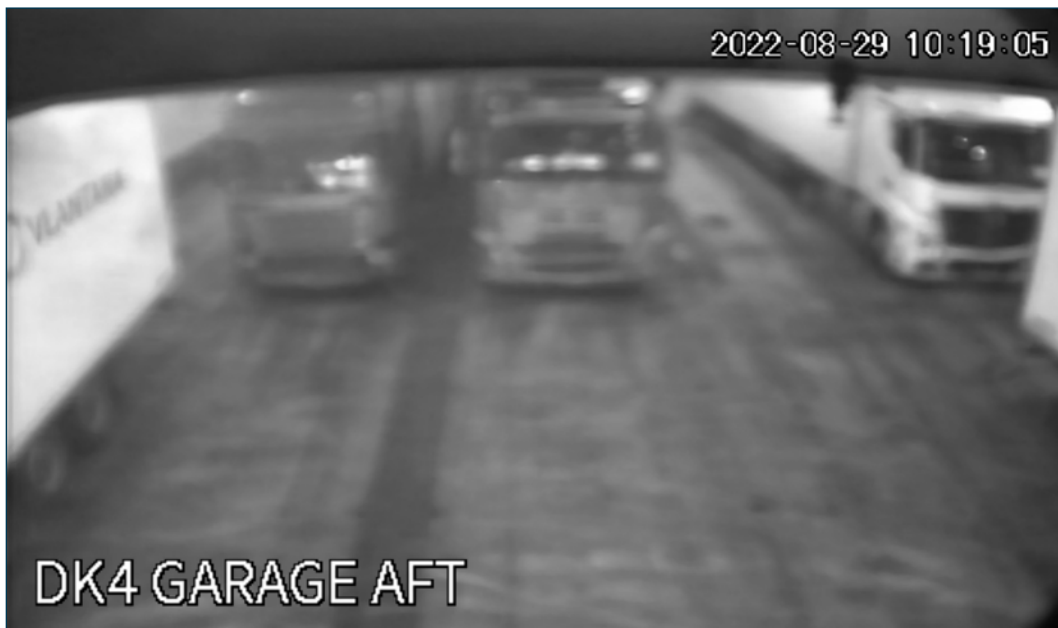
Figure 33: Deck 4 at 12:16:05. Visible smoke.  
Source: DMAIB

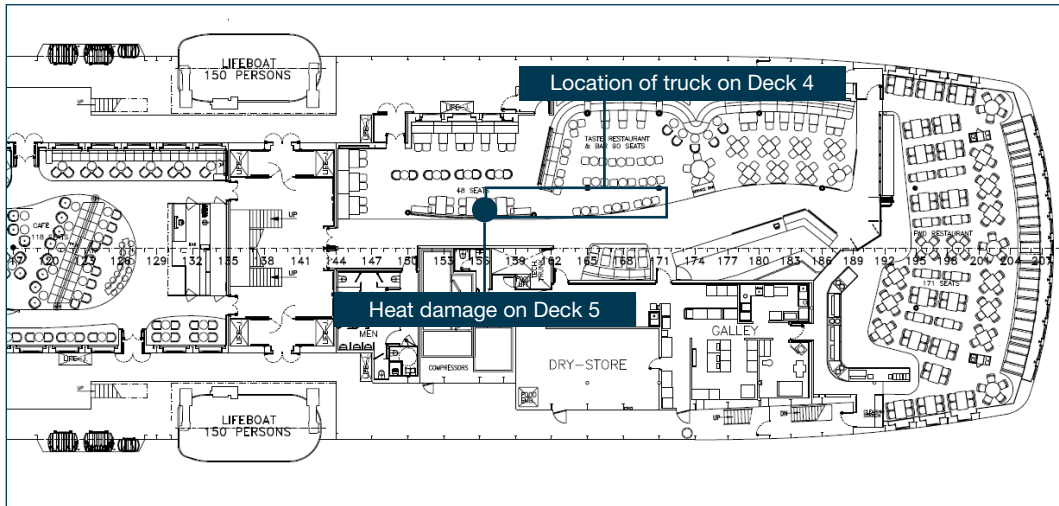
On Deck 4, water from the firefighting soaked and loosened the fastenings of the fireproof insulation which separated from the deckhead and fell to the deck. With the steel exposed to the heat from the fire, heat radiation occurred in the passenger area above the burning truck. During the fire, crew members monitored the temperatures in the compartments adjacent to the fire scene using a thermal scanner. On Deck 5 in the lounge and reception area, surface temperatures of 60°C were read, and boundary cooling was initiated at 1253. When the carpet in the lounge area was removed following the fire, significant heat damage to the carpet adhesive was found at a covered cable duct located just above the fire scene on Deck 4 (Figure 37).

Figure 37: Location of heat damage in lounge area on Deck 5 and indication of truck position on Deck 4.  
Source: Stena Rederi A/S, modified by DMAIB

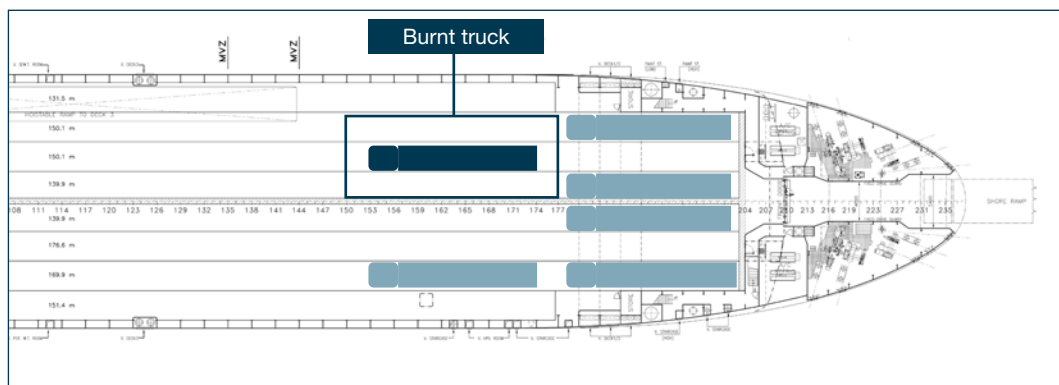
The fire did not spread to other vehicles because the sheltered part of Deck 4 was not stowed to its full capacity, and the burning truck had empty lanes either side (Figure 39). Furthermore, no vehicles were stowed directly in front of the truck and, although two trucks were stowed behind, they were not affected by flames because the fire did not spread to the rear of the trailer of the burnt truck.

Figure 39: Stowage of trucks in the sheltered part of Deck 4.  
Source: Stena Rederi A/S, modified by DMAIB

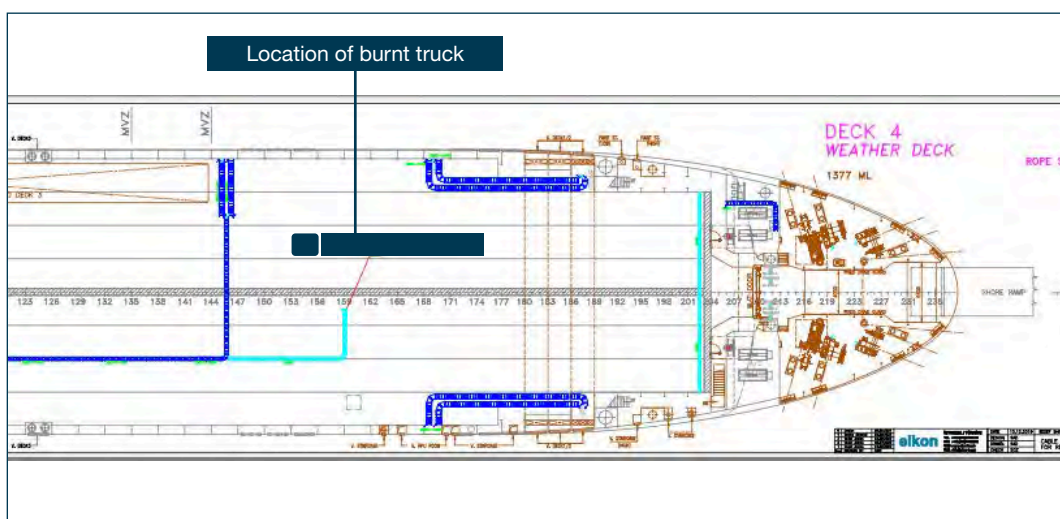
Figure 43: Cable tray diagram Deck 4.  
Source: Stena Rederi A/S, modified by DMAIB

Photo documentation of the fire scene proved that several cable trays were fitted in the area directly above the truck on fire (Figure 42). However, the cable diagrams valid at the time of the accident indicated there were no cable trays installed in this area (Figure 43). The diagram did not correspond with the actual layout on Deck 4. Furthermore, no information was available regarding which cables were in the cable trays above the truck.

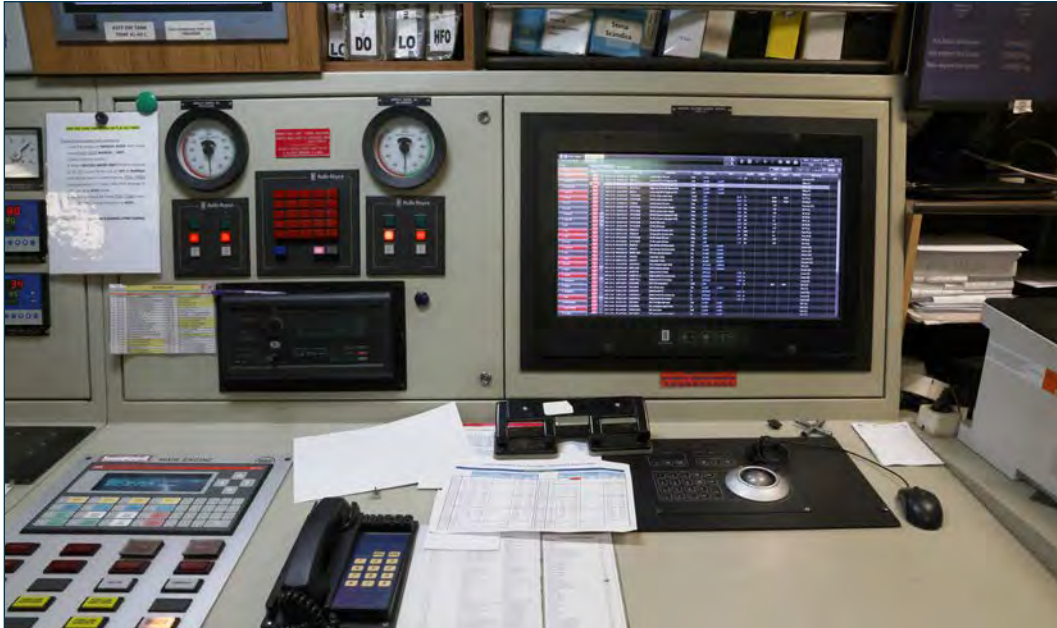
Figure 44: Monitor for alarm monitoring system.  
Source: DMAIB

From 12:18:09, the alarm monitoring system started to be flooded with internal alarms, and at 12:18:23 the general alarm was raised. At 12:18:21, the trip alarm was issued for the 24V switchboard/UPS located in the emergency generator room, and, four minutes later at 12:22:11, alarms signalled that UPS units were activated. Both the trip alarm and the UPS battery-on alarm were acknowledged. In the period between the trip alarm and the UPS on-battery alarm, 294 alarm entries were issued and presented on a monitor with 37 alarms visible at a time (Figure 44).

This means that the alarms were visible on the monitor for an average of 30 seconds, during a stage of the accident where the general alarm had just been raised and the engine team was busy mustering and subsequently starting drenchers and isolating the electrical power in the fire area. This explains why the alarms were acknowledged in the engine control room but were not recognized cognitively by the engine crew at this stage.

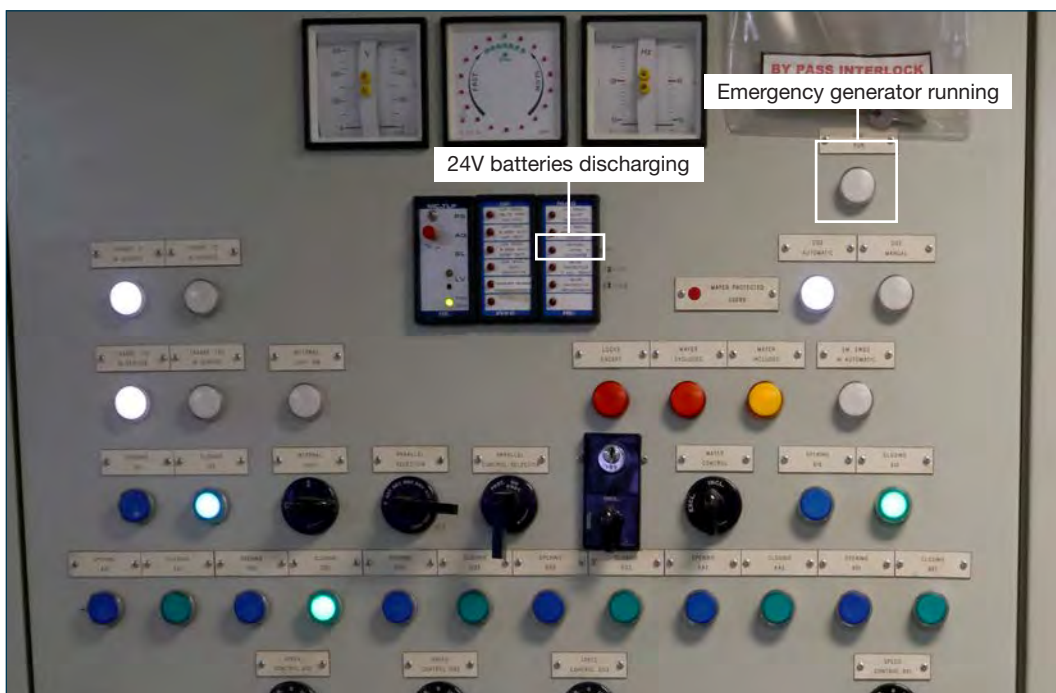
Figure 45: Indicator lamps on main switchboard panel.  
Source: DMAIB

The engine crew became aware of the power supply failure as they started to lose indications for the engines. This brought the engine crew's attention to the main switchboard panel, where two small indicator lamps were lit to signal that the emergency generator was running and 24V UPS batteries were discharging (Figure 45).

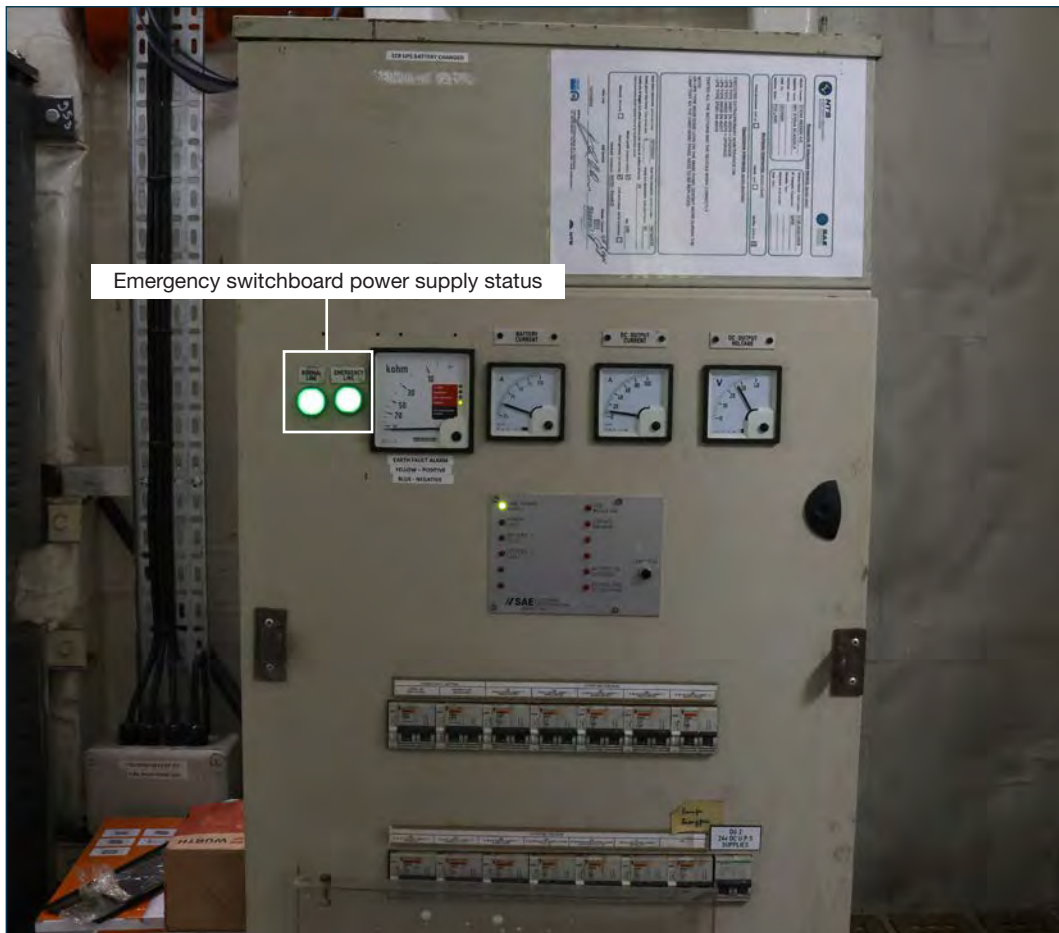
Figure 46: Indicator lamps on 24 V switchboard/UPS located in engine control room.  
Source: DMAIB

The engine crew then examined the 24V switchboard/UPS in the engine control room and established that the indicator lamps were signalling that the UPS unit was not supplied from the emergency switchboard (Figure 46).

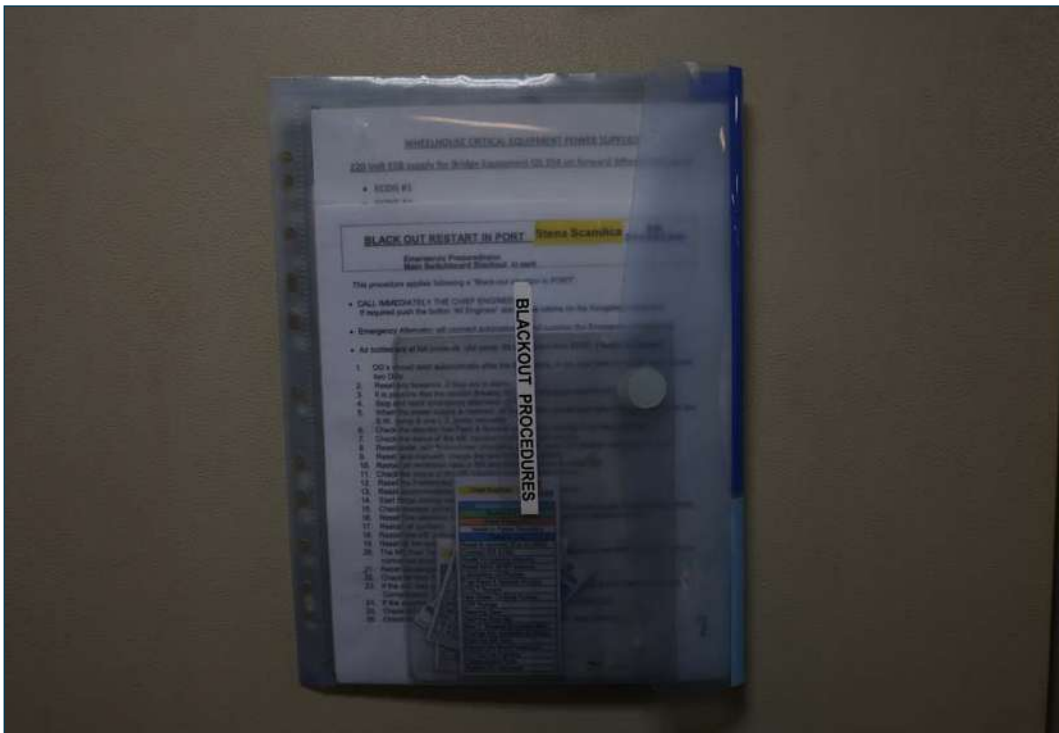
Figure 47: Folder with blackout procedures found in the engine control room.  
Source: DMAIB

Additionally, a plastic folder labelled "Blackout procedures" was stuck to a panel in the engine control room (Figure 47).

These blackout procedures were not included in the ship's operation manual. The folder contained, among other things, a laminated procedure entitled "Black out at Sea". The procedure comprised a list of 29 step-by-step directions of actions to restart the ship.

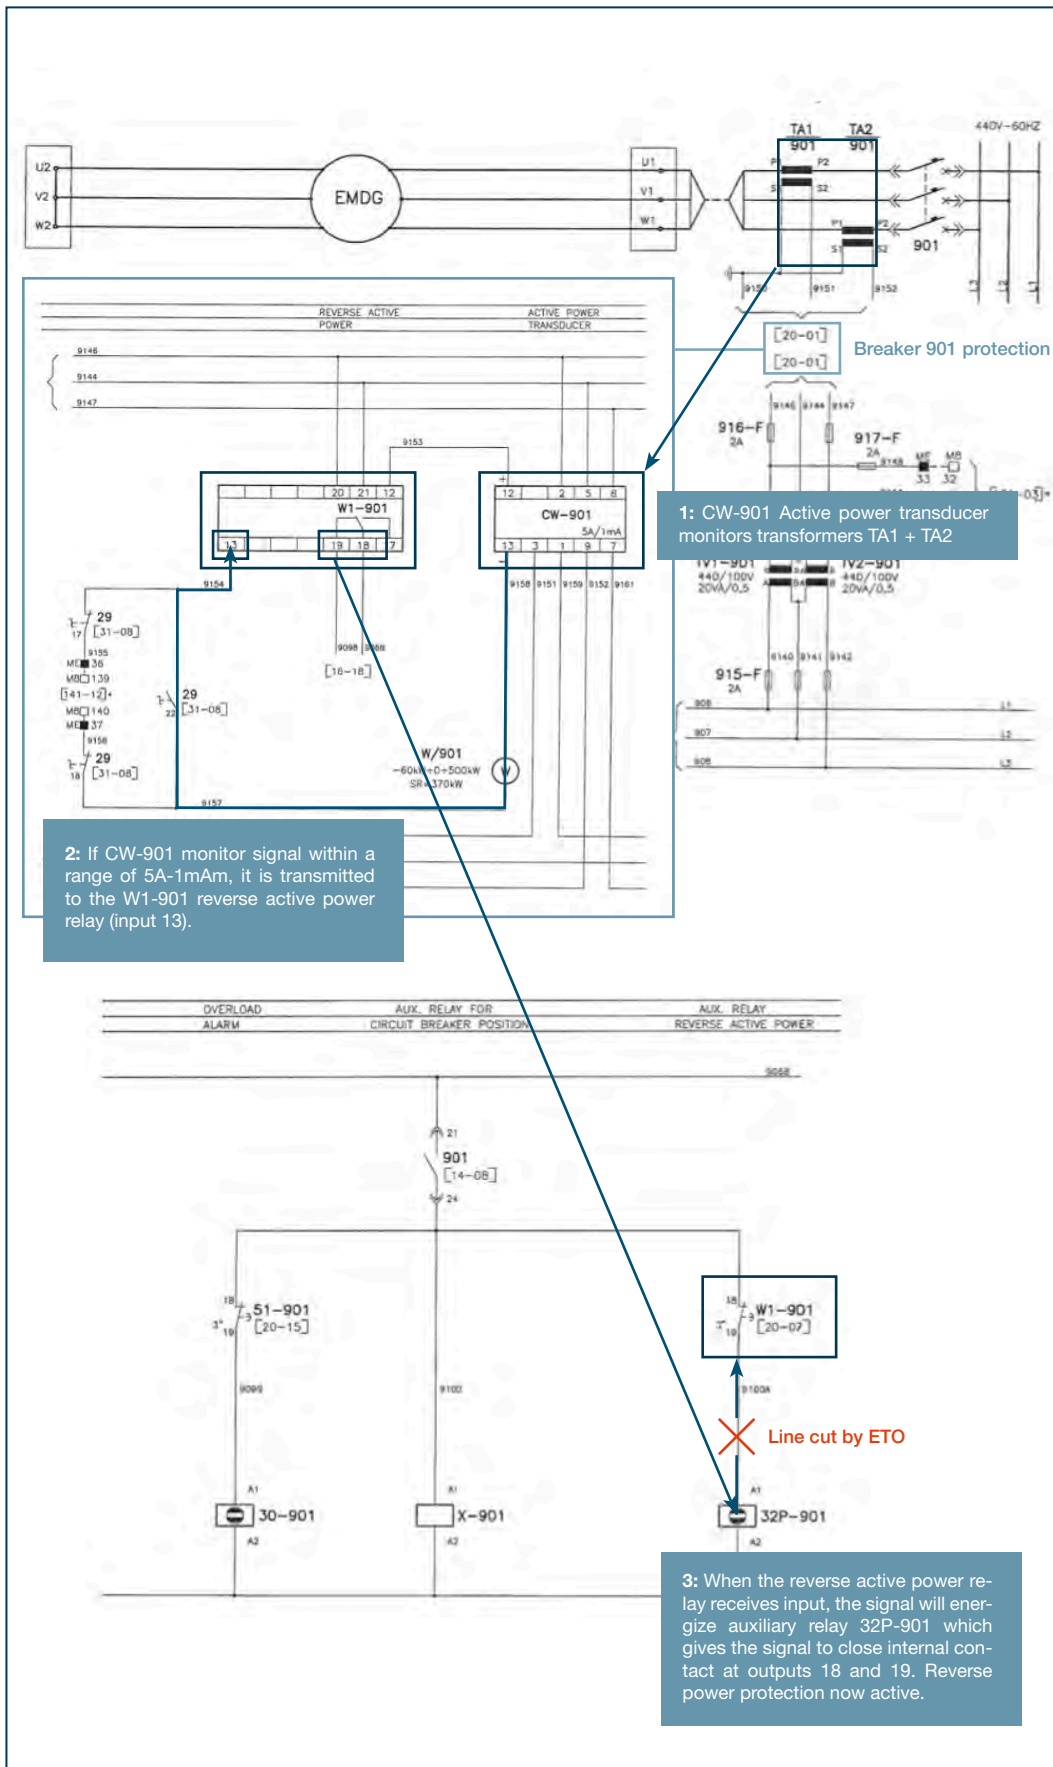
Figure 50: Reverse power protection logic.  
 Source: Stena Rederi A/S, modified by DMAIB

Breaker 901 had protection functionalities for reverse power and generator overload. During the ETO's attempt to manually close breaker 901 he observed that the reverse power protection activated and caused breaker 901 to trip, preventing the emergency generator from connecting to the emergency switchboard. The reverse power protection tripped the breaker continuously, though it was reset several times and all consumers were disconnected on emergency switchboard.

As there was no voltage on the emergency switchboard, the ETO concluded that the reverse power protection reacted to a faulty signal and decided to deactivate the reverse power protection by cutting the line for the auxiliary relay that put reverse power protection into effect. The reverse power protection logic is presented on the next page (Figure 50), and the line the ETO cut is marked with a red cross. Cabinet containing reverse power protection is shown on Figure 51.

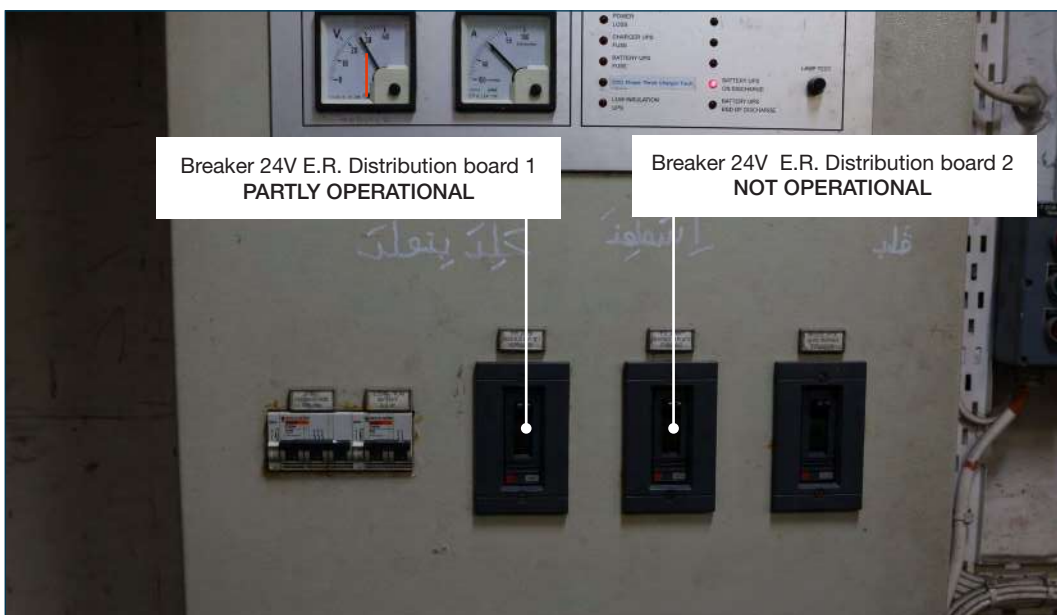
Figure 52: 24V switchboard/UPS in emergency generator room.  
Source: DMAIB

After the diesel generator was started, the engine crew initiated an attempt to start the port main engines. Restart of the port main engines required 24V service and 220V emergency service from the emergency switchboard. At the emergency switchboard, the ETO concluded that though the cable for 24V service to distribution board 1 was grounded, it was possible to establish power supply on this line. The cable to distribution board 2 short-circuited due to cable damage and was not operational (Figure 52). Also, the cable providing 220V was damaged and not operational.
