SAFETY INVESTIGATION REPORT

REPORT NO.: 12/2023

July 2023

MT *SUNNY ISLES* **Fatal injuries to a crew member** **in the steering gear room,** **in position 21° 46' N 059° 58' E** **18 July 2022**

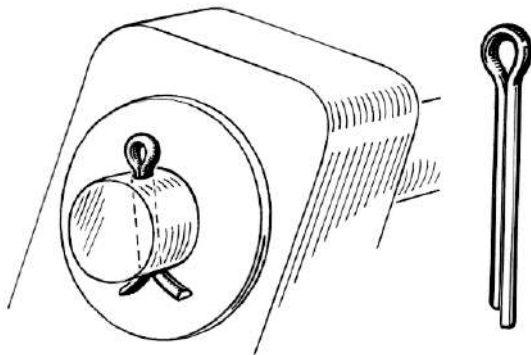
Figure 9: Split pin (or cotter pin)

The crew members stated that, after the removal of all steel plates from the accident site, they found the turnbuckle and the hook at the running end of the chain block, released. They further found the pin at the released end of the turnbuckle not in place (**Figures 7 and 8**). The split pin⁷ (red arrow in **Figure 8**), which was designed to prevent the turnbuckle pin from slipping out, was found in the vicinity, intact but not in its place. No damages were observed on any part of the securing arrangement.

Slipping of the split pin and the turnbuckle securing pin

A split pin is used to prevent a bolt or securing pin from slipping out of its place. The pin is inserted into a pre-drilled hole in the bolt / securing pin and the ends of the pin are then twisted outwards to prevent the split pin itself from falling out (**Figure 9**).
