ANNUAL DIGEST

CHIRP

2023

Annual Digest of Reports and Insight Articles 2023-24

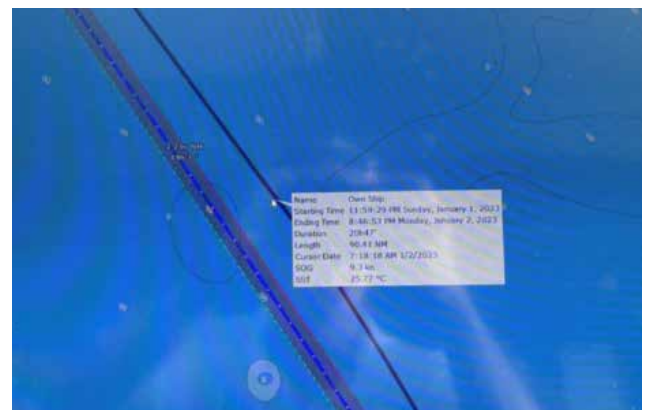
Screenshots of ECDIS (Electronic Chart Display and Information System) show that the planned track – shown as a dotted line – went over the top of a 1.9m shoal depth even though the vessel's draft was 2.3m. The vessel's course – shown as a solid line – was starboard of the planned track but still grounded because of a combination of shallow water, speed and squat. This resulted in the vessel dry-docking for several weeks for significant repairs.

The reporter explained that the master created all passage plans, but none were recorded in the vessel's navigation management system and that watchkeepers frequently had to deviate from the planned routes to avoid charted hazards. Our reporter was concerned that the master's proficiency in planning navigationally safe routes was lacking and that they sometimes struggled to interpret RADAR and ECDIS information. The reporter's employment was terminated when they raised these concerns through the company's safety reporting system.

Subsequent correspondence with the reporter revealed that to satisfy the owner or guests' requests to visit certain locations, the vessel often navigated to areas 'by eye,' i.e., visually detecting shallow areas because even large-scale charts lacked sufficient sounding data.

This report raises several issues. Firstly, although certificated, the master's navigational skills appear inadequate. It is vital that company managers validate the skill of masters and other senior officers and do not rely solely on the possession of a certificate as a measurement of competency. Secondly, route plans should always be cross-checked by another watchkeeper because even the best navigators can make mistakes.

CHIRP discussed with the relevant hydrographic office (HO) the issues experienced concerning navigating in the area related to the report. Crucially, a compliant ECDIS system must be used, and the charts must be updated to the latest edition and corrections. It was noted that an official ECDIS system with ENC was not used for the navigation of the vessel.

The HO placed great weight on using the sailing directions for the area as a pre-requisite before planning the passage. They contain valuable navigational information, including the nature of the seabed and the likelihood of shifting sandbanks, which in this case were prone to shifting. The vessel's speed must be set according to the under-keel clearance to avoid significant squat. Most fine-lined super yachts will trim by the stern when experiencing squat effect, and damage to the propellers and rudder can be expected if the vessel touches the seabed.

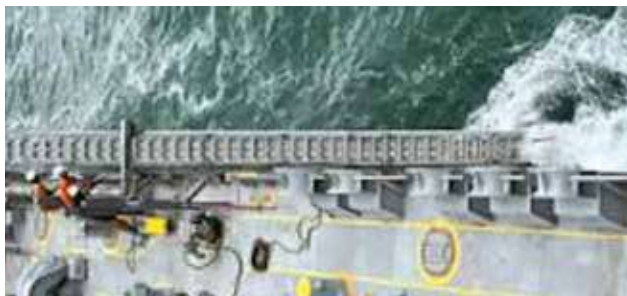
M2162

Severe Near Miss – accommodation ladder wire parts after pilot disembarks

The pilot reported that after disembarkation to the awaiting pilot launch, the accommodation ladder (part of a combination rig) was seen trailing in the sea when the wires for the accommodation ladder parted.

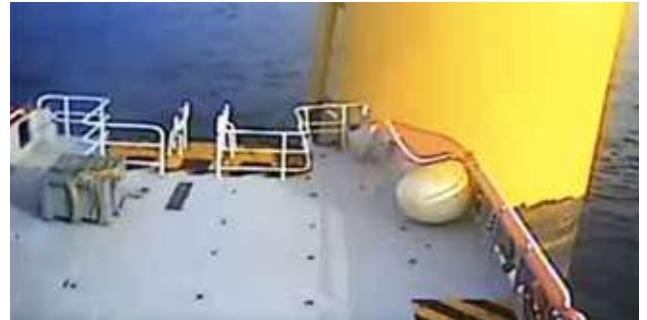
Workload distractions lead to a high-speed collision

As a Crew Transfer Vessel (CTV) was returning to port at high speed, the master became distracted by a lengthy radio conversation and did not notice that the vessel had been pushed off course by the tide. It collided with a wind turbine tower at speed, causing significant damage to the vessel. The weather and visibility were good. As is common for vessels of this length, only the master was on the bridge; nobody else was keeping a lookout during the radio exchange.
