SAFETY DIGEST

Lessons from Marine Accident Reports

1/2024

MARINE ACCIDENT INVESTIGATION BRANCH

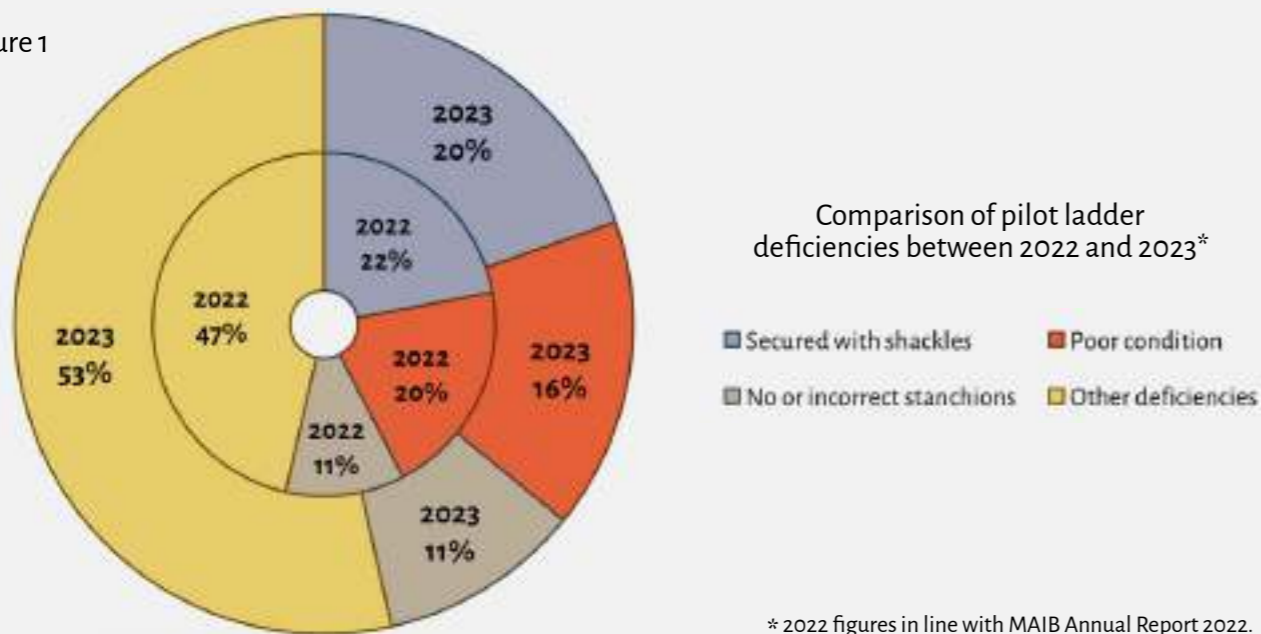
Figure 1

Approximately 50% of all pilot ladder incidents reported to us in 2023 involved the same three deficiencies as those reported during 2022 (Figure 1), the leading deficiency once again being pilot ladders secured using shackles over the side ropes (Figure 2). Also known as 'choke shackles', this arrangement brings the entire weight of the ladder onto one step, which is not designed to take a weight that should be borne by the side ropes. As in 2022, the next most common deficiencies were the ladder being in poor condition or having no or incorrect stanchions (Figures 3 and 4).

- Inspect** → Examine the ladder at regular intervals and before each use to identify damaged or degraded parts and replace it as necessary. Make sure there are sufficient spares of a suitable quality on board.
- Check** → Secure the ladder to strong points using manila rope tails tied in a rolling hitch around both side ropes. Do not use shackles to secure the side ropes.
- Check** → Make sure the stanchions at the top of the climb allow the pilot to gain a firm grip during the transition between deck and ladder.
- Confirm** → Test the ladder to be certain it remains secure when weight is applied. Pilots are not always able to check this themselves, particularly during inclement weather.

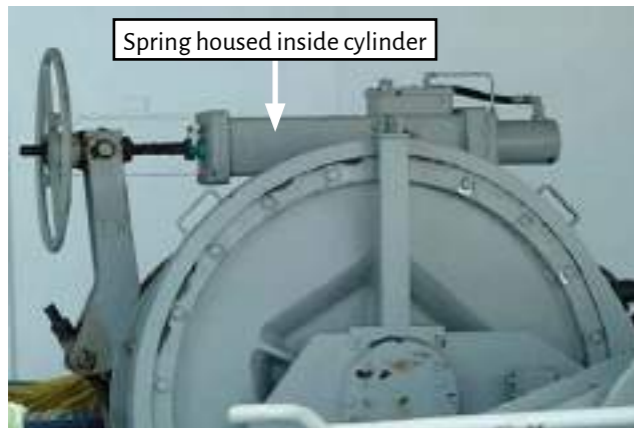
A ferry was approaching harbour at 17 knots (kts) with its anchor cleared away ready for emergency use. Suddenly, there was a loud bang and the anchor cable started paying out rapidly. The crew on the forward mooring deck attempted to apply the anchor brake (Figure 1) but it would not hold. The master realised that the anchor was paying out and applied maximum power astern. The ferry came to a halt just as the anchor cable was stopped by the operation of the deck clench.

Figure 1: Anchor cable brake assembly

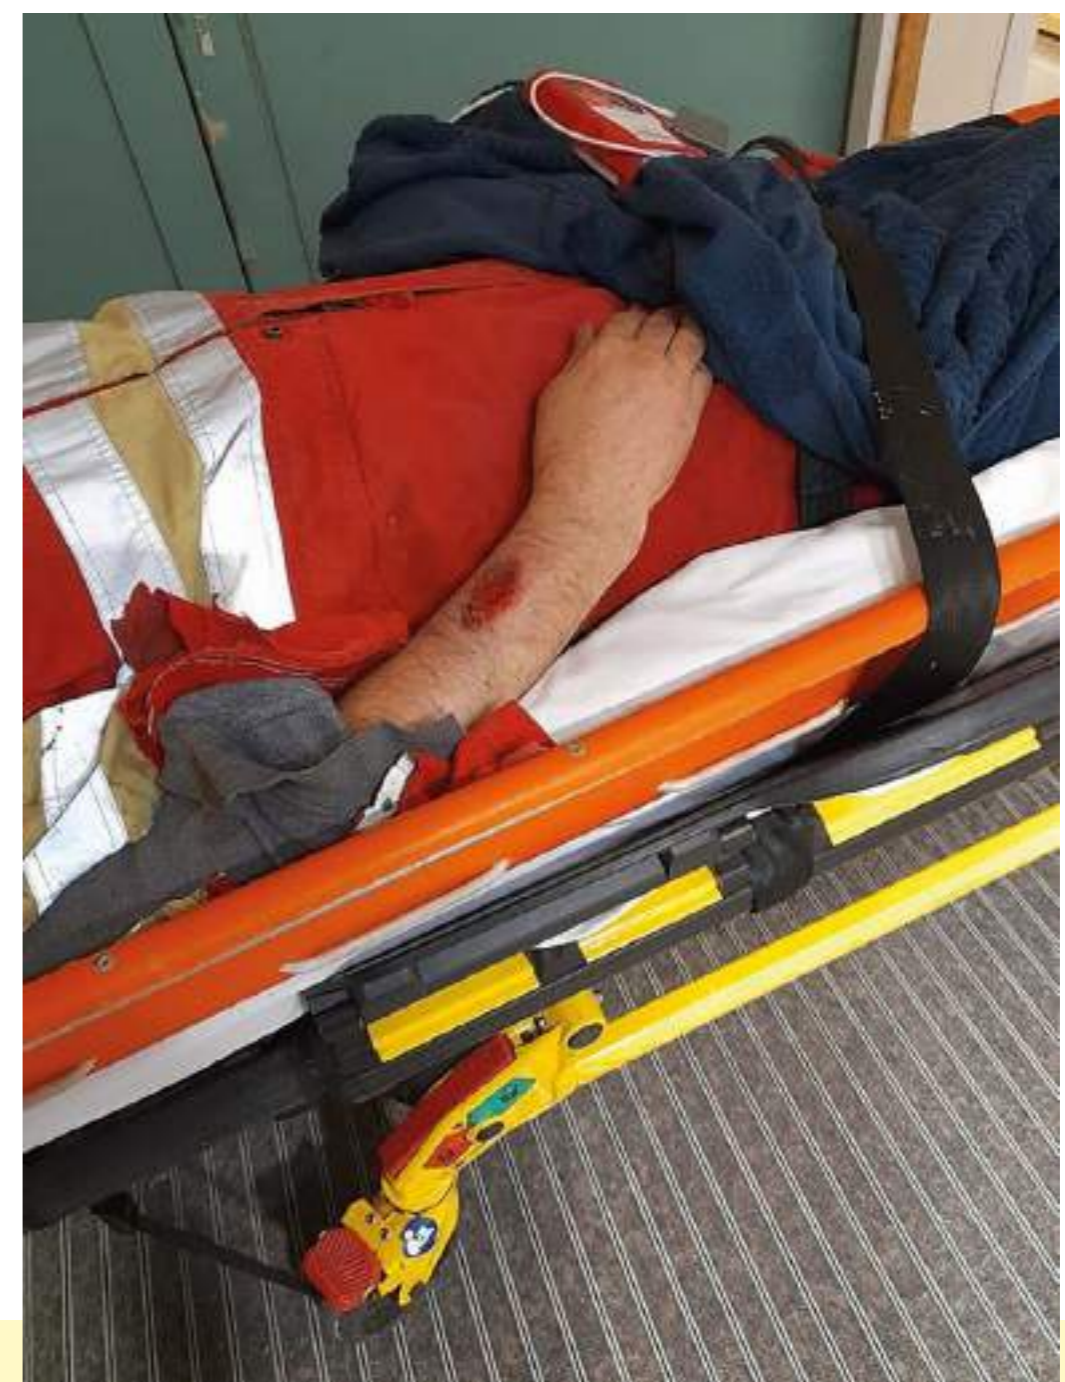
When the winch brake was released the tension in the line connected to the cargo barge caused the winch drum, and still attached cranking handle, to spin uncontrollably. The spinning cranking handle violently struck one of the crew members, fracturing their wrist and inflicting significant pain (Figure 2). The crew member was evacuated from the tug by a Royal National Lifeboat Institution (RNLI) lifeboat and

Figure 2: The crew member's fractured wrist

1. **Risk** → The pusher tug's crew might have identified the risk posed by the hazard of the still attached cranking handle had they collectively taken a moment to undertake a dynamic risk assessment rather than rush to complete the task. Empowering crew to identify hazards, assess the risks involved and report their concerns contributes to a proactive on board safety culture and reduces the likelihood of accidents.
2. **Monitor** → The master could not safely undertake the simultaneous tasks of steering the pusher tug and trying to control the aft deck operations from a position of limited visibility. The use of the closed-circuit television (CCTV) to provide operational oversight from a remote position can help to identify any safety issues and take immediate preventative action.

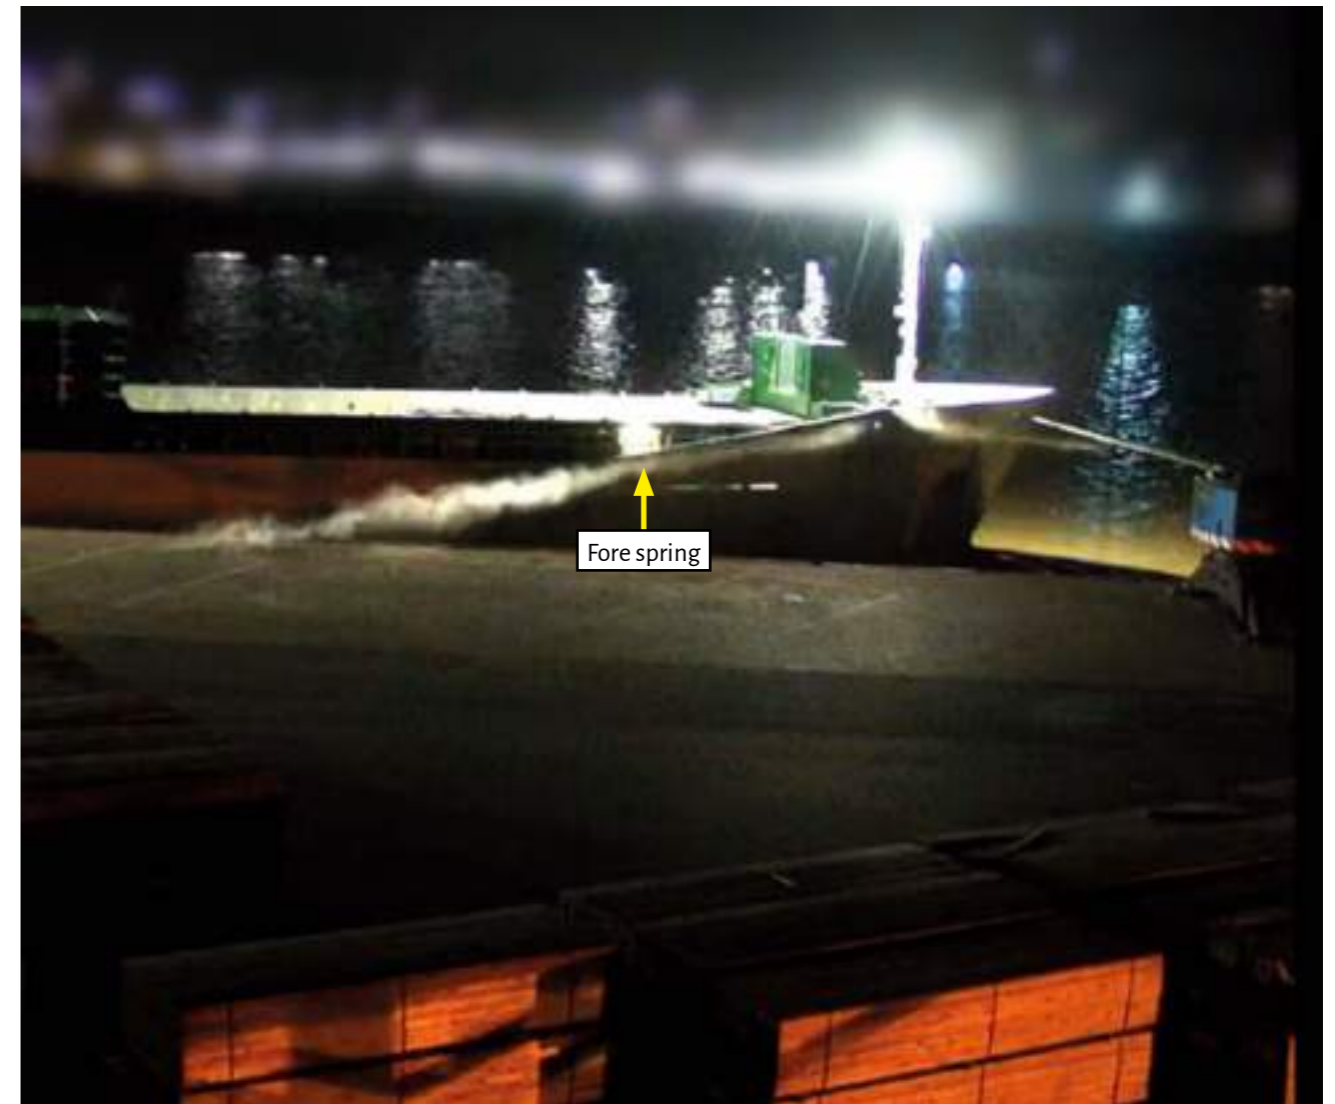
Figure 2: Video still, showing the moment the fore spring snapped

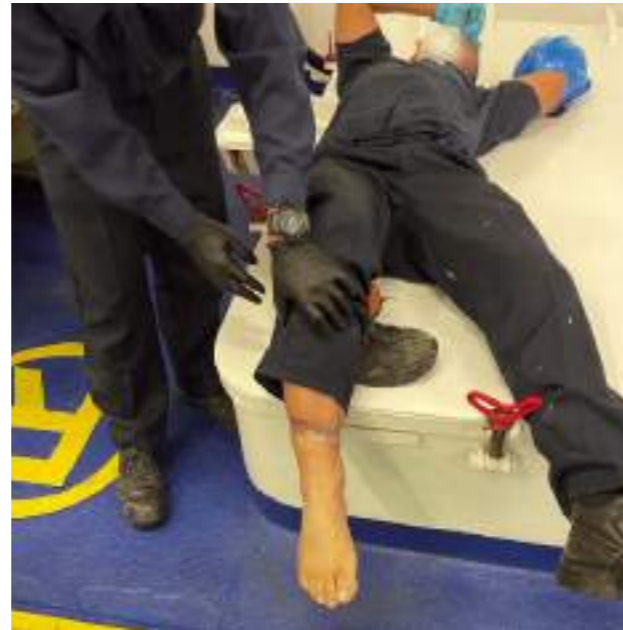
Realising what had happened the AB let go of the messenger line, but was unaware that it had formed a bight around their right leg. As the bight tightened, the AB was pulled towards the winch drum and then dragged over it. The AB's screams alerted the winch operator, who promptly stopped the winch.

The AB was disentangled from the messenger line and immediately taken ashore for medical treatment for a broken shin bone and other leg injuries (Figure 2).

Figure 2: The AB's leg injury

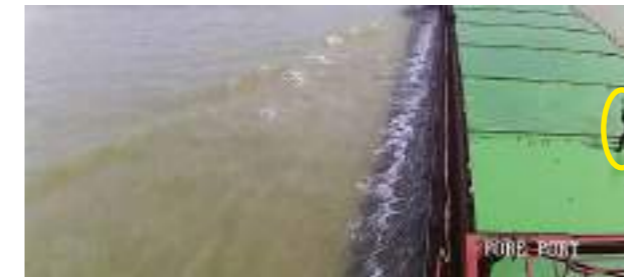
The crew member quickly approached the wedge and, without taking time to prepare, swung the sledgehammer (Figures 1 and 2).

Figure 1: Crew member swinging the hammer

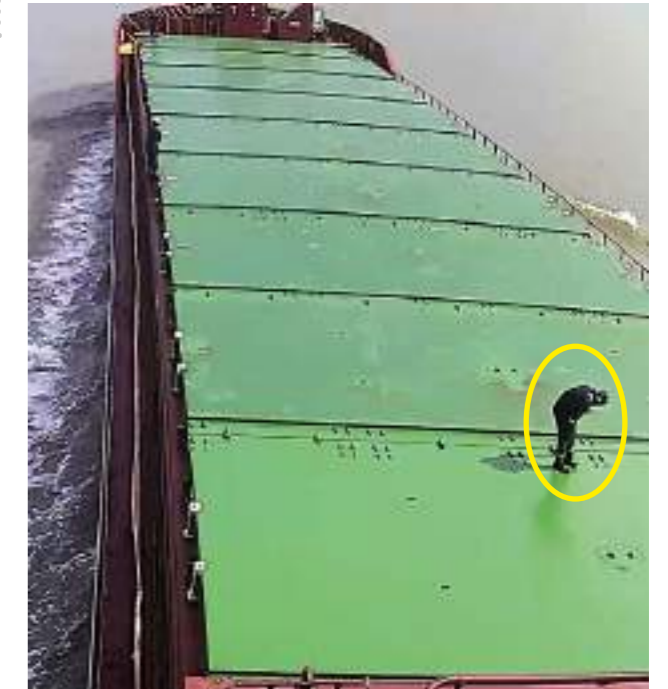
When the hammer impacted the wedge it remained lodged in place and shattered, sending debris flying towards the crew member. A small fragment of the securing wedge penetrated the crew member's right leg, just below the knee (Figure 3). The crew member received first aid and was signed off work for 3 days to recover from their injury.

Figure 3: The injured crew member

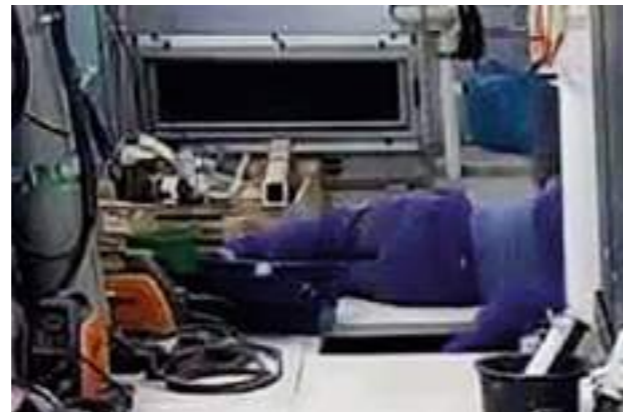
Meanwhile, the cruise ship began its scheduled departure in rippled sea conditions with the wind gusting to 30kts. Shortly after leaving its berth the vessel rolled slightly and the compressor tilted from its suspended position, crushing the contractor.

Figure 1: Contractor lying on deck to reach and disconnect mounts

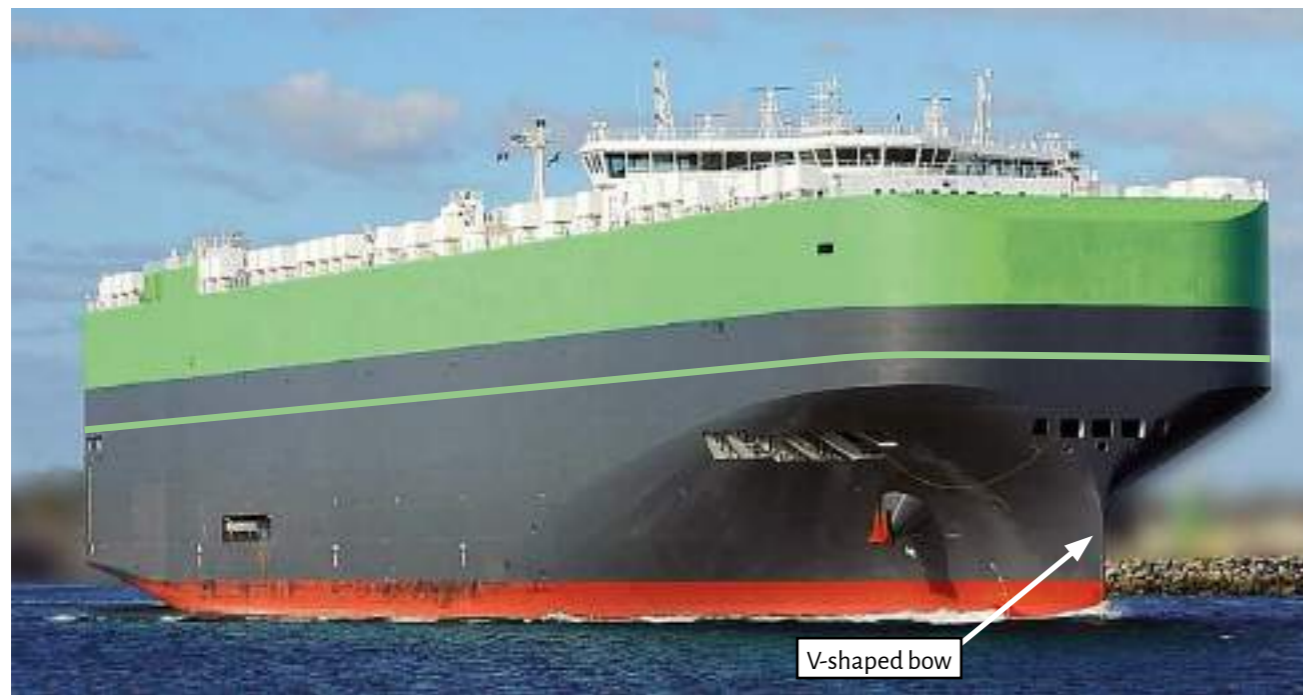
Figure 1: The car carrier

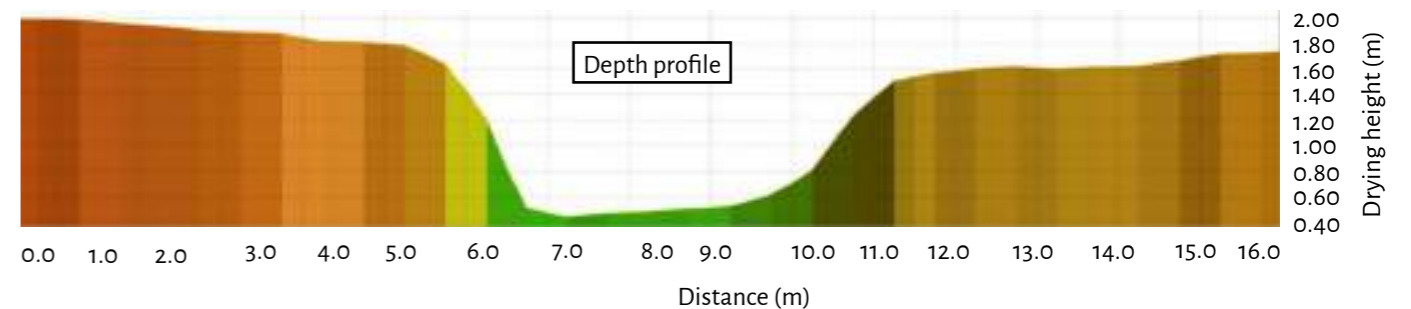
tidal stream meant the ship took longer to slow down than planned. The pilot had to apply a hefty amount of astern power, which was unusual and caused the ship to veer off track towards a mud bank close to the harbour. The ship took a long time to stop, but the pilot managed to line the car carrier up with the dock entrance and the berthing operation was subsequently uneventful. Neither the pilot nor the master noted anything too worrying with this excursion from the plan but subsequent analysis identified that the ship had grounded, leaving a decent imprint in the mud (Figure 2). There was no damage to the car carrier or to the tugs.

Figure 2: Hydrographic survey data, showing the bow imprint in the mud

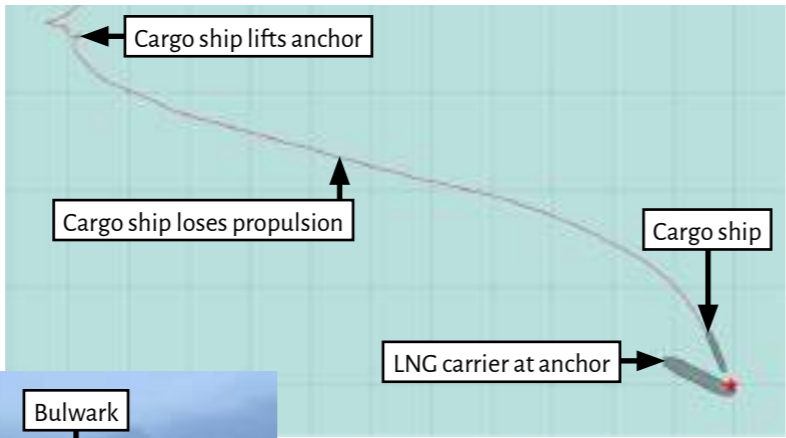
had stopped because the fuel supply pump had not been started up as the ship was prepared for departure. The engine had run just long enough on the fuel in the system for the ship to lift the anchor before it stopped.

Figure 1: Track of the cargo ship

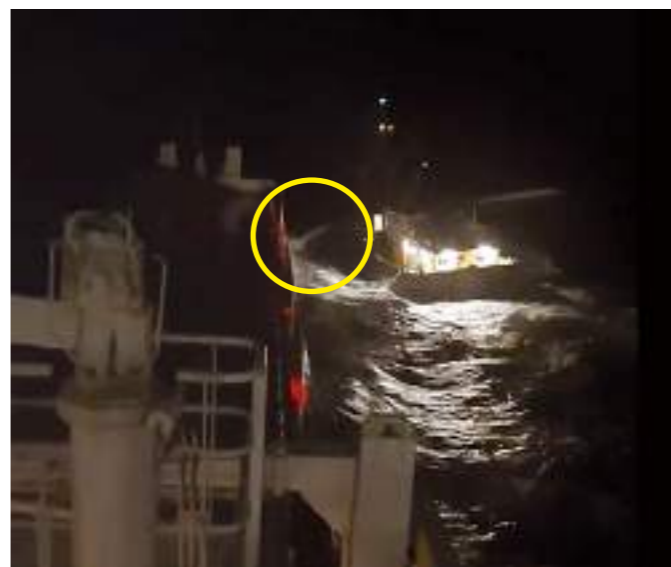
The OOW became aware all was not well and started to alter course to port but it was too late for the bulk carrier to avoid contact with the port derrick arm of the fishing vessel, which momentarily keeled over by about 15° (Figure 1) before it righted itself and passed clear down the starboard side. The fishing vessel limped back into harbour several hours later, hampered by its unrecoverable fishing gear. The crew were uninjured but there was substantial damage to the derrick's arm and posts (Figure 2) and the fishing gear was written off. The bulk carrier suffered plate and frame damage (Figure 3).

Figure 1: Video still showing the bulk carrier hitting the fishing vessel's deployed derrick arm

- Monitor** → Whatever the plan, it must be monitored throughout. The OOW became distracted by the other crew members watching a movie on the bridge, which resulted in a delayed reaction to the developing situation. The safety of the crew, the ship and other mariners relies on watchkeepers staying alert while on duty.

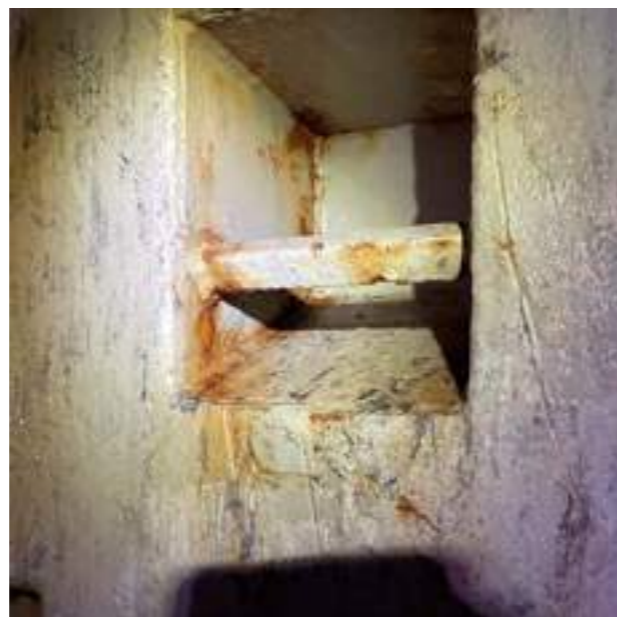
A couple of hours later, the ship's cook/AB was working at the bulkhead at the forward end of the hold. Wearing a safety harness with a lanyard and safety hook, the AB used the recessed footholds (Figure 1) in the side of the cargo hold to climb about 2.5m to access one of the bulkhead locking bolts and attached the safety hook.

Figure 1: A recessed foothold

- Equipment** → The safety harness worn in this case was equipped with only one lanyard and hook, limiting the ability of the wearer to move around safely at height. Once the safety hook is disconnected to move to another locking point, the wearer remains at height without any fall arrest or fall prevention measures apart from hand and footholds; this might be unsuitable in the local conditions. A harness with twin lanyards and safety hooks enables movement at height while providing a means of fall prevention.

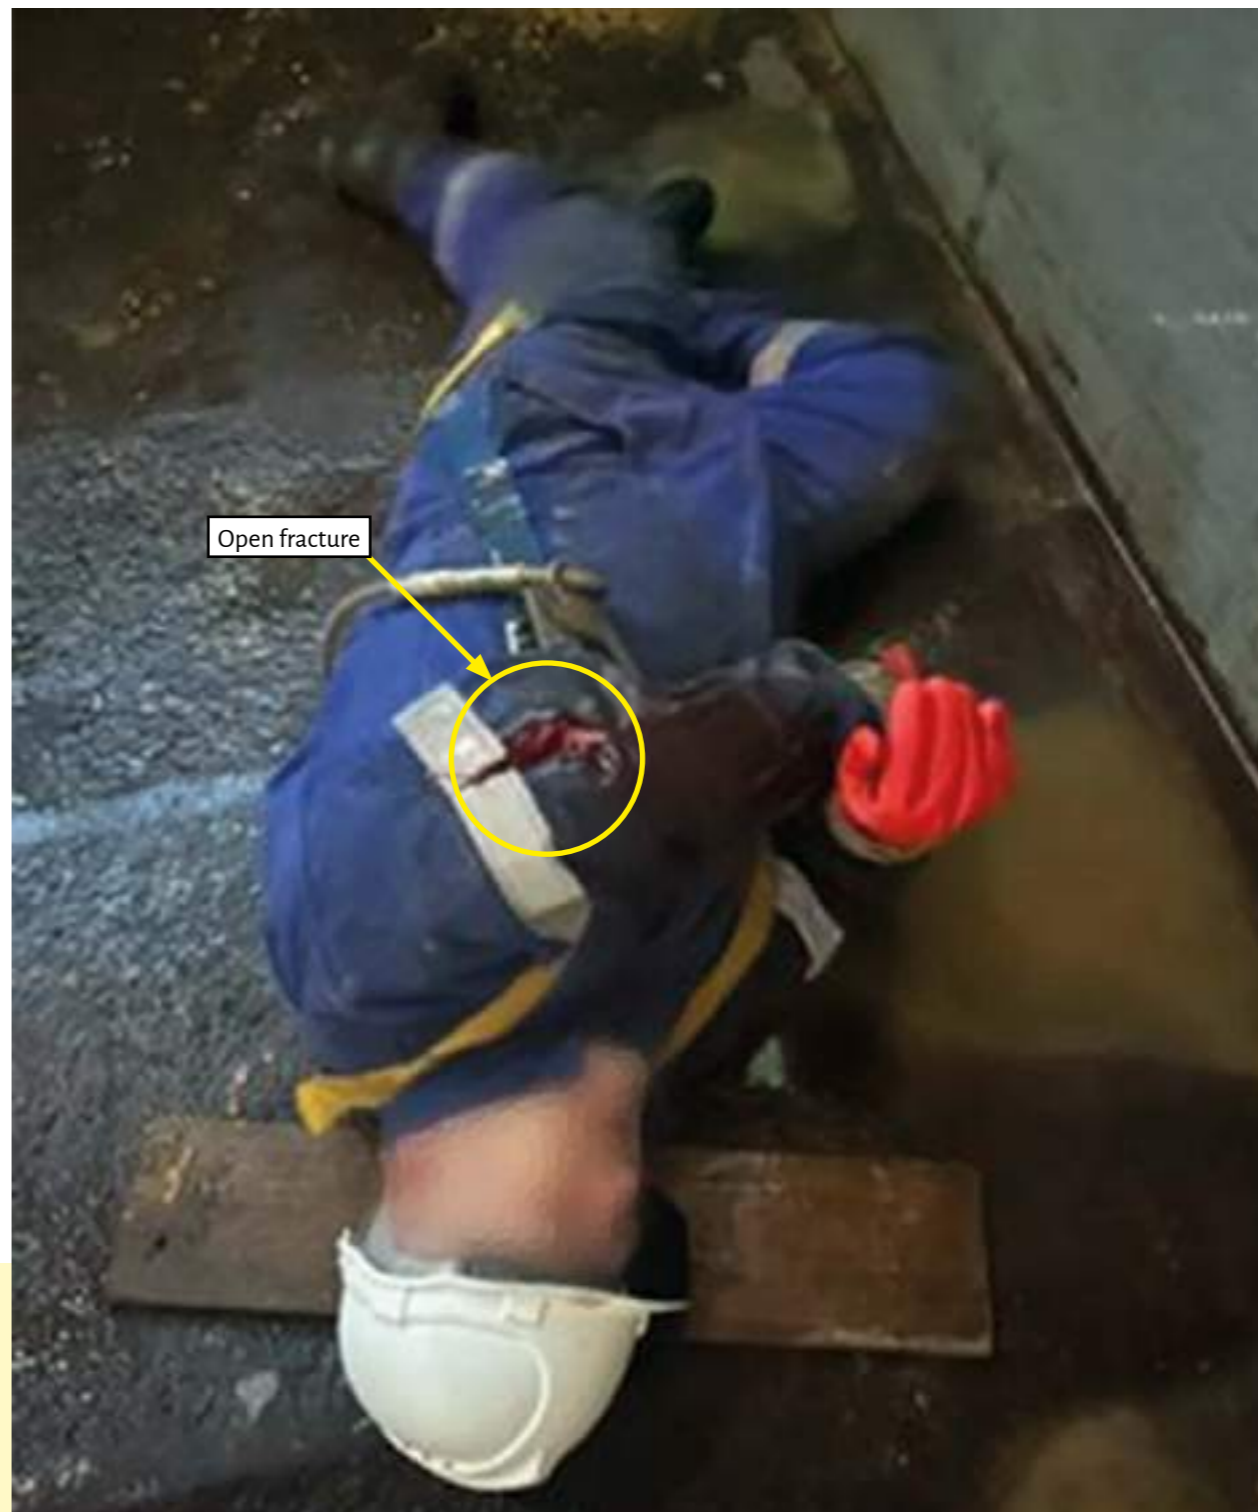
before the safety hook could be attached to a securing point. The AB fell to the hold bottom, resulting in an open fracture to their upper arm (Figure 2).

Figure 2: The injured AB lying in the hold

- Procedure** → The ship did not have procedures or equipment to recover an injured person from the cargo hold. Without suitable crew training and recovery equipment, it is possible for a survivable injury to become a fatality. Think about what could go wrong and then plan and be prepared to respond in the event that it does; it could be you lying at the bottom of the hold in serious pain.

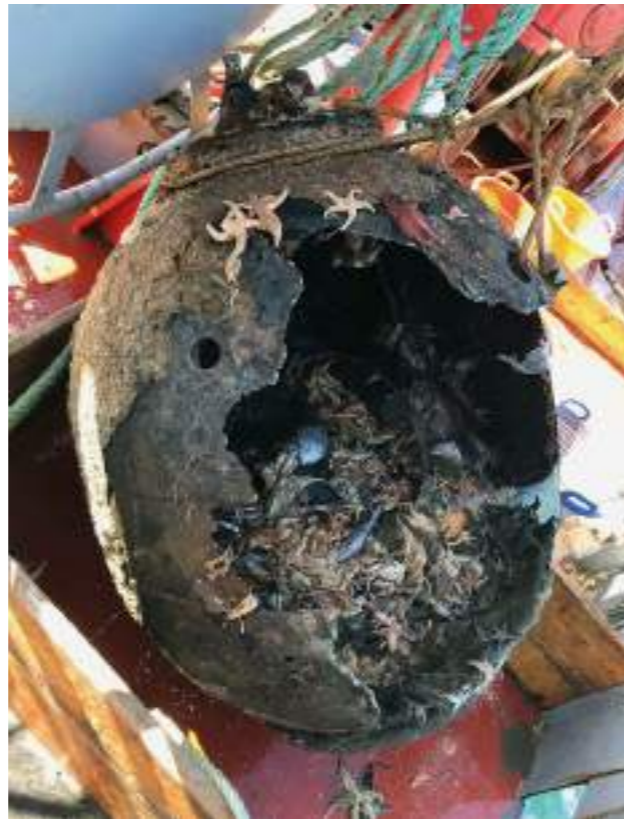
A Royal Navy Explosive Ordnance Disposal (EOD) team was tasked by the coastguard to attend and deal with the situation. On arrival, the EOD team identified some residual explosive material within the sea mine that could still be dangerous and proceeded to cut the sea mine free from the vessel's net, lower it carefully to the seabed and mark it with a yellow float.

Figure: A typical sea mine recovered from the seabed

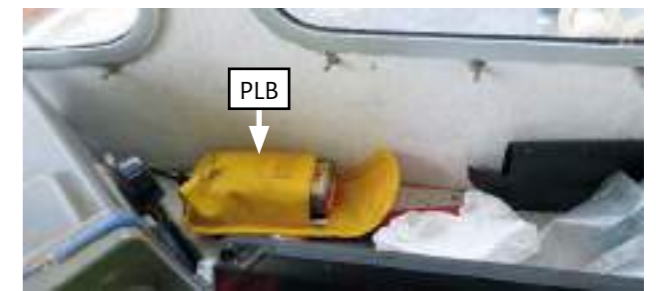
The skipper was able to free their foot from the gear, but could not catch up with the vessel as it motored away and had to fight to stay afloat in the water with no means to raise the alarm: the skipper was not wearing either a personal locator beacon (PLB) or personal flotation device (PFD), both of which were stowed in the wheelhouse (Figures 1 and 2).

Figure 1: The skipper's PLB

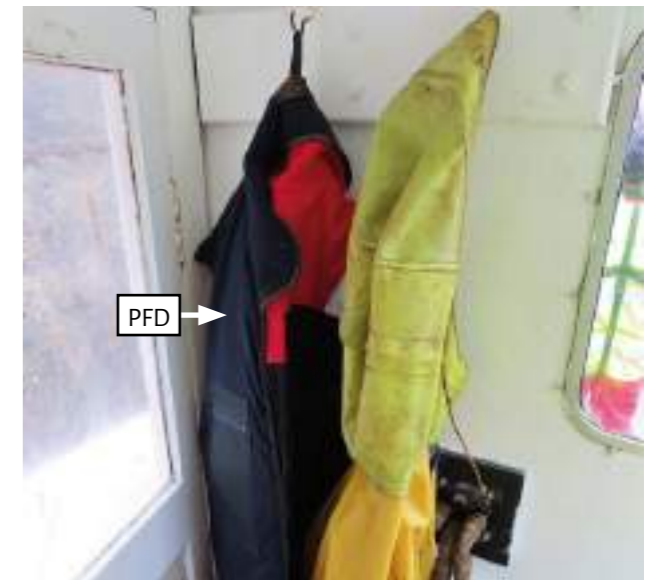
Figure 2: The skipper's PFD

This is one of several similar accidents investigated over the years where the inherent risks involved in the lone operation of small boats had not been managed, resulting in tragedy.

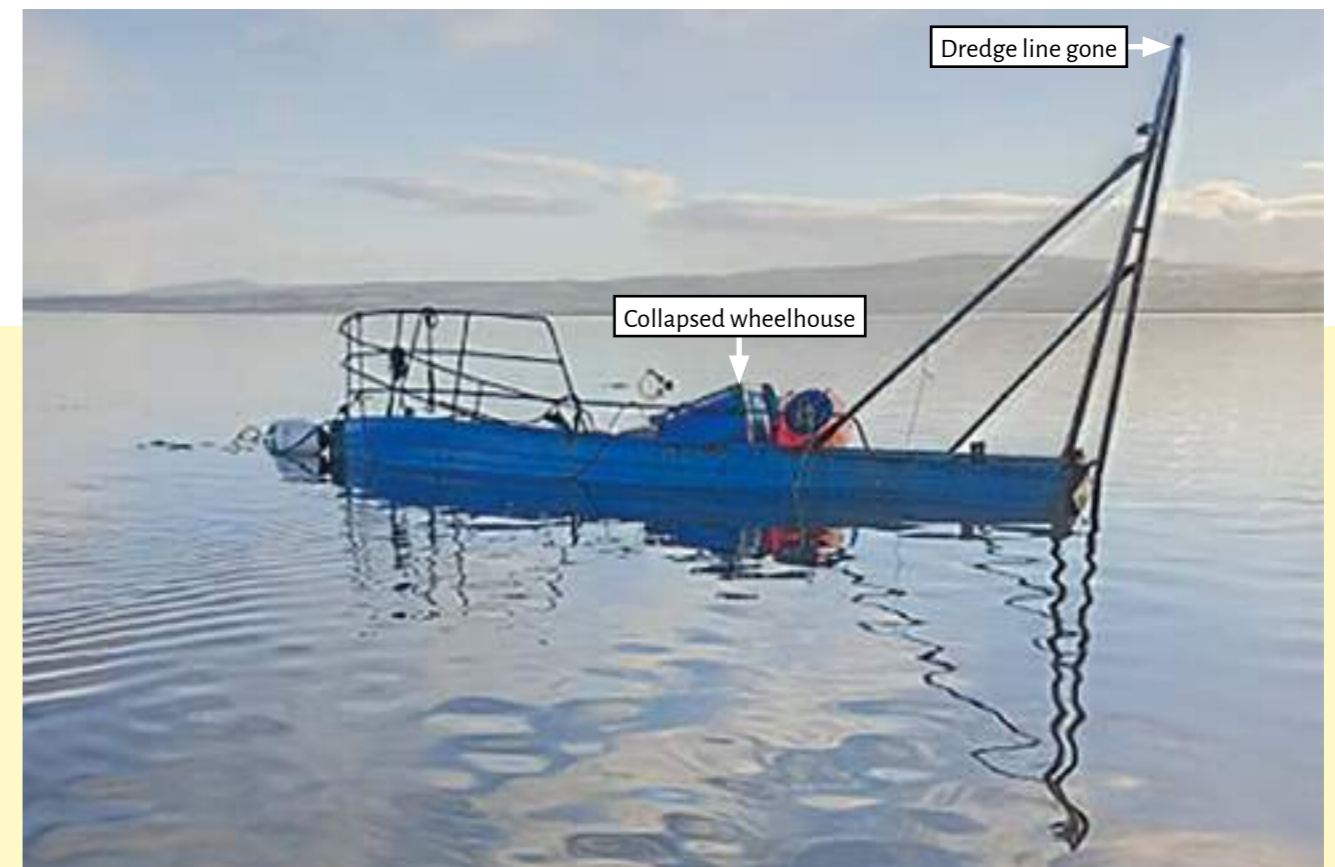
The fishing vessel's wheelhouse had partially collapsed during the capsize and, in the days following the accident, the dredge line had parted due to rough weather (Figure 2). The fishing vessel was recovered during the next spell of good weather and later repaired. On recovery of the dredge it became clear that this had come fast on a disused anchor for salmon nets.

Figure 2: The dredger before recovery

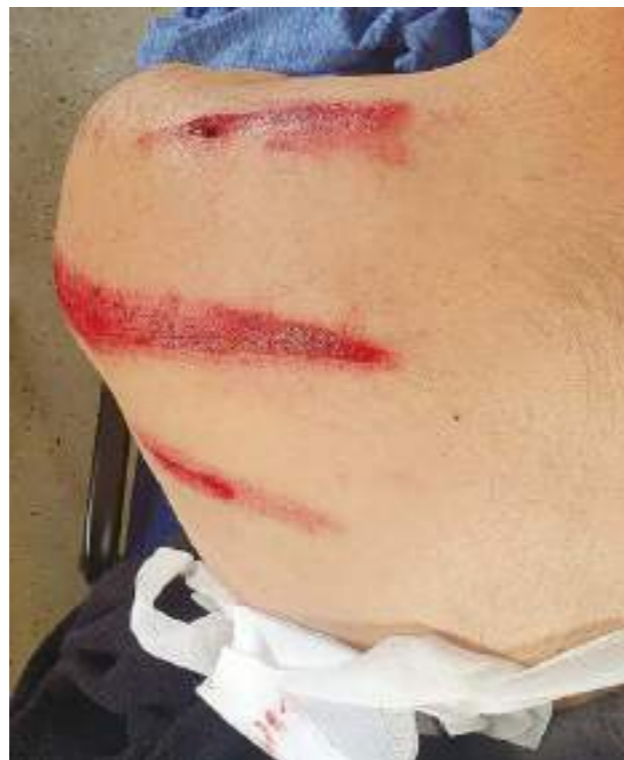
The instructor was standing next to the novice coxswain at the helm and another student was sitting on the starboard sponson towards the stern. The novice coxswain conducted the drill as instructed, but as the boat turned sharply to port the student on the sponson fell into the water and was struck on the shoulder by the propeller (see figure).

Figure: The student's injuries

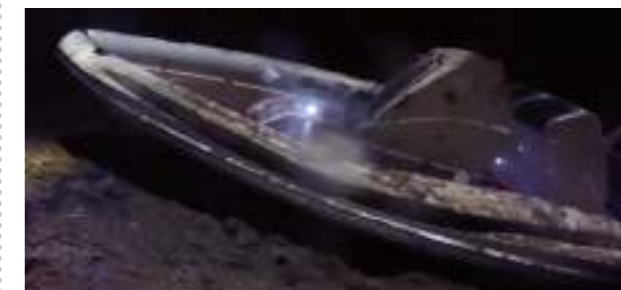
The RIB was driven at high speed and the driver did not use the on board plotter to guide the craft's track. On approach to the marina the driver made a turn to follow the channel when, without warning, the RIB stopped. The fast deceleration caused all the occupants to be thrown forward, one of whom suffered a back injury. The RIB had grounded at high speed on mud flats at the entrance to the channel (Figures 1 and 2). One of the group raised the alarm by using VHF radio to call the coastguard and two RNLI lifeboats, a coastguard rescue helicopter and emergency ambulances were immediately tasked to the scene.

Figure 1: The RIB on the mud flat

- Aware** → The driver did not reduce the RIB's speed to safely navigate the channel on approach to the marina and could not see the drying mud flats in the darkness. Dark conditions are not ideal for a high-speed passage over open water, when unlit hazards such as non-navigational buoys or objects in the water cannot be seen.

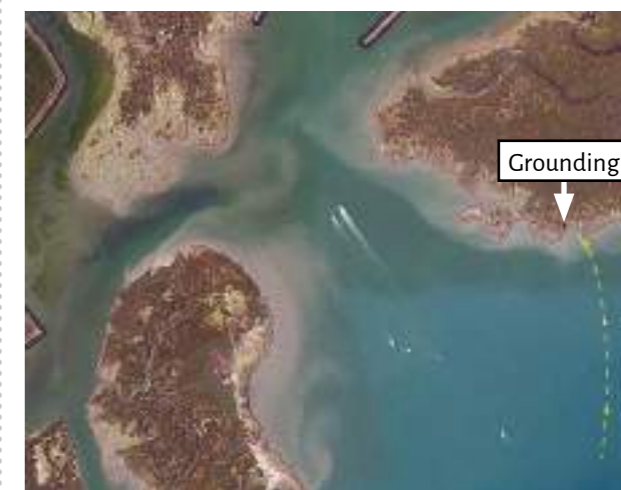
Figure 2: Aerial view of the RIB's predicted track to its place of grounding on the mud flat

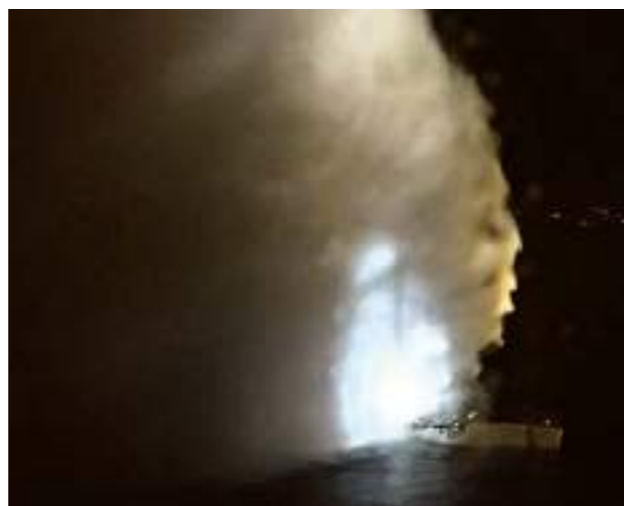
The coastguard arrived 45 minutes later, by which time a fourth small fire had been extinguished and the crew had retreated to the upper deck due to smoke inside the yacht's cabin. The coastguard started to tow the yacht but yet another fire started around 30 minutes before arrival into port, this time engulfing the yacht. The crew were beaten back by clouds of thick smoke (Figure 1) and evacuated to the attending rescue vessel.

Figure 1: Smoke envelops the yacht, forcing the crew to evacuate

- Maintain** → Regular checking and maintenance of hatch seals and operating mechanisms can make all the difference. This accident stemmed from a leaking hatch in the forward cabin but the yacht crew did not discover this leak until the weather worsened, by which time it was too late; the flooding caused the fires and the fires resulted in the loss of the vessel. A very costly lesson.

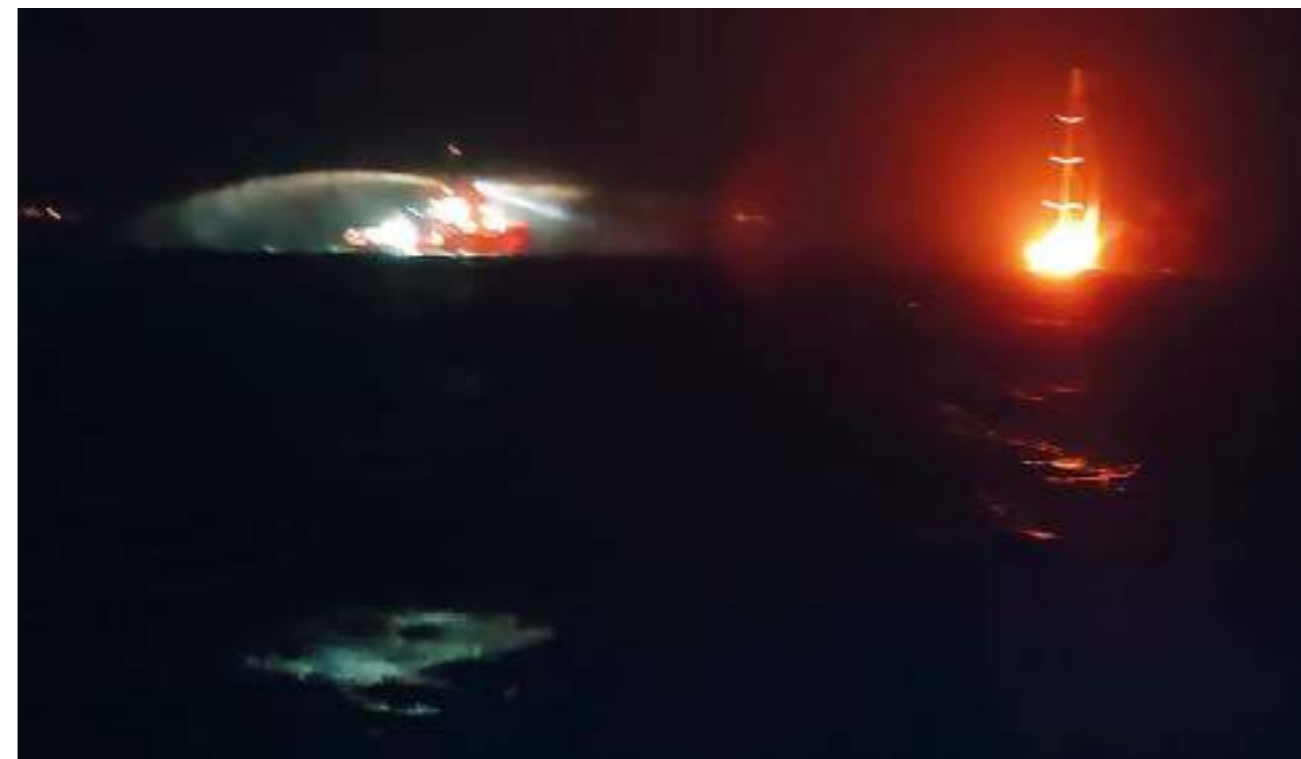
The crew of the coastguard vessel used their fire monitors to hose down the yacht but the flames continued to spread (Figure 2). The yacht crew watched aghast as the main mast collapsed and

Figure 2: The fire takes hold, despite the best efforts of the rescue vessels

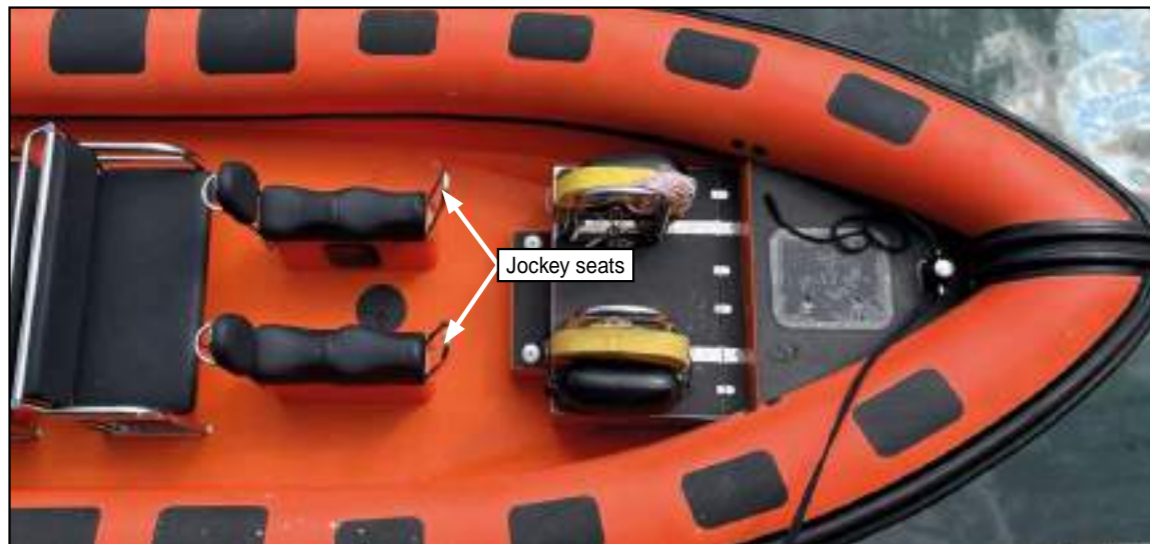
On 7 June 2023, a passenger on a rigid inflatable boat (RIB) sea safari suffered a spinal injury that left them paralysed from the waist downwards. Twelve passengers had boarded the RIB and, once it was clear of the jetty, the two crew gave them a safety briefing and instruction on the wearing of lifejackets. The RIB then proceeded out to sea and was increasing speed in choppy sea conditions when it encountered a steep-sided wave. The boat fell off the wave and slammed violently into the trough, dislodging a passenger from a forward jockey seat (**Figure 1**). The passenger immediately lost feeling in their legs.

Figure 1: Front of RIB with jockey seats

When the boat hit the trough, the resulting force applied to the passenger's spine was of sufficient magnitude to fracture a vertebra. With a normal BMD level and no pre-existing conditions to increase their susceptibility to this type of injury, the factors contributing to the fracture related to the activity being undertaken. These included:

- Urgently review their operations and risk assessments, with reference to the CoP and MGN 436 (M+F). This review should assess and mitigate the risks associated with the requirement to seat passengers in the front area of a RIB and ensure that the risk assessment includes and addresses the variability of weather conditions and the ability of passengers.
- Review their passenger pre-departure briefing and ensure that it includes a specific explanation of how to use the seat(s) and their associated handholds, including how to maintain the correct posture and stability to mitigate against injury.

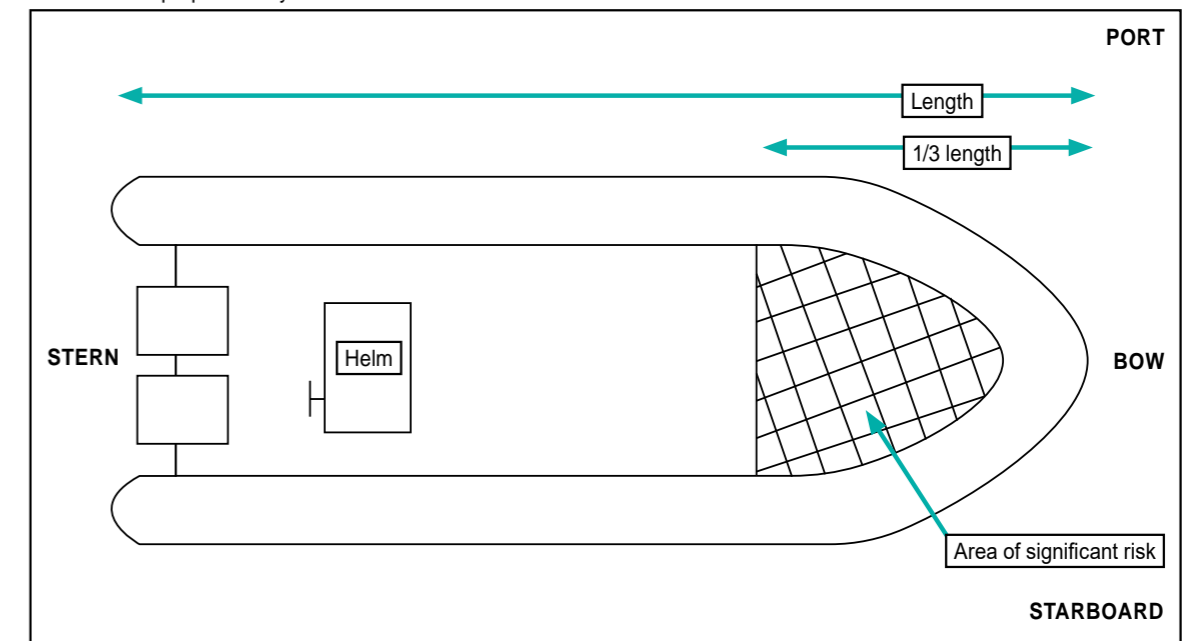
Commercial passenger tours using RIBs, including sea safaris and thrill rides, have experienced a surge in popularity across the UK, with a corresponding increase in the occurrence of accidents. Since 2001, the MAIB has been notified of 54 accidents during RIB rides that have resulted in lower back injuries, 17 of which resulted in spinal fractures. Initial analysis of these previous accidents as part of this investigation indicates that passengers seated in the front third of a RIB's overall length (**Figure 2**) are exposed to a significantly higher risk of lower back injuries than those seated further back, as the vertical motions experienced are generally greater towards the bow.

Figure 2: RIB outline highlighting the area of significant risk

There is a significantly higher risk of spinal fractures to people seated in the front area of RIBs, regardless of speed.

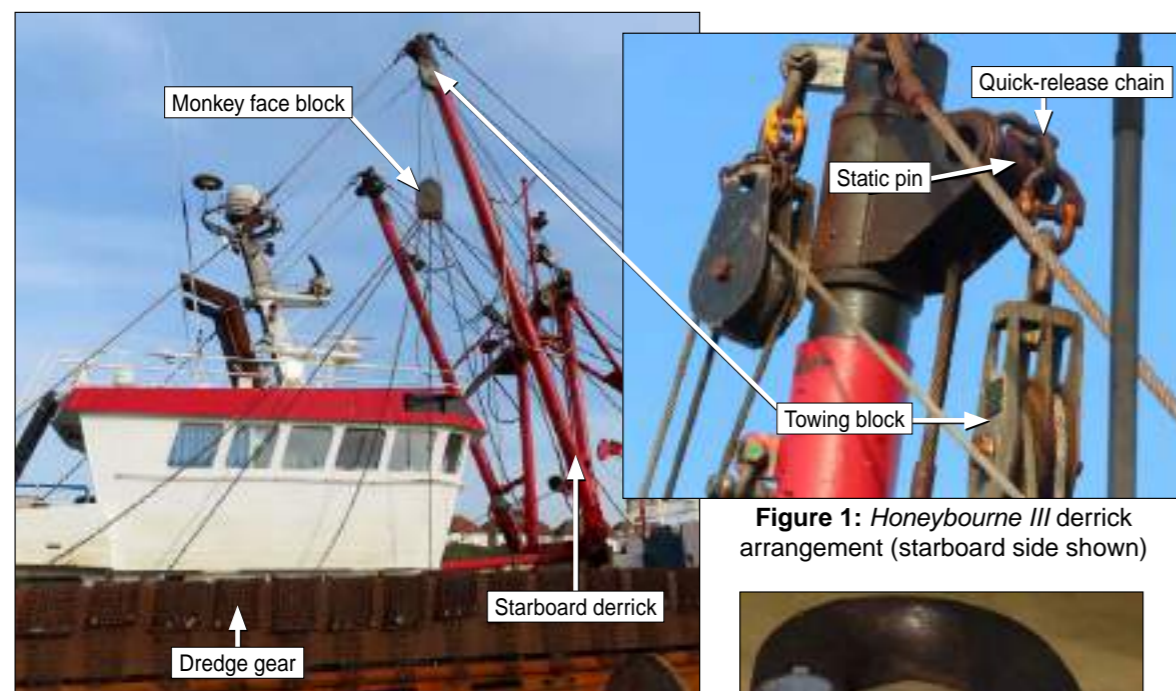
The ongoing MAIB investigation has found that a section of chain in the port dredging gear quick-release assembly failed as the gear was being retrieved. A 32mm chain link, which was led over a static steel pin at the derrick head (**Figure 1**), parted (**Figure 2**) and allowed the towing block, monkey face block and associated gear to fall to the deck below.

Figure 1: *Honeybourne III* derrick arrangement (starboard side shown)

It is therefore imperative in the short-term that these types of release mechanisms and derrick head pins are subject to regular inspection and replaced at the earliest sign of wear.

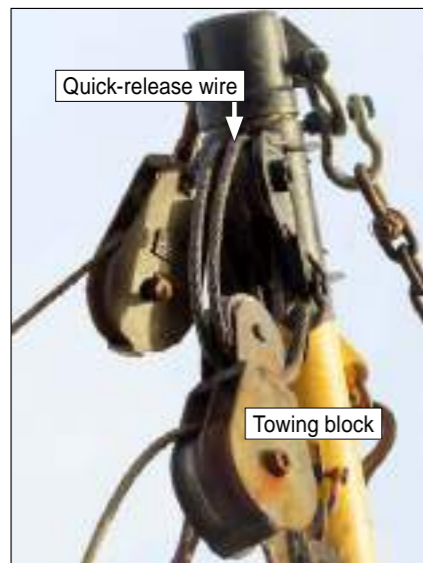
Figure 4: Quick-release arrangement with derrick head quick-release wire and sheave

Alternative arrangements for the quick-release mechanisms at the derrick head that either do not include a chain passing over a static pin, or remove the risk of the gear falling in the event of a failure, have been fitted to vessels to mitigate the risk of gear falling from height in the event of a failure of the chain arrangement. The alternative configurations observed by the MAIB have included the use of wire and sheave arrangements (**Figure 4**), the replacement of the derrick head arrangement with a swinging arm mechanism (**Figure 5**), and the provision of warp tension monitoring and release systems. Options have also been suggested for a secondary means of retaining the gear, in addition to the chain, to prevent the gear from falling in the event of a chain failure while still allowing the release of the gear in an emergency (**Figure 6**).

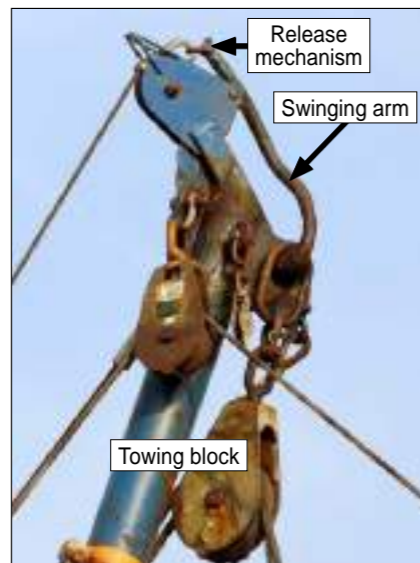
Figure 5: Quick-release arrangement with derrick head swinging arm

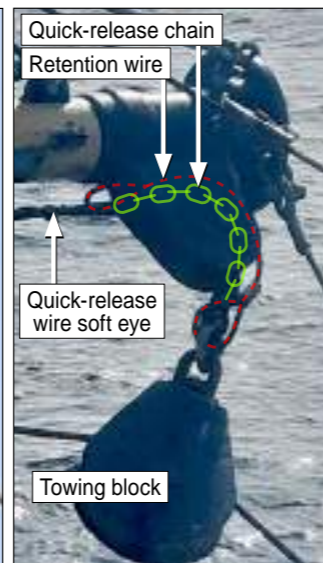
Figure 6: Quick-release arrangement with secondary means of gear retention

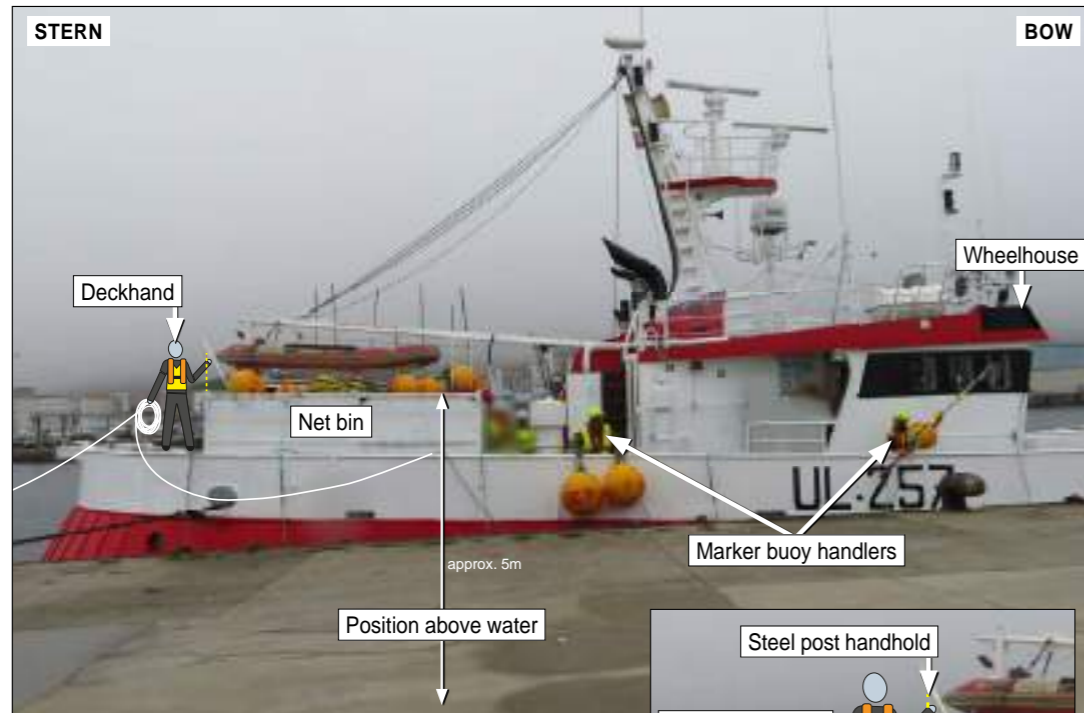
Reconstruction, showing the positions of the deckhands during the final phase of shooting the net
