Marine Investigation Preliminary Report

Contact of Containership *Dali* with the Francis Scott Key Bridge and Subsequent Bridge Collapse

Location:	Baltimore, Maryland	Accident Number:	DCA24MM031
Date and Time:	March 26, 2024 0129 local time (eastern daylight time)	IMO Number:	9697428
Ship:	<i>Dali</i> (Neo-Panamax containership)	Injuries:	8 (6 fatal)

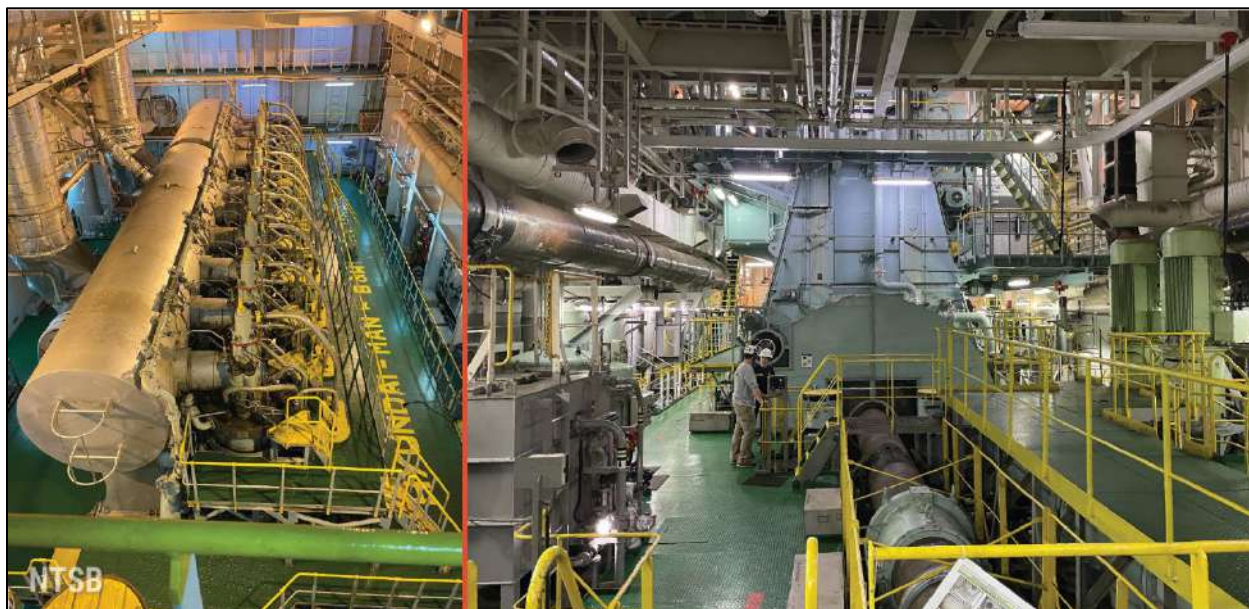
Figure 2. Left: The *Dali*'s main engine room (looking aft), showing the vessel's engine. Right: NTSB investigators examining the lower level of the vessel's engine room (looking forward).

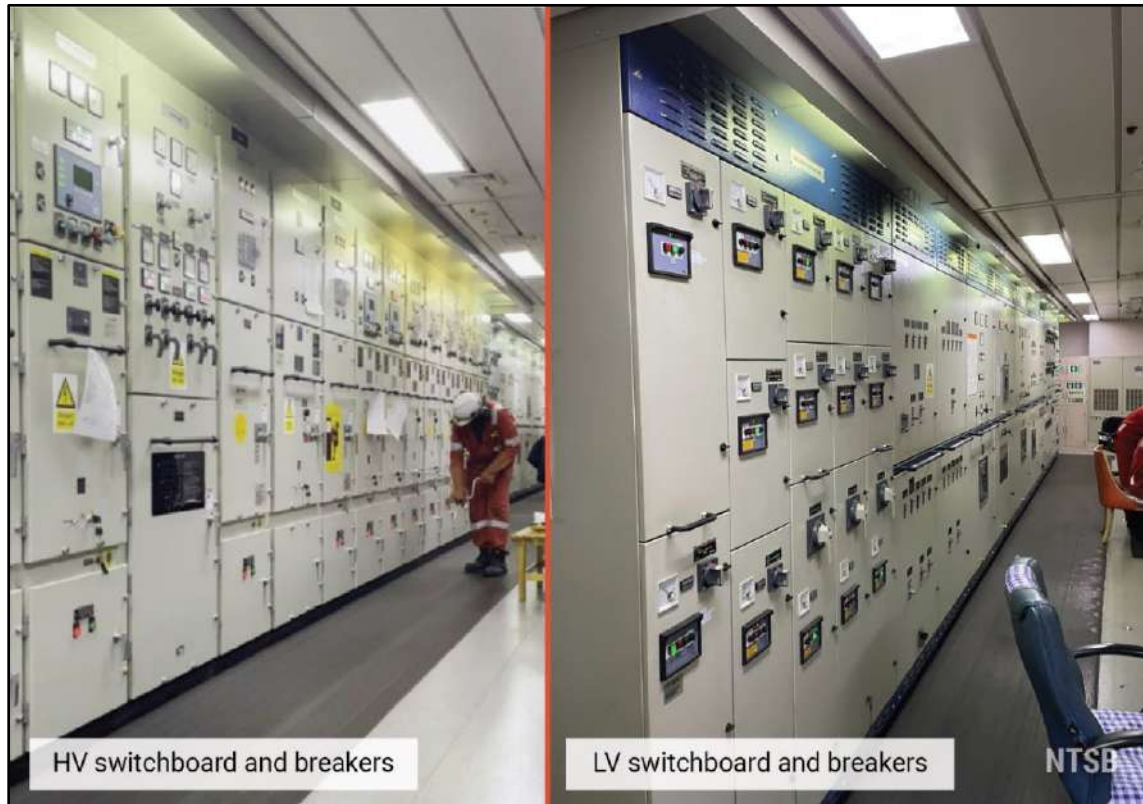
Figure 3. The *Dali*'s power management system in the ship's engine control room. The HV switchboard (which houses the HV bus) and breakers (*left*) and the LV switchboard (which houses the LV bus) and breakers (*right*).

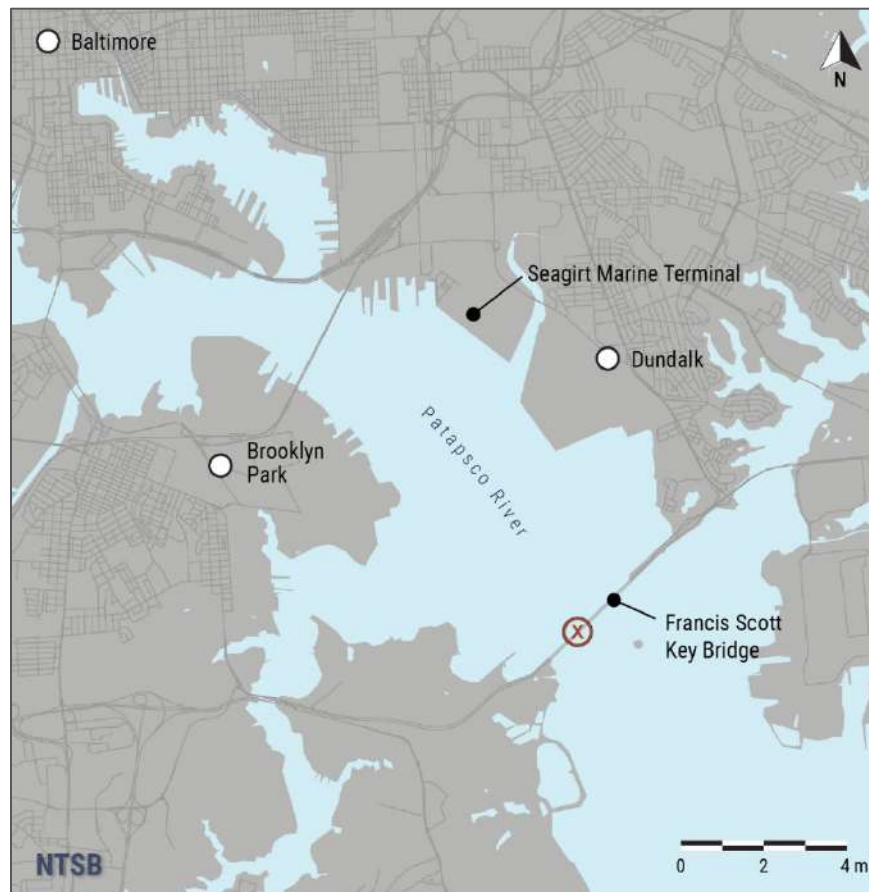
Figure 4. Area where the *Dali* struck the Key Bridge, as indicated by the red X. (Background source: Google Maps)

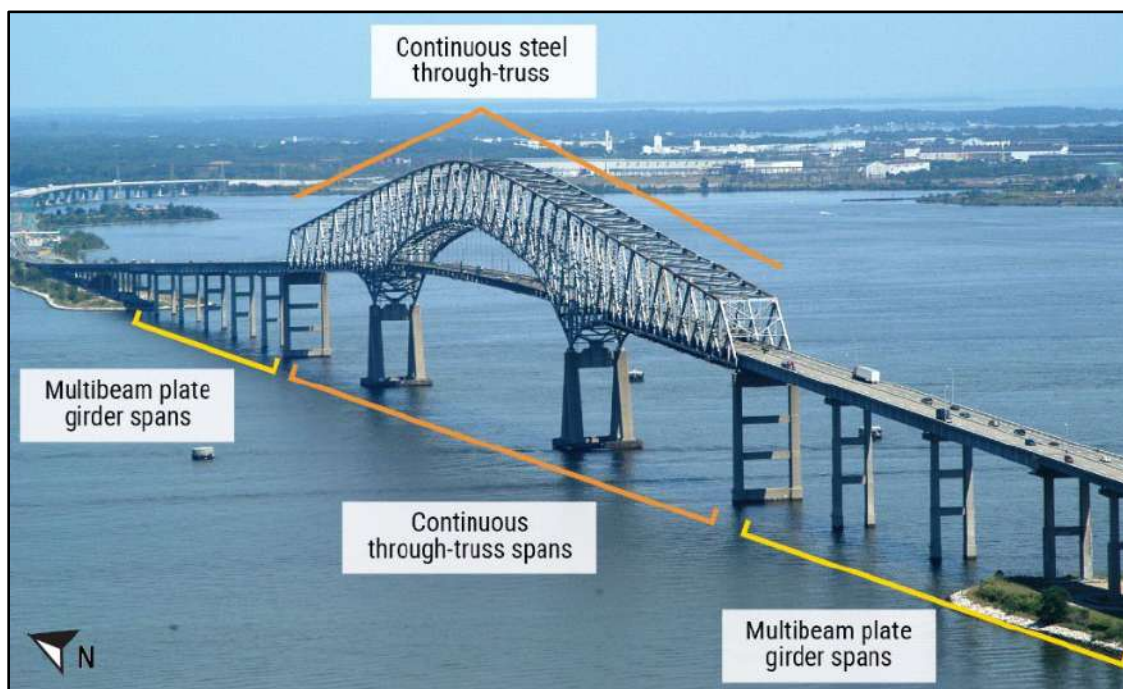
Figure 10. The Key Bridge with its truss and spans labeled. (Background source: MDTA)

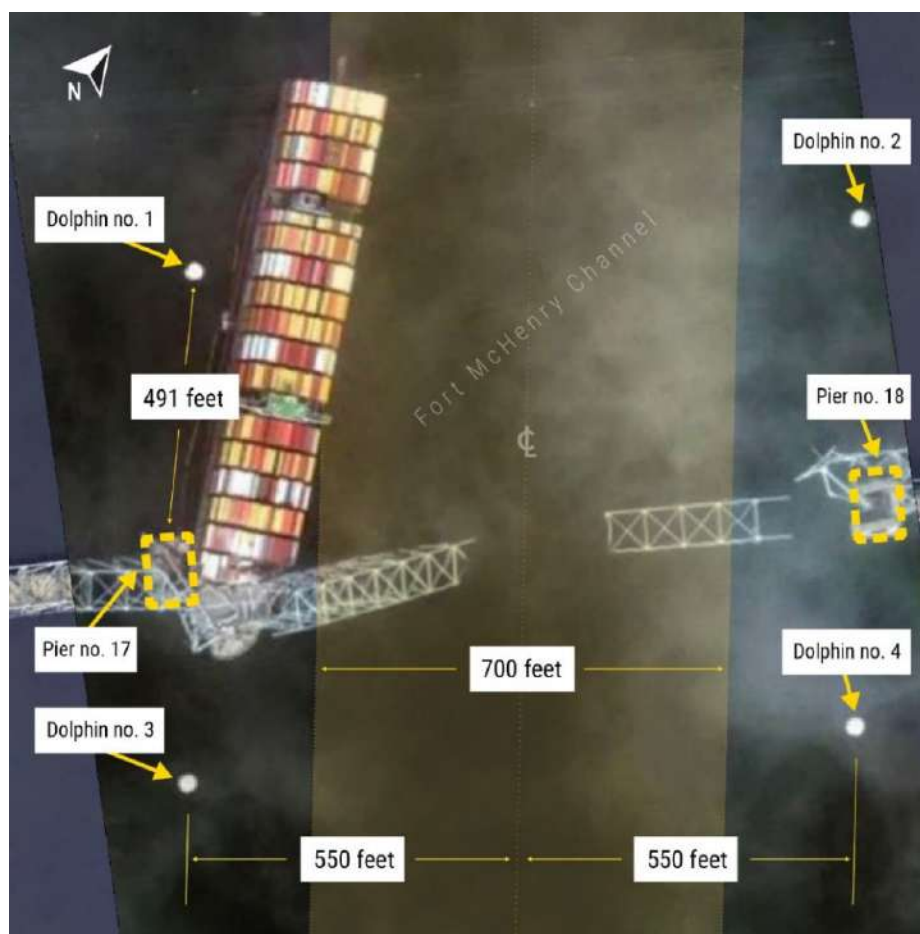
When the Key Bridge was constructed, four large dolphins—two located on the west side of the bridge and two located on the east side of the bridge—were also constructed at the same time to protect pier nos. 17 and 18 supporting the bridge’s central through-truss spans. Dolphin no. 1 was about 491 feet west of the center of pier no. 17 and 550 feet clear of the centerline of the navigational channel (see figure 11). The dolphins were constructed with a 25-foot-diameter sheet pile filled with tremie concrete and capped with reinforced concrete (see figure 12). Attached at various locations on the dolphin were 17-foot-long rubber fenders.

Figure 11. Locations of dolphins relative to the *Dali*, the Key Bridge, and Fort McHenry Channel. (Background sources: MAXAR and Google Earth)
