Report on the investigation of the  
grounding of the roll-on/roll-off passenger ferry

***Alfred***

at Swona Island, Pentland Firth, Scotland

on 5 July 2022

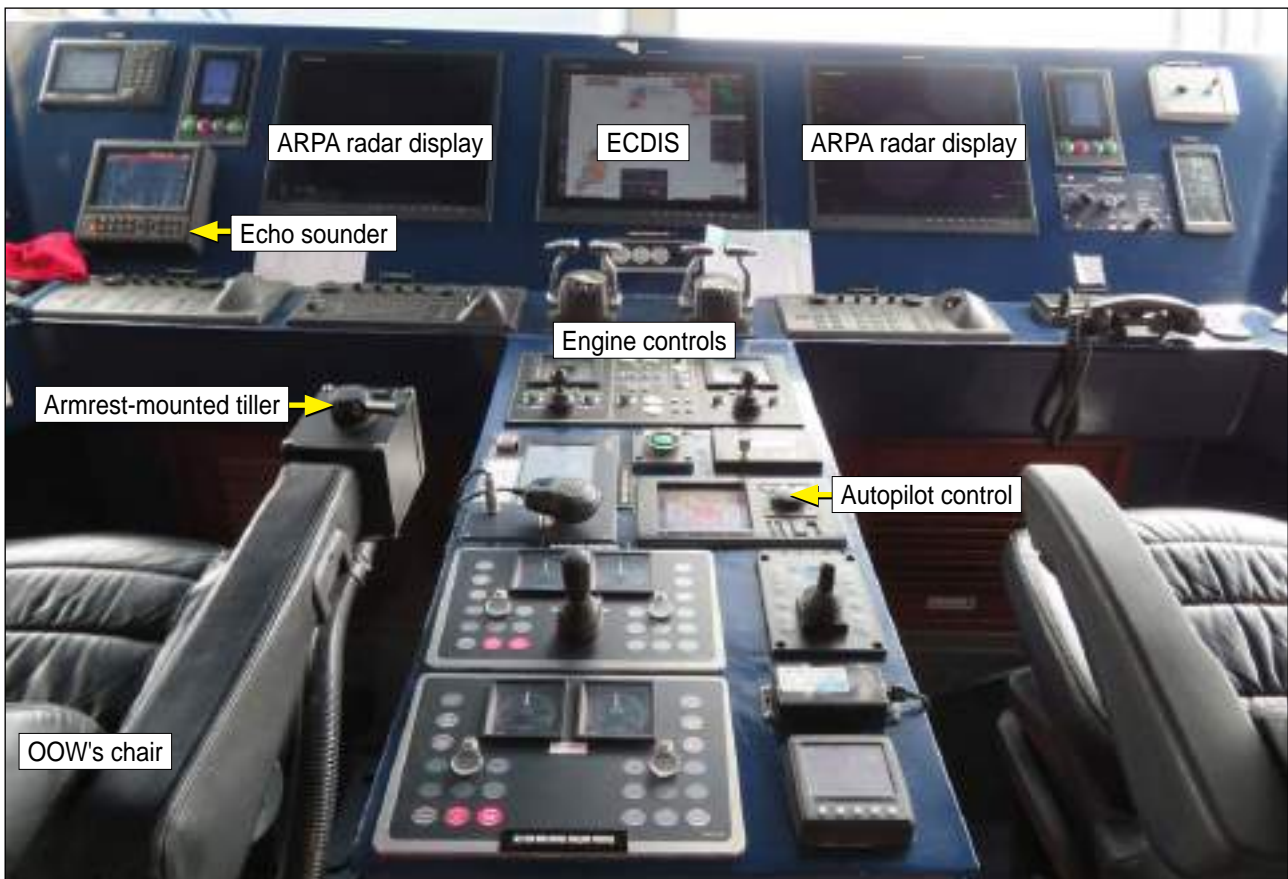
**Figure 2:** Central OOW console, showing the layout of steering controls and navigational equipment

At 1356, the master changed from autopilot to manual steering as *Alfred* passed the southern end of Swona Island and through the tidal race. He then used the armrest-mounted tiller (see **Figure 2**) to con the vessel and navigate *Alfred* along the east coast of Swona Island, remaining about 250m from shore. Shortly afterwards, *Alfred* entered the Orkney Islands Council Harbour Authority's area of responsibility.

*Alfred's* propulsion consisted of four diesel engines, two in each hull, each driving a fixed pitch propeller. The engines were controlled from the bridge. The vessel also had four rudders controlled by either autopilot, an armrest-mounted tiller located on the right-hand side of the OOW's seat (see **Figure 2**) or bridge wing control modules. *Alfred* had a turning diameter of approximately 280m and a stopping distance of about 400m.

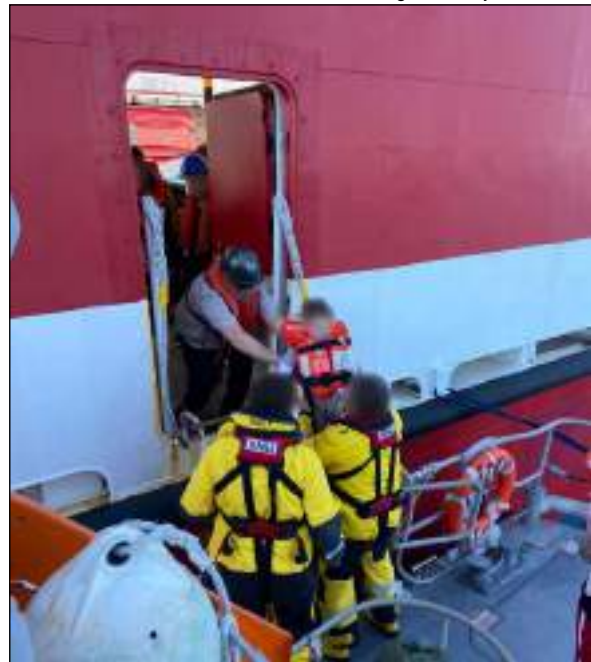
**Figure 5:** Passengers transferring from *Alfred* to the Longhope all-weather lifeboat

At 1440, the Longhope ALB came alongside *Alfred's* starboard pilot door and the crew of both vessels started to transfer 42 passengers from the ferry to the lifeboat via the starboard pilot ladder (**Figure 5**). The Thurso ALB arrived at the scene shortly afterwards and held off while waiting to be called alongside by *Alfred's* master.

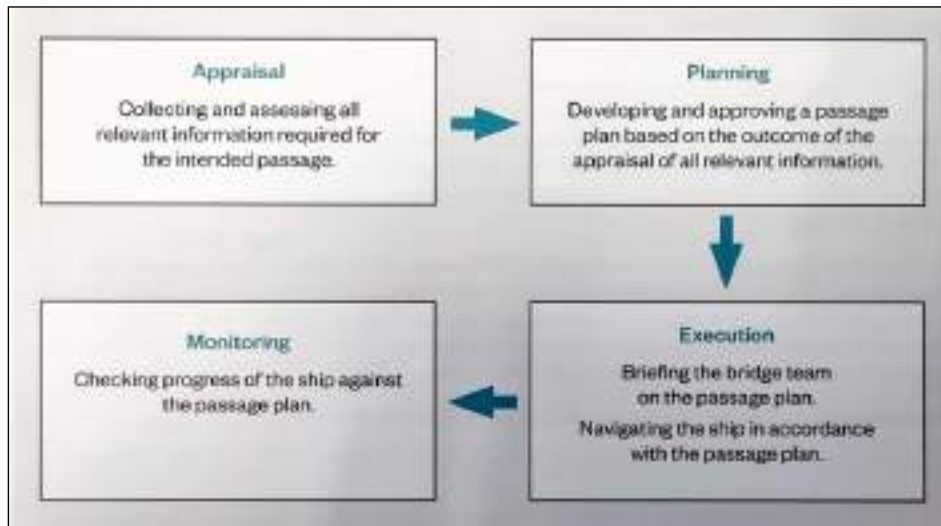
**Figure 8:** The four stages of a safe passage plan

The International Maritime Organization (IMO) *Resolution A.893(21) Guidelines for Voyage Planning* was used to create the International Chamber of Shipping (ICS) *Bridge Procedures Guide*<sup>8</sup>. The guide described *Appraisal, Planning, Execution* and *Monitoring* as the four stages required to achieve a safe passage plan (**Figure 8**) and also defined the necessary information to be shown when plotting an ECDIS route (**Figure 9**), highlighting *the importance of passing charted features at a safe distance* when operating in coastal waters.

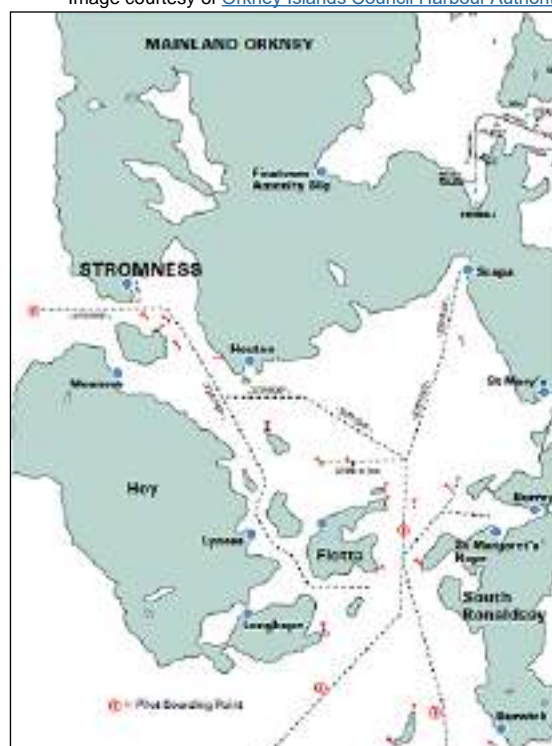
**Figure 12:** Extract from the *Ports Handbook for Orkney* (6th Edition), showing suggested tracks

The harbourmaster managed the safe operations of the area using vessel traffic services (VTS) to monitor marine traffic. Merchant vessels were required to employ either a qualified marine pilot or a shipboard PEC holder to oversee inbound and outbound harbour manoeuvres (**Figure 12**).

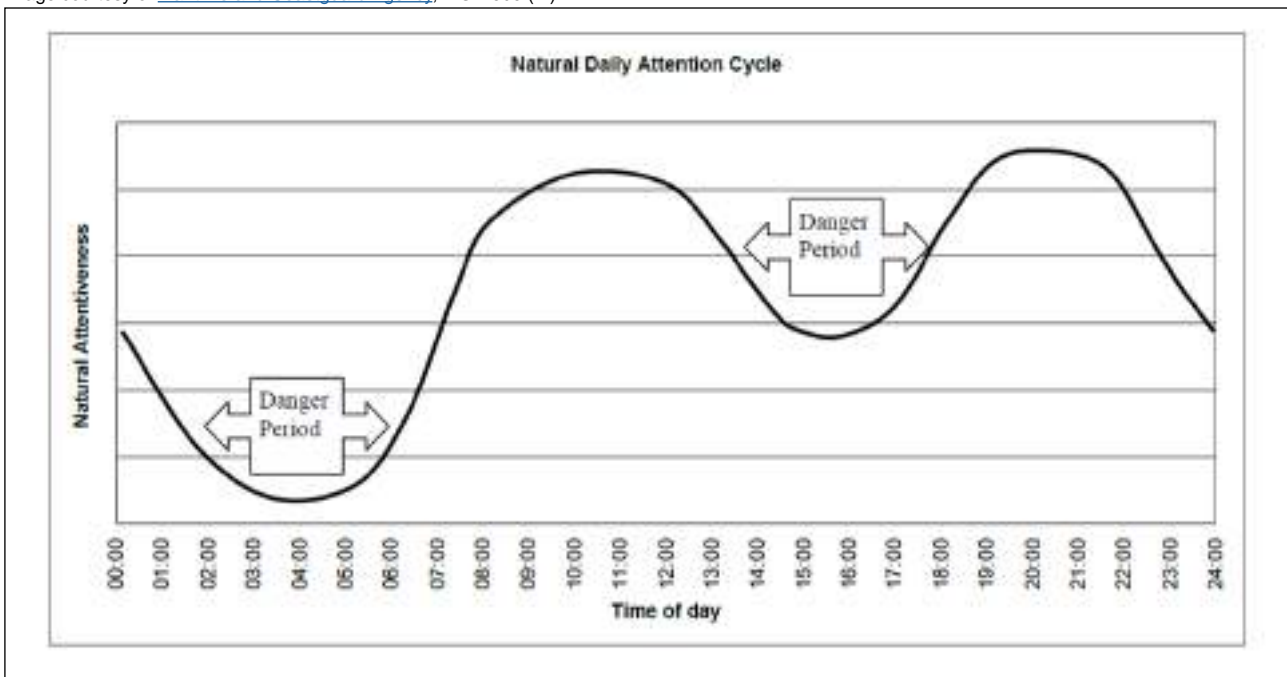
**Figure 14:** Extract from MGN 505 (M), showing the natural daily attention cycle

MGN 505 (M) also outlined the potential hazards for seafarers resulting from the natural daily attention cycle, or circadian rhythm<sup>18</sup> (**Figure 14**), noting that seafarers were naturally more prone to falling asleep, making errors, making misjudgements and having accidents<sup>19</sup> during two danger periods: 0200 to 0600 and 1330 to 1800 (also known as the post-lunch dip),
