Report on the investigation of  
a fall from height on the bulk carrier

***Equinox Seas***

resulting in one fatality

at ONEX Syros Shipyard, Ermoupoli, Syros, Greece

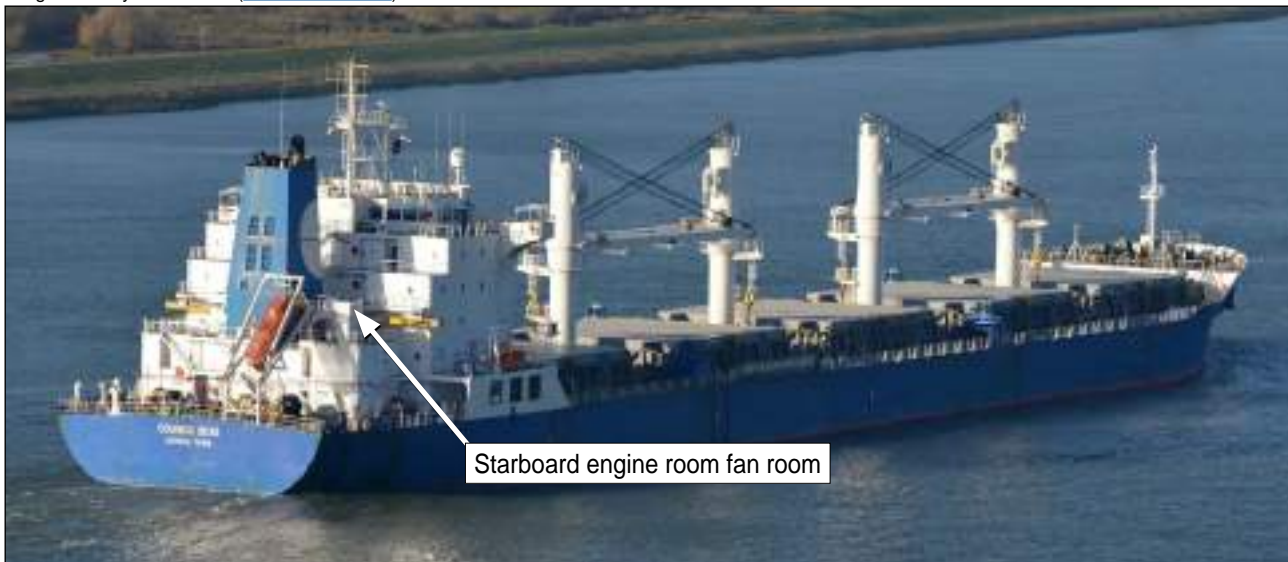
**Figure 2:** *Equinox Seas* general arrangement

*Equinox Seas* had two engine room ventilation fans situated in separate fan rooms either side of the funnel casing on the second deck (**Figure 2**). Each fan was installed within a cowling that was fastened to a pedestal with an internal diameter of 1.20m and a height of 0.79m above the deck level. Within each pedestal was a fire damper that enabled the ventilation trunk to be closed off in the event of a fire.
