MARINE SAFETY INVESTIGATION REPORT

Safety investigation into a fatality on board the
Maltese registered oil tanker

SEAPRINCESS

in TK Tuzla Shipyard, Türkiye
on 14 August 2023

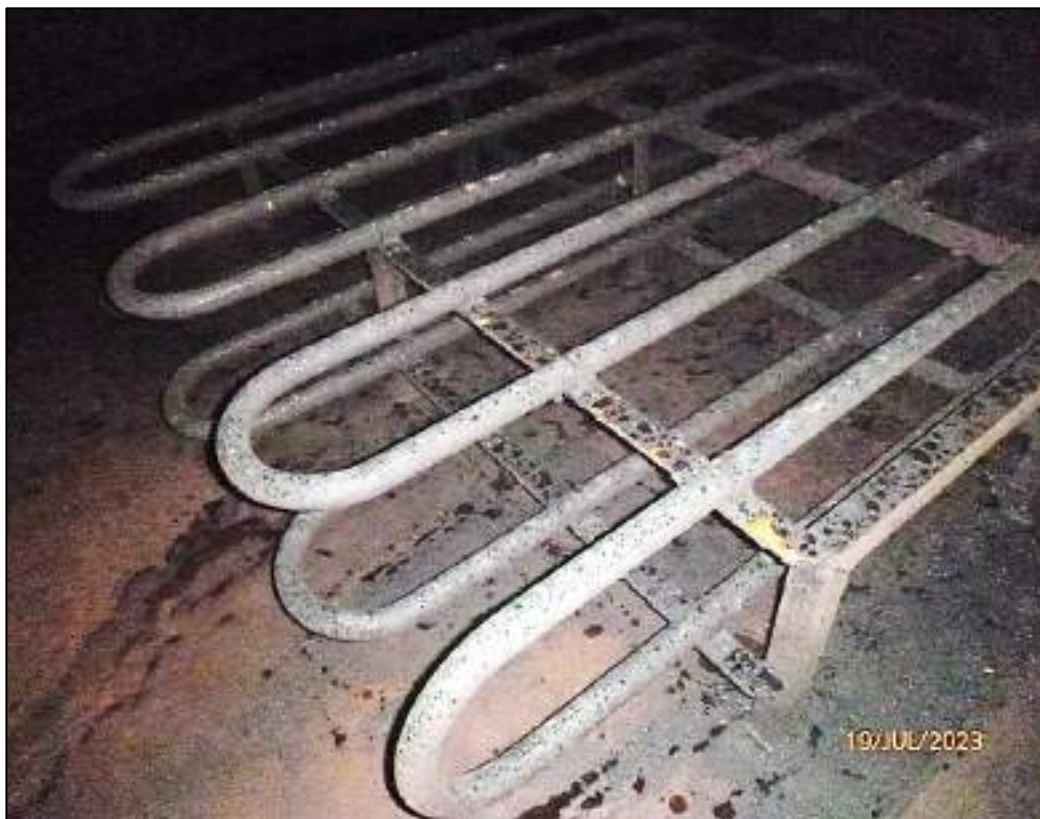
Figure 5: Photograph of the clean and dry slop tank

Prior to the accident, all the cargo tanks had been cleaned following which, the slop tanks were cleaned. All slops were pumped out to a slop barge on 24 July, at Piraeus anchorage. By the time the vessel arrived in the dry-dock, the slop tanks had been cleared of all oily-water and carbon residue (**Figure 5**).

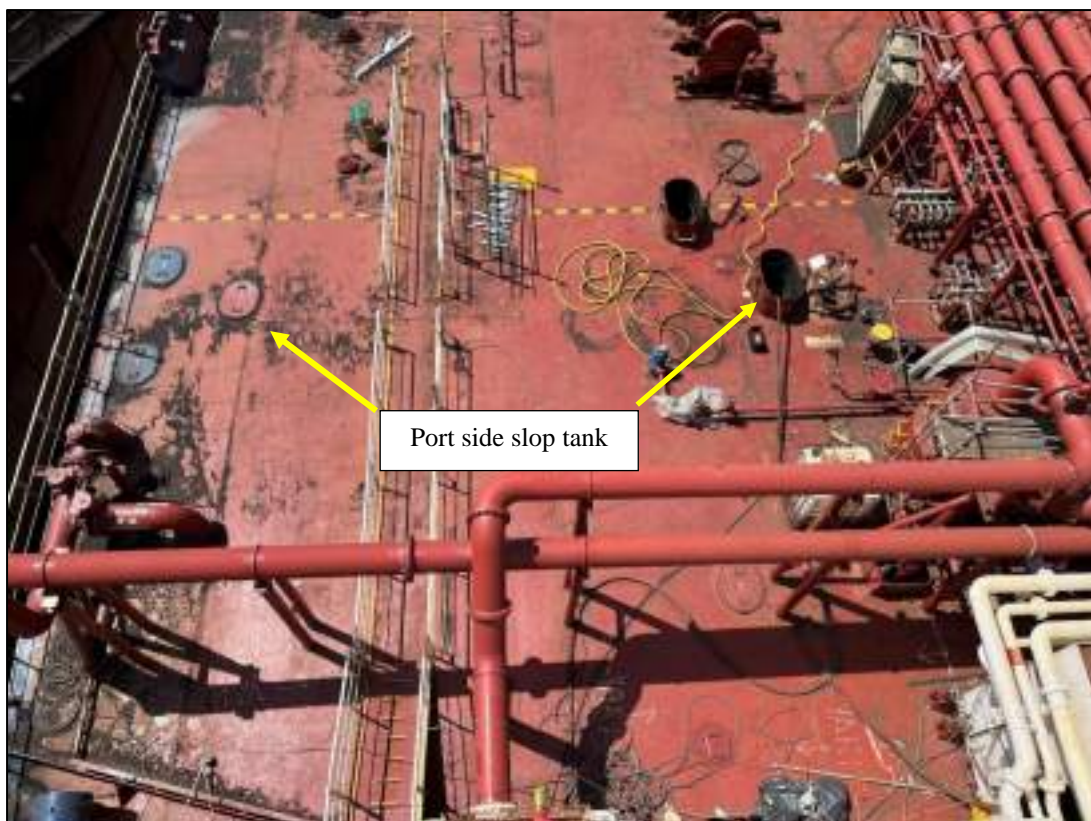
Figure 7: Overview of the port side slop tank's manhole and tank dome

On 14 August, welders 1 and 2 arrived on board in the morning to start their work. Following the toolbox meeting, they were tasked to first complete the repair on the anchor lashing arrangements on the windlass that they had been working on during the previous day. After this task was completed, they reported back to the foreman who then showed them the two stanchions in the port side slop tank, advising them that the structure required alignment and welding. The foreman, along with welder 2, entered the slop tank (**Figure 7**) to explain and point out the work that had to be carried out.
