Australian Government
Australian Transport Safety Bureau

Steering failure and contact with navigational beacon involving CMA CGM Puccini, Port of Melbourne, Victoria, on 25 May 2023

Investigation number	Report release date	Report status
MO-2023-002	12/02/2025	Final
Investigation level	Investigation type	
Short	Occurrence Investigation

Final report

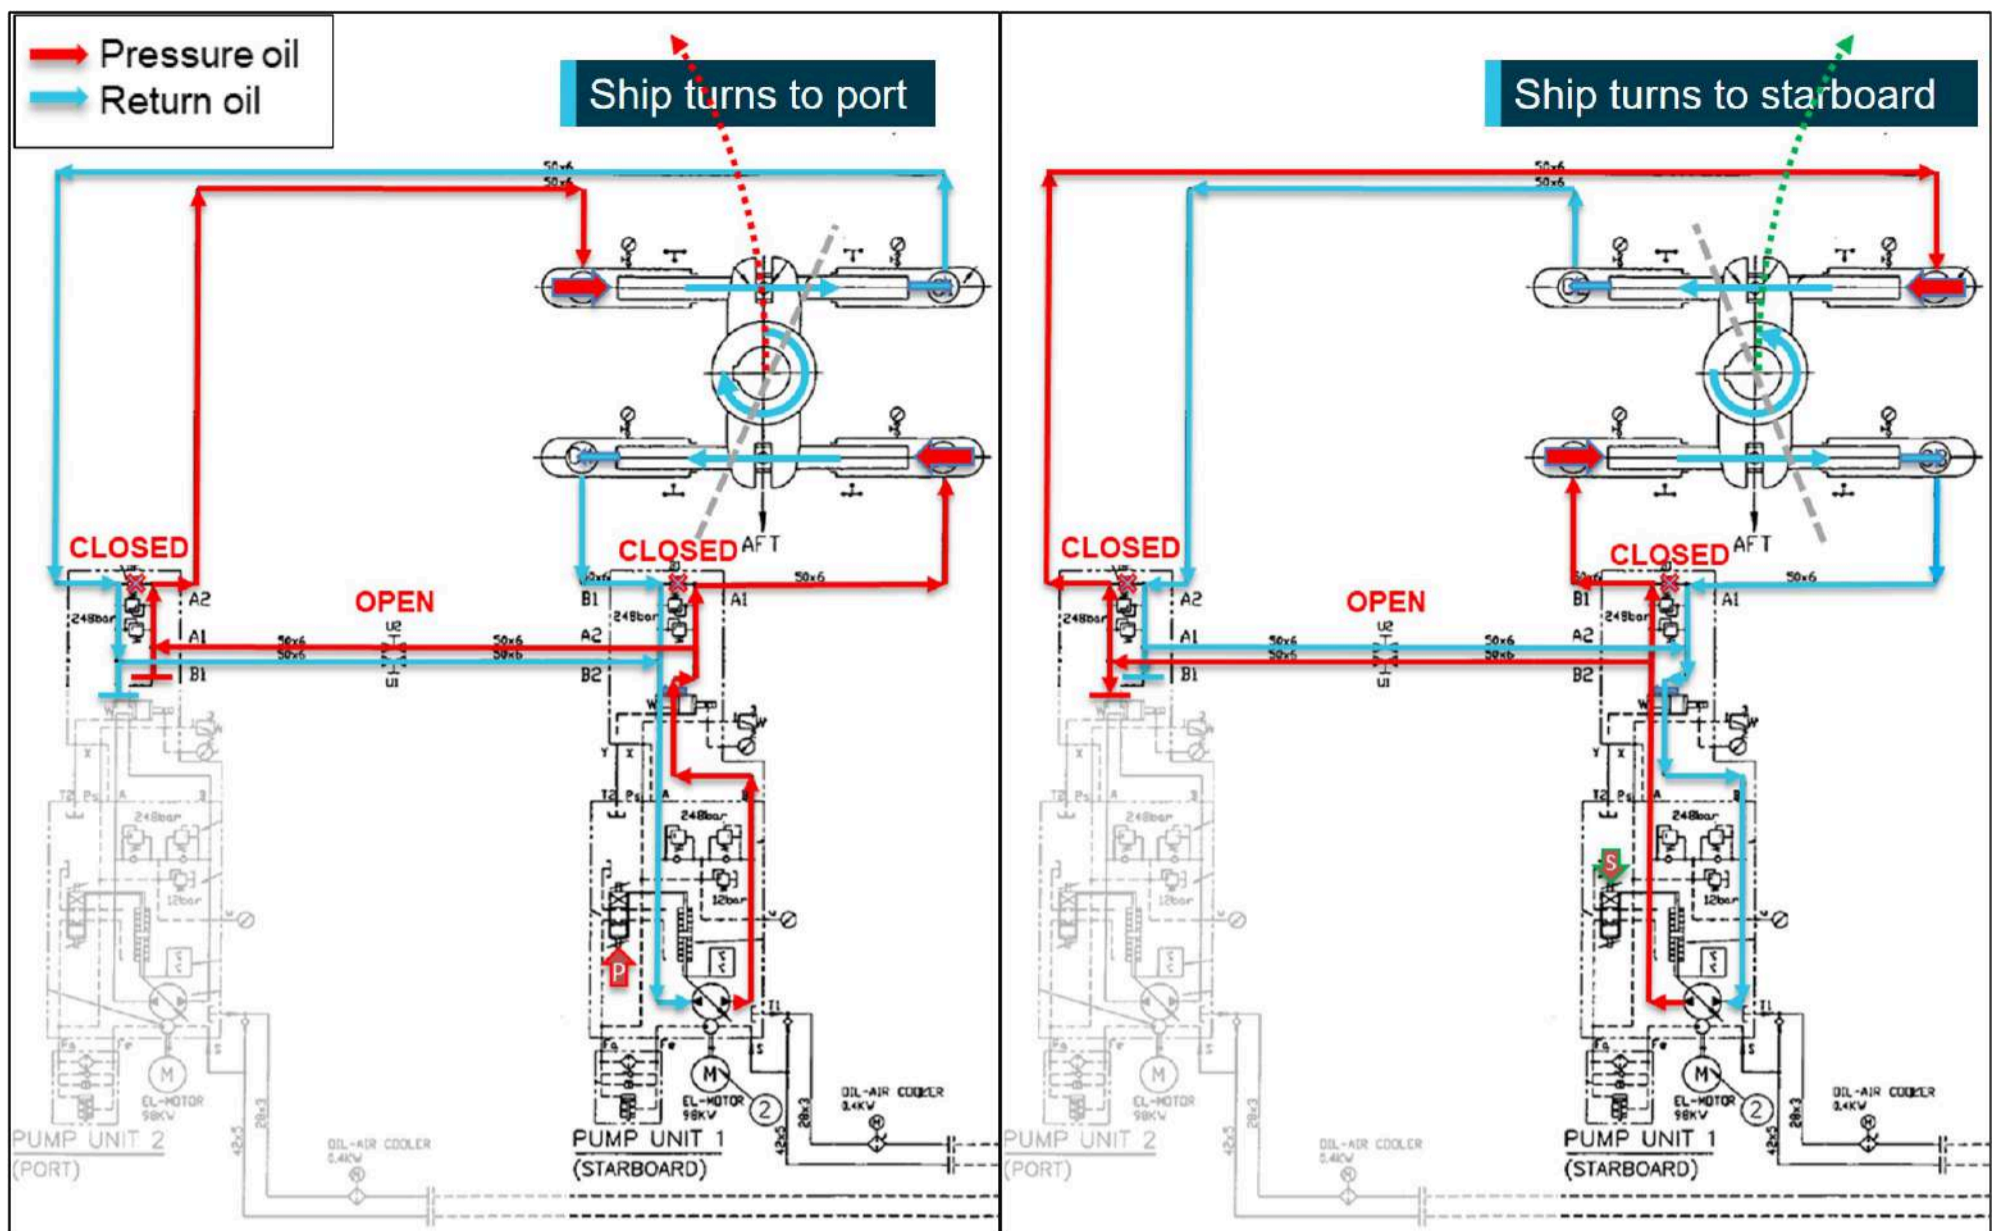
Figure 5: Single pump, 4-cylinder, normal operation of steering, to port and starboard

During normal operation either one or both pumps were running, supplying all 4 cylinders. Isolation valves (U1 and U2) were open, pump bypass valves (B1 and B2) were closed (Figure 5).

Single pump (#1) operation shown; diagram is similar for pump 2. Isolation valves (U1, U2) open, pump bypass valves (B1, B2) closed. Signal is received into the proportional valve altering the flow rate and direction of oil at the pump. System response will be improved (faster) with second pump operating in parallel. Source: CMA CGM, annotated by the ATSB

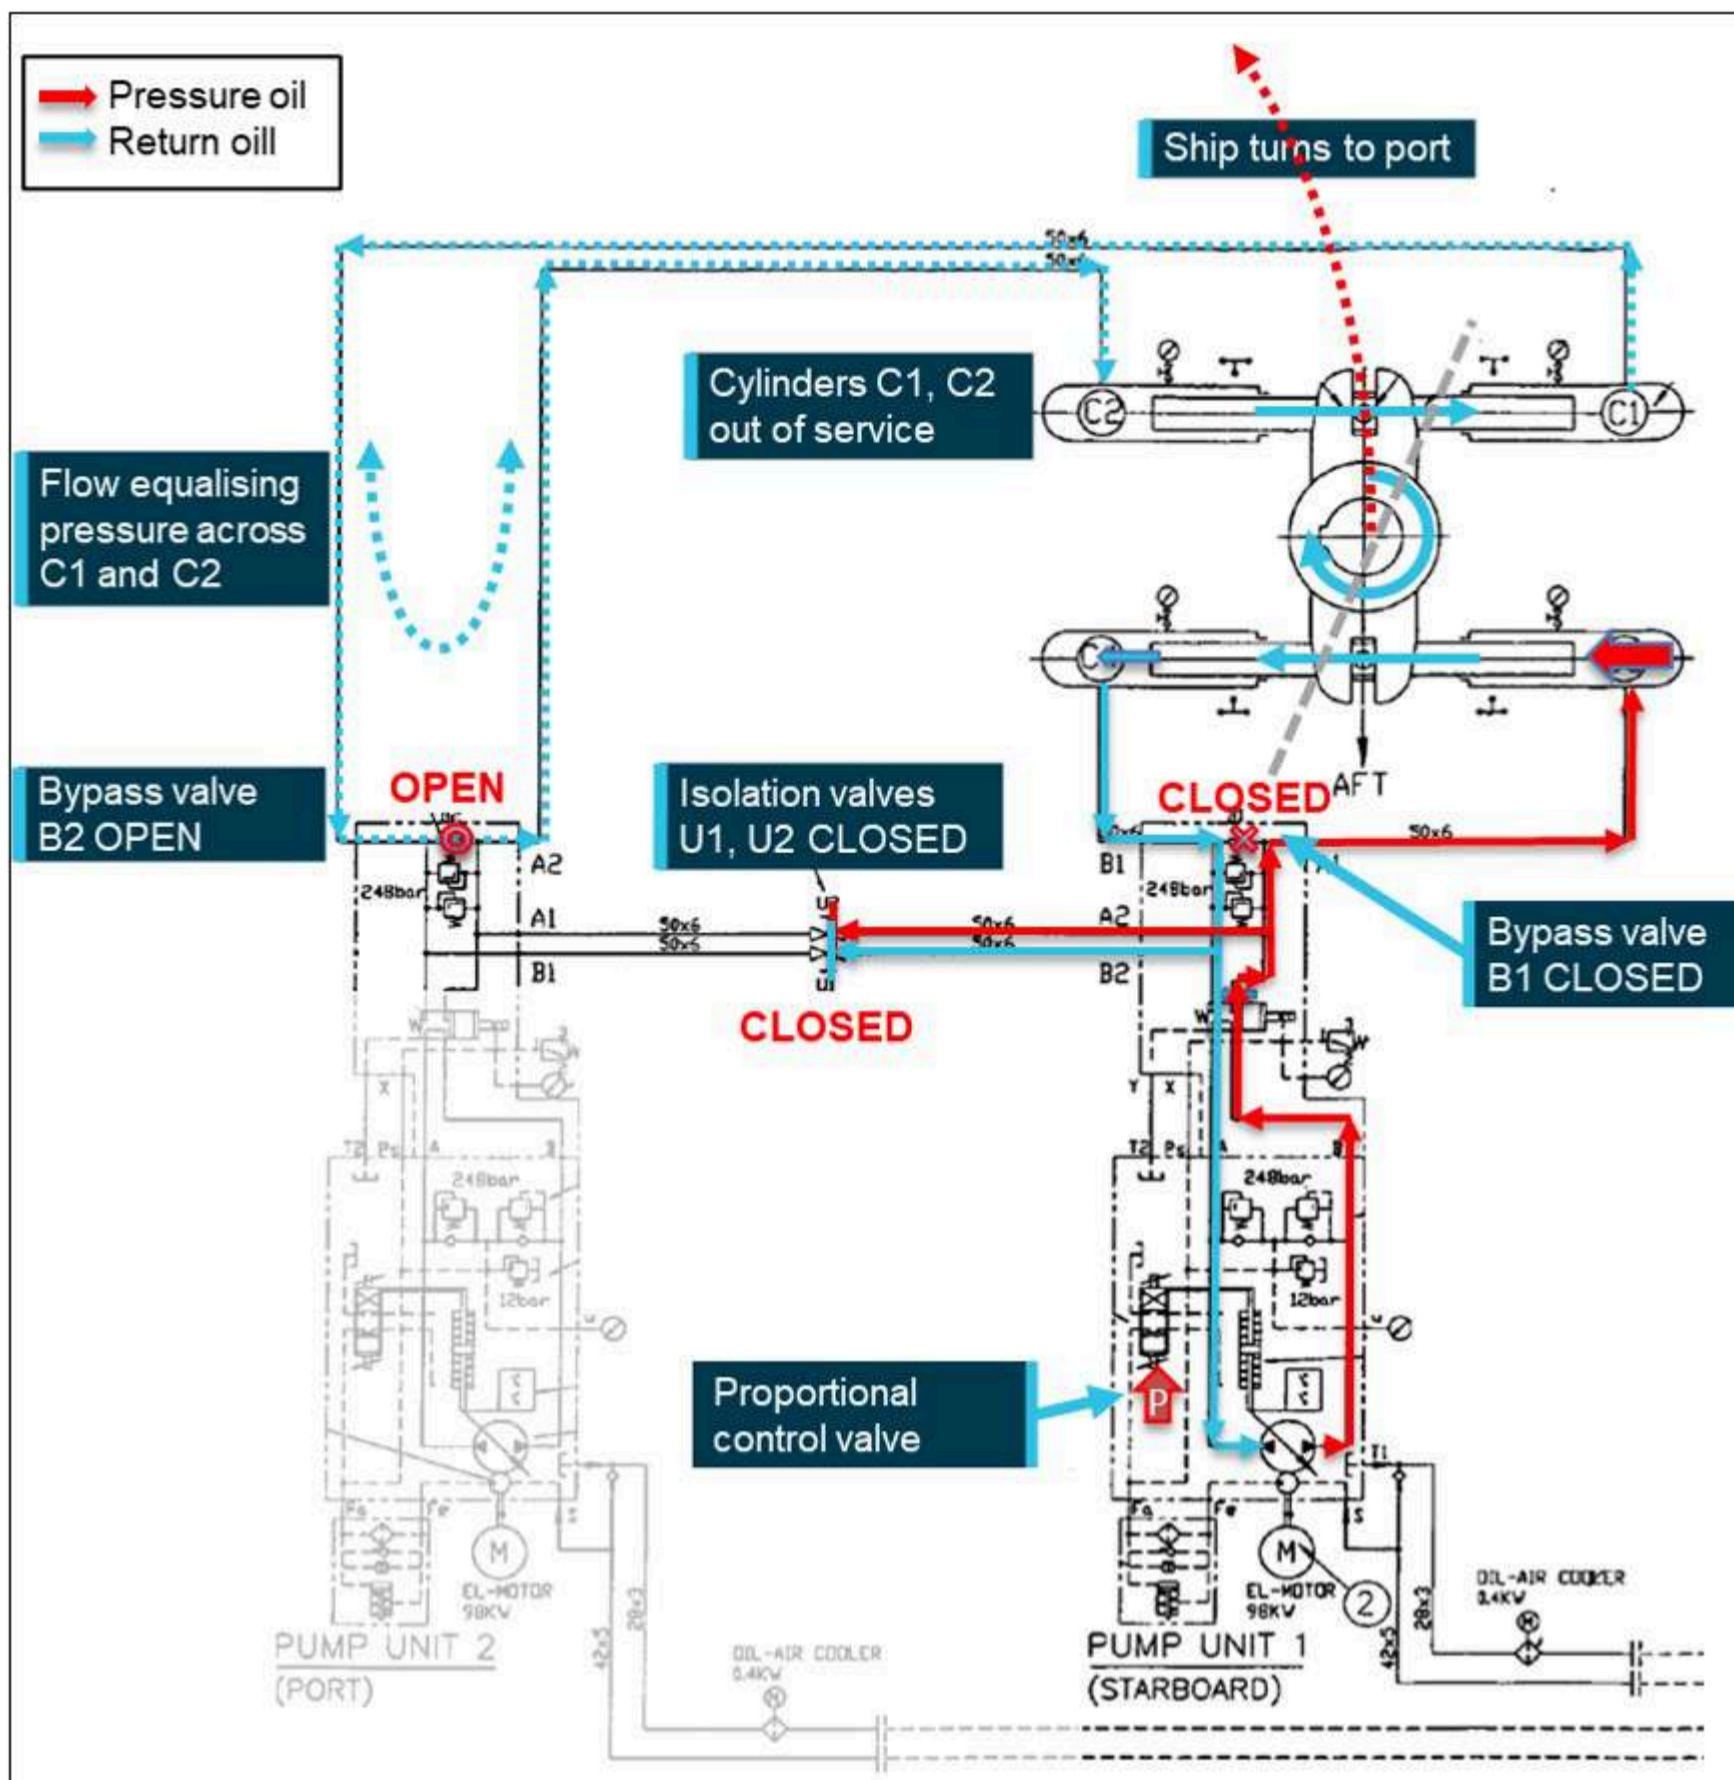
Figure 6: Port rudder using pump 1 with hydraulic system 2 (pump 2, cylinders C1 and C2) isolated

It was possible to separate the 2 hydraulic circuits and operate on one circuit (and pump) alone. In this case, the isolation valves were to be closed and the bypass valve on the non-running pump was to be opened (Figure 6). This mode of operation was referred to in the shipboard procedures in relation to steering gear failure with oil leakage in one of the circuits.

Hydraulic system 2 out of service, isolation valves (U1, U2) closed, pump 2 isolated, pump 2 bypass valve (B2) open to allow oil flow between cylinders C1 and C2 and prevent hydraulic locking. Source: CMA CGM, annotated by the ATSB
