Interim report on the investigation of the collision between the container ship *Solong* and the oil/chemical tanker *Stena Immaculate*, resulting in one fatality, 14 nautical miles north-east of Spurn Head at the entrance to the Humber Estuary, England, on 10 March 2025

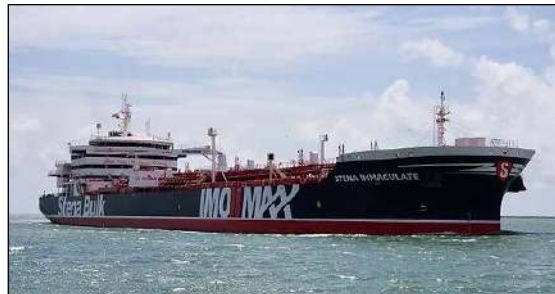
Figure 1: *Stena Immaculate*

On 27 February 2025, the USA registered oil/chemical tanker *Stena Immaculate* (**Figure 1**) departed Agioi Theodoroi, Greece with a cargo of 220,204.5 barrels¹ of aviation fuel on board. The tanker was bound for Killingholme, England, and was expected to berth on 11 March 2025.

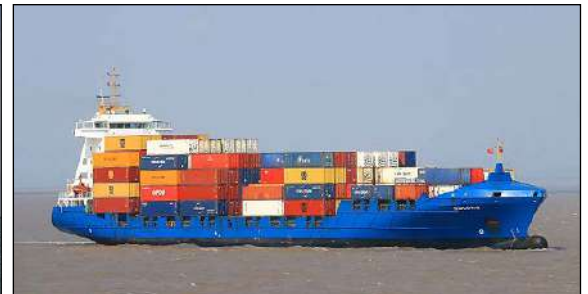
Figure 2: *Solong*

The Portugal registered containership *Solong* (**Figure 2**) was engaged in fixed trade in the North Sea, sailing between Rotterdam, Grangemouth and Hull. On 10 March 2025, its containerised cargo included various products including some designated as dangerous goods.
