**MARINE ACCIDENT
INVESTIGATION REPORT**

Vessel Type and Name: Bulk Carrier EVER FELICITY

Accident Type: Injury and Fatality of Stevedores

Date and Time: May 20, 2024, at around 07:35

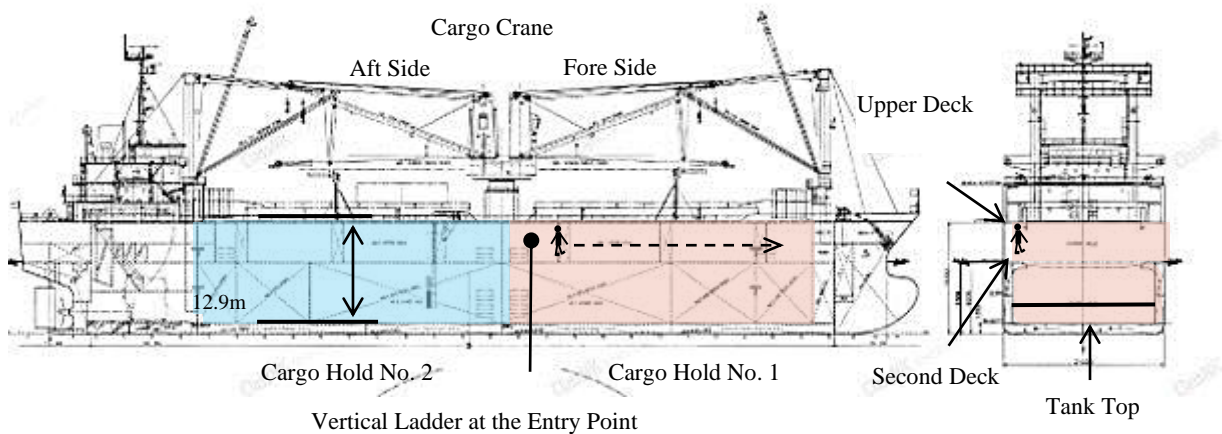
Figure 2 – Overview of Vessel Structure

Note: The second deck inside the cargo hold is walkable.

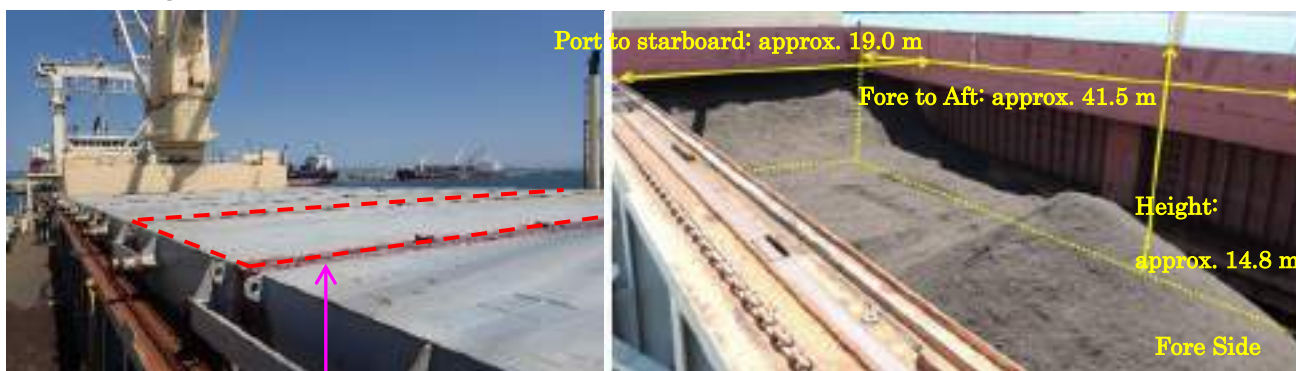
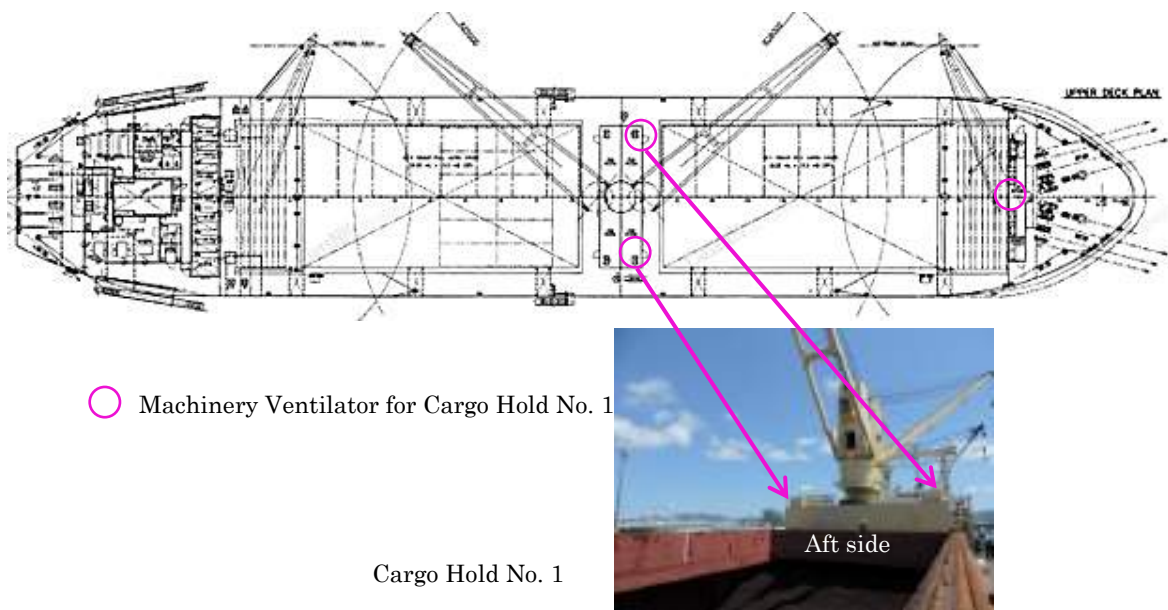
Figure 5 - Hull Structure and Equipment

At the time of the accident, the Vessel had no abnormalities in its hull, machinery, hatch covers, or other cargo-handling equipment and related systems.

The hatch cover is divided into multiple sections.
