UK P&I CLUB

CAR MATTERS

*Car Carriers, Ro-Ro and Ro-Pax Ship Safety
– A Guide for Crew*

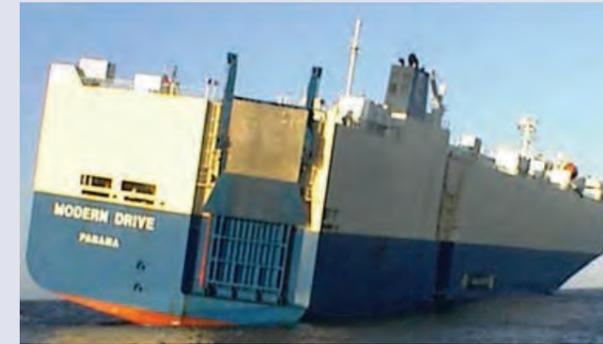
Date: 26 May 2001
 Location: 26 miles south-south west of East London, South Africa
 Ship Type: Car Carrier
 Fatalities: None

The car carrier ‘MODERN DRIVE’ was on a voyage from Abu Dhabi to South America. During the passage around the South African coast, the ship encountered heavy weather and sea conditions.

The ship was reported to be rolling and pitching heavily in the rough seas and as a result, the lashings securing one of the ship’s forklifts parted, allowing it to move across the vehicle deck. As a result, severe damage was caused to the cargo of cars and larger vehicles stowed on that deck. The fuel tanks of some of the vehicles were ruptured, which then resulted in a fire within the cargo space.

As black smoke entered the engine room, the crew believed that they were dealing with an engine room fire and the crew activated the engine room CO² firefighting system. With the main engine shut down, the ship drifted beam-on to the prevailing sea and swell, resulting in more cargo breaking loose and shifting causing a heavy list.

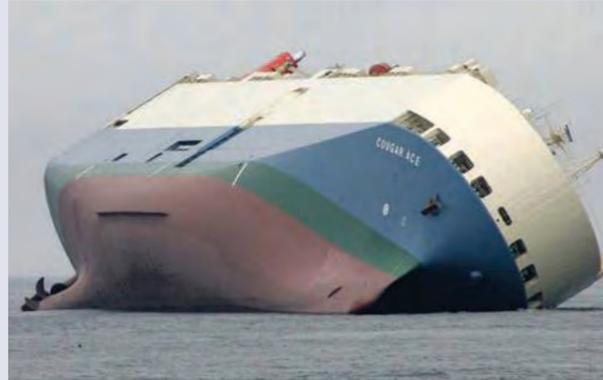
Date: 23 July 2006
 Location: 230 miles south of Aleutian Islands, North Pacific
 Ship Type: Car carrier
 Fatalities: 1 member of salvage team

'COUGAR ACE' was en route from Japan to the USA with a cargo of 4,812 vehicles. During the voyage the crew were carrying out ballast water exchange operations (BWE) in preparation for entering US waters. During that process, the ship's starboard ballast tanks failed to refill, which reduced the GM to zero. Loss of stability and wave action caused the ship to assume an angle of loll of 60 degrees to port, which meant that the propeller and rudder were no longer submerged. Sufficient righting moment remained at that angle of heel, due to the ship's large freeboard, and further listing to port and possible capsizing was prevented.

The ship was salvaged and towed to the Aleutian Islands where portable pumping equipment was used to first increase the bottom weight within the ship. Once sufficient stability had been regained, it was brought upright again.

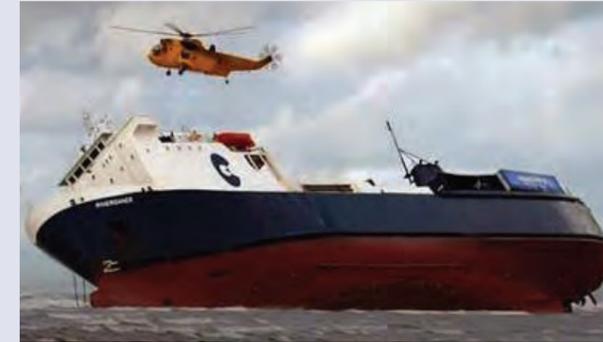
'RIVER DANCE'

Date: 31 January 2008
 Location: Irish Sea
 Ship Type: Ro-Ro passenger ferry
 Fatalities: 0

The ship departed Warrenpoint when weather forecasts predicted gales of force 8 to storm force 10 conditions in the Irish Sea. Departure draughts were read but no stability calculation was made prior to departure. Despite the prevailing weather conditions, the ship was noted to be only rolling gently due to her good seakeeping characteristics. However, as the ship approached shallower water of Heysham, the sea state worsened and the roll motion increased, resulting in some of the cargo shifting and causing an eventual list to port of around 35 degrees. The ship drifted towards the shore and eventually grounded with a list of about 5 degrees.

Various ballasting operations were carried out to prepare for a refloat attempt which failed and resulted in the ship grounding again with a 30 degree list to starboard. The ship was finally declared a constructive total loss and scrapped in situ.
