EMSA/OP/01/2016

Study investigating cost effective measures for reducing the risk from fires on ro-ro passenger ships (FIRESAFE)

This is a study commissioned by the European Maritime Safety Agency, EMSA. It consists of two parts, investigating risk control options (RCOs) for mitigating the risk from fires on ro-ro decks. The first part considers RCOs in relation to *Electrical Fire as ignition risk* and the second part considers RCOs to mitigate the risk of *Fire Extinguishing Failure (with focus on drencher systems)*. The study considers both newbuildings and existing passenger ships, and has been done per the instructions and limitations in the Tender Specifications (EMSA /OP/01/2016).

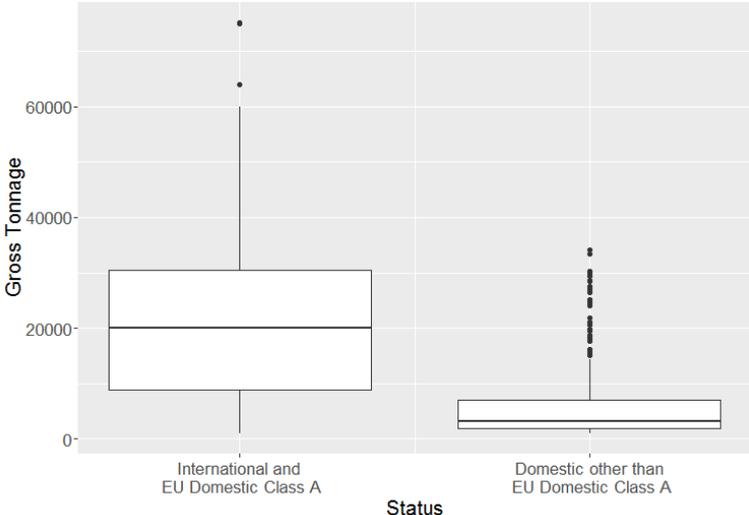
Figure 2.2-1: Gross Tonnage in the International and EU Domestic Class A fleet and Domestic other than EU Domestic Class A.

The boxplots show that the *International and Domestic Class A* fleet and the *Domestic other than EU Domestic Class A* fleet are two distinct fleets that cannot be studied together, due to their intrinsic differences, in terms of size and capacity, even if both fleets were SOLAS compliant.

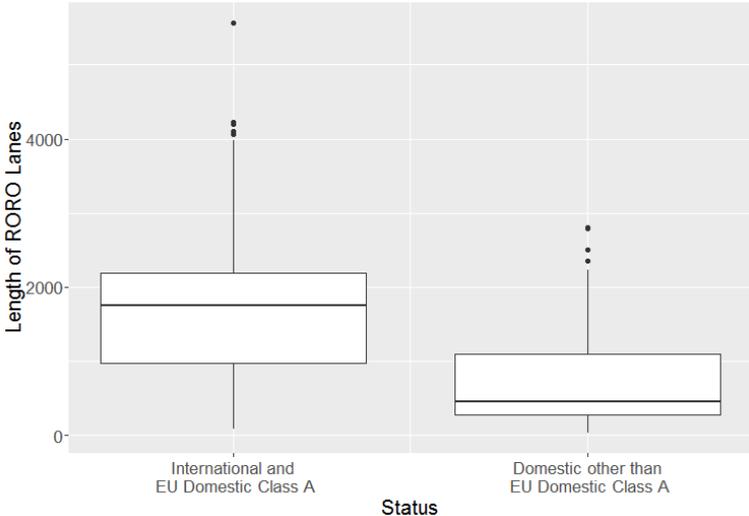
Figure 2.2-2: Length of ro-ro lanes in the International and EU Domestic Class A fleet and Domestic other than EU Domestic Class A⁴

⁴ This figure does not provide a picture of the whole fleet as zeros (non-recorded length of ro-ro lanes) have been removed from the analysis. This boxplot has been computed based on the data for 503 out of 872 ships (368 *International and Domestic Class A*, and 135 *Domestic other than EU Domestic Class A*).

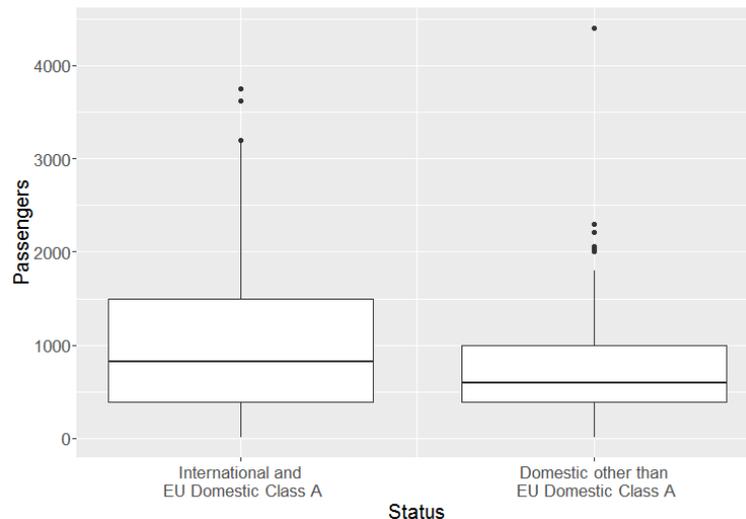
Figure 2.2-3: Passenger capacity in the *International and EU Domestic Class A fleet* and *Domestic other than EU Domestic Class A*⁵

⁵ This figure does not provide a picture of the whole fleet as zeros (non-recorded passenger capacity) have been removed from the analysis. This boxplot has been computed based on the data for 800 out of 872 ships (458 *International and Domestic Class A*, and 342 *Domestic other than EU Domestic Class A*).

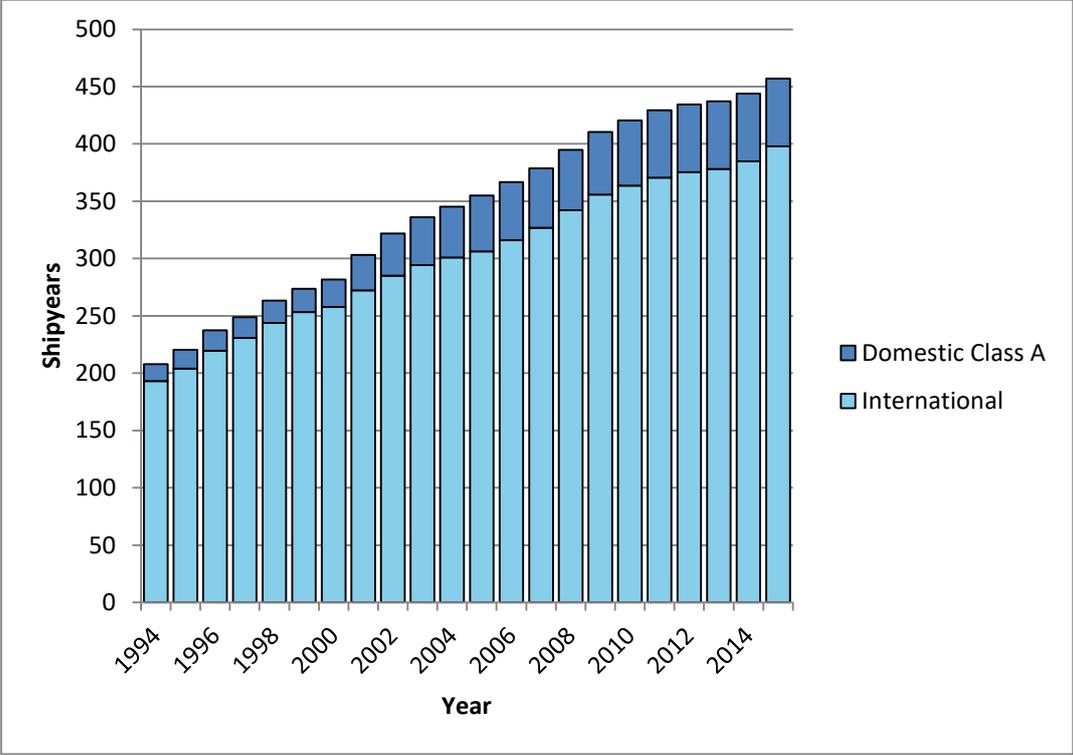
from about 210 shipyears in 1994 to 460 shipyears in 2015. The cause of this increase can be attributed to the filtering criteria selected for the study. The fleet under consideration consists of the ships compliant with the above-mentioned criteria. Each year, new ships enter the fleet (newbuildings compliant with the criteria), and contribute for additional shipyears, while almost no ships leave the fleet (since conversions are not considered and almost no scrapped or lost are observed). It seems a fair assumption to consider that the ships characteristics remain unchanged over time.

Figure 2.2-4: Number of shipyears per year for the FIRESAFE fleet between 1994 and 2015.

This led to a total of 7567 shipyears for the period 1994-2015, and 5530 shipyears for the period 2002-2015.

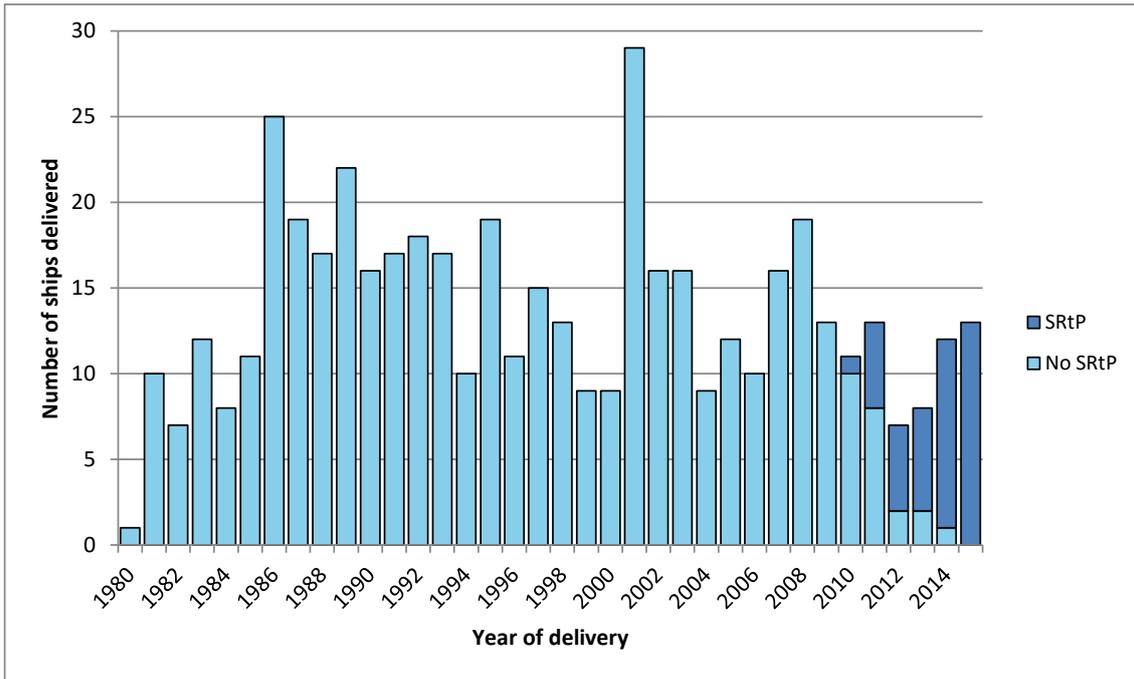
Figure 2.2-5 shows the number of ships delivered per year. Due to the filtering criteria (keel laying date), only one ship FIRESAFE-compliant has been delivered in 1980. No trend can be determined over the period.

Figure 2.2-5: Number of ships delivered according to delivery date⁶.

⁶ When keel laid date was not provided in the database – for 10 out of the 41 ships concerned, criterion has been applied to *built date*, as provided in MARINFO, therefore number of ships identified might be slightly over-estimated.

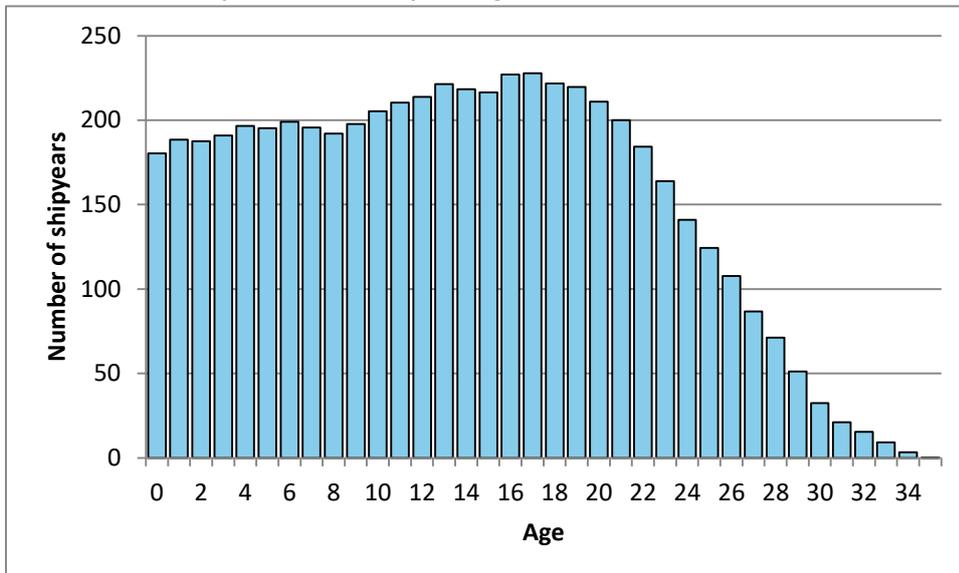
Figure 2.2-6 shows the number of shipyears with respect to the age of ships over the period 2002-2015. This figure shows a slight increase up to around 18 years old (meaning more exposure for the youngest ships), then the number of shipyears decreases linearly with increasing age until the age of 30 years old and declines gradually until 35 years old, which is the maximum age that a ship can reach given the filtering criteria and the period of study being considered.

Figure 2.2-6: Number of shipyears for ships observing the given age during the period 2002-2015

As an increase of the average age of the fleet over the investigated period is observed, it might be argued that the fleet selected is not homogenous and that it will affect the incident rate. By normalizing the number of accidents for each age with the exposure time (which has been plotted shown in Figure 2.2-6), it has been possible to determine the accident frequency as a function of the ship age. This has been investigated in the Casualty data analysis section.

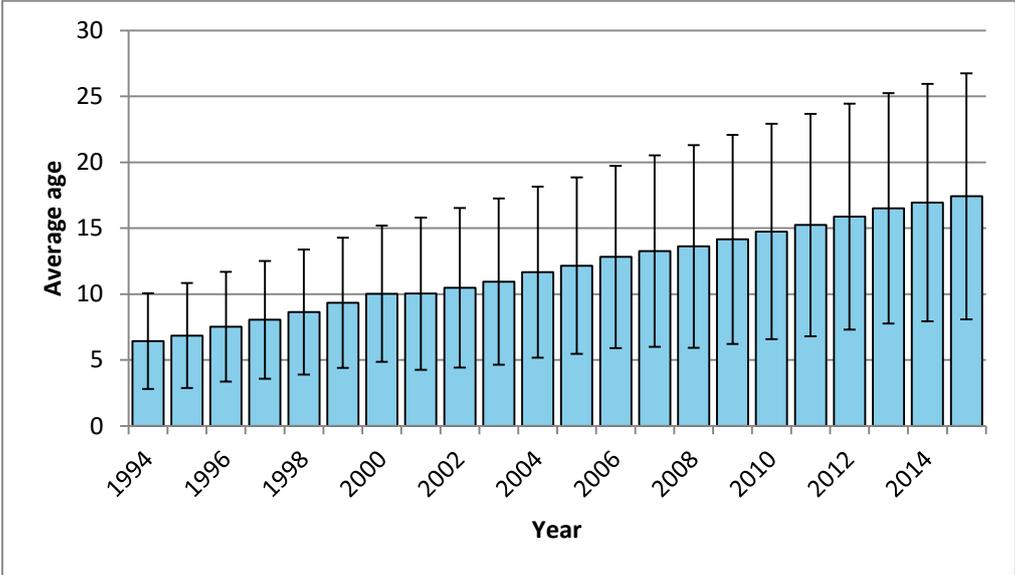
Figure 2.2-7 shows the average age of the fleet for the period 1994-2015. The age of a ship is calculated from the 31st of December of each year. The average age is increasing from year to year due to the filtering criteria (keel laid date). Each year, each ship takes one more year (with almost no scrap or lost ships) while only few ships enter in the fleet (as shown in Figure 2.2-5). In 2015, the average age of the fleet is 17.4 years old.

Figure 2.2-7: Average age of the fleet between 1994 and 2015 (+/- one standard deviation)

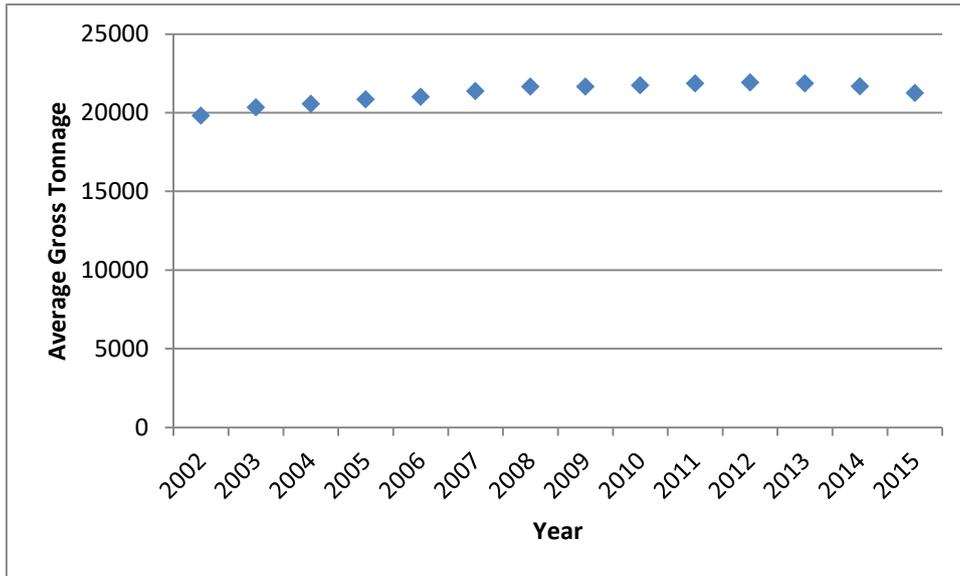
Figure 2.2-8 shows the evolution of the average gross tonnage of the fleet under consideration over the period 2002-2015. A slight increase can be observed between 2002 and 2012, followed by a slight decrease until 2015.

Figure 2.2-8: Evolution of the average gross tonnage of the FIRESAFE fleet over the period 2002-2015

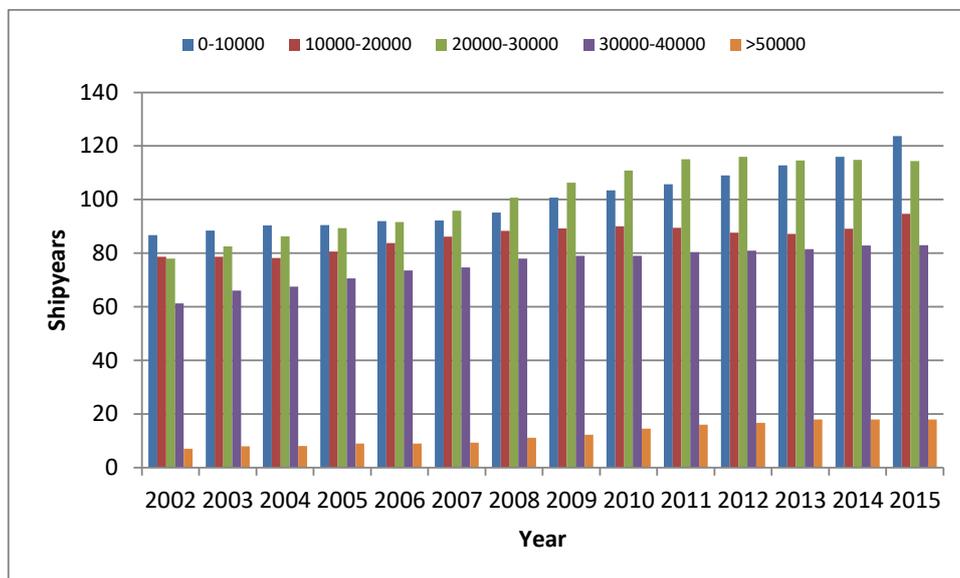
Figure 2.2-9 provides the number of shipyears per year for the FIRESAFE compliant ships, over the period 2002-2015, broken down by GT category. It can be seen that the larger part of the operational fleet is coming from the ships below GT 30000. Based on the 490 ships, median for the gross tonnage has been calculated to GT 20030 with an interquartile from GT 8790 to GT 30430.

Figure 2.2-9: Number of shipyears per year for FIRESAFE fleet, over the period 2002-2015, broken down by size category (GT)

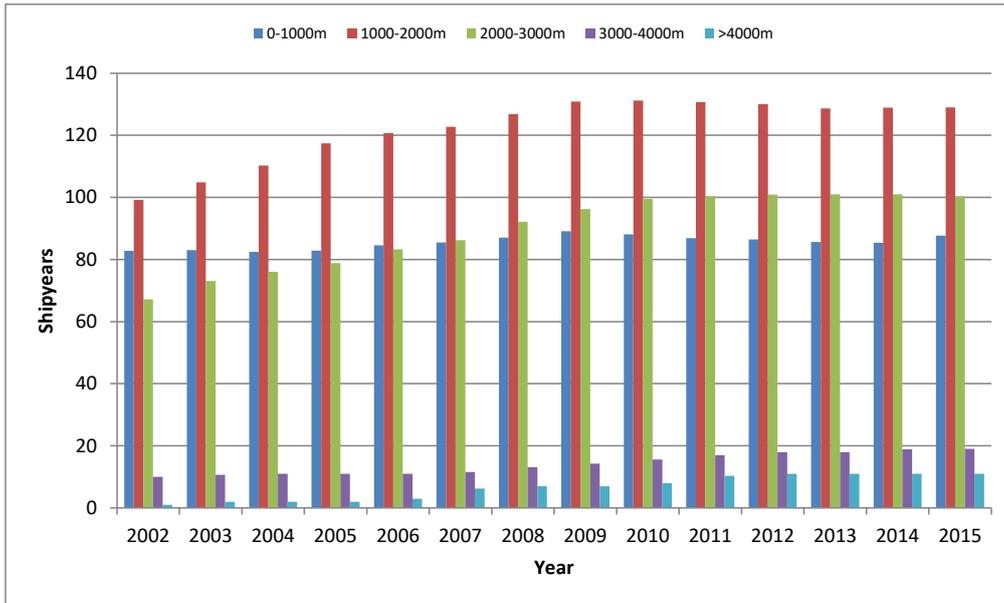
Figure 2.2-10 shows the number of shipyears per year for 5 different categories of lane meters. It should be noted that the first category (0-1000m) is expected to be higher (data on the length of ro-ro length were missing for ships with low GT).

Figure 2.2-10: Number of shipyears per year for the FIRESAFE fleet over the period 2002-2015, broken down by lane meters categories.

Although the largest part of the fleet consist of ships with lane meters smaller than 2000m (taking into account missing data below 1000m), as shown in Figure 2.2-10, on annual basis, the largest total cargo capacity is provided by ships with length of ro-ro lanes comprised between 1000m and 3000m, as shown in Figure 2.2-11⁷. It should be noted that the total cargo capacity provided by ships with lane meters above 4000m has continuously increased over the period of study. The average length of ro-ro lanes on ro-ro passenger ships of the fleet has increased throughout the period of study.

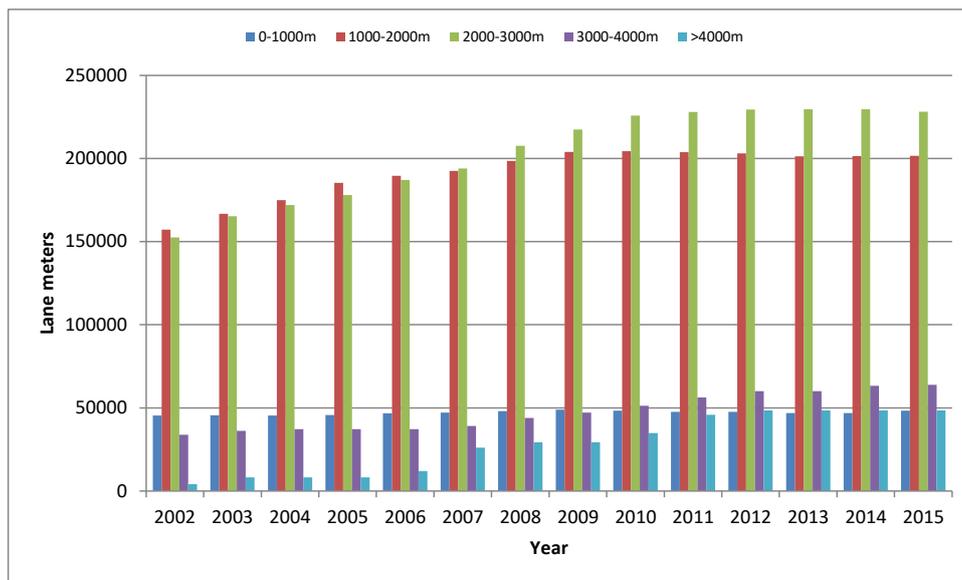
Figure 2.2-11: Total length of ro-ro lanes per year for the FIRESAFE fleet over the period 2002-2015, broken down by lane meters categories

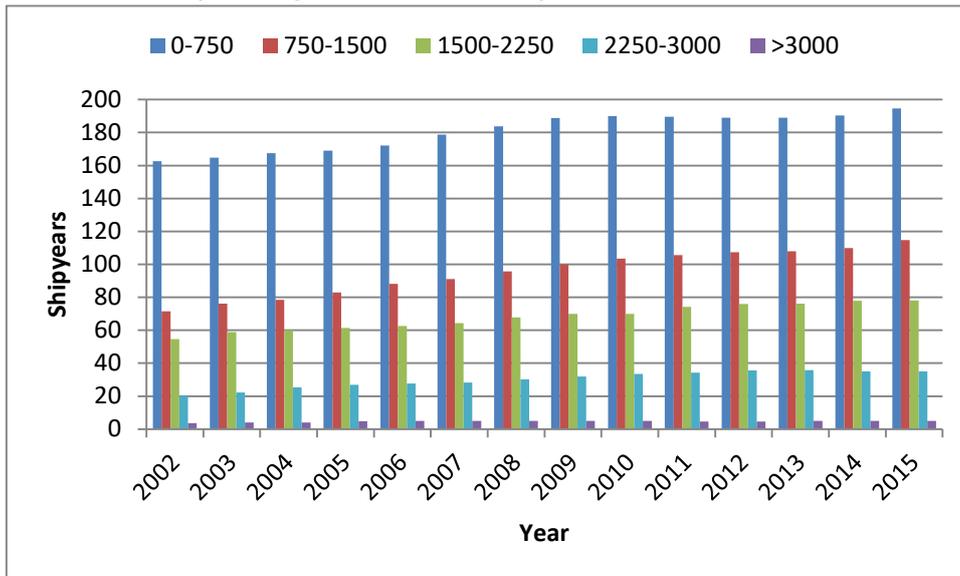
Figure 2.2-12: Number of shipyears per year for the FIRESAFE fleet over the period 2002-2015, broken down by passenger capacity categories

Although the ships having a passenger capacity below 750 persons represent the biggest part of the fleet (almost 50%, as shown in Figure 2.2-12), on annual basis, the largest total capacity of passengers is provided by ships with a passenger capacity between 750 and 2250 passengers (as shown in Figure 2.2-13). The average passenger capacity of the fleet has increased throughout the period.

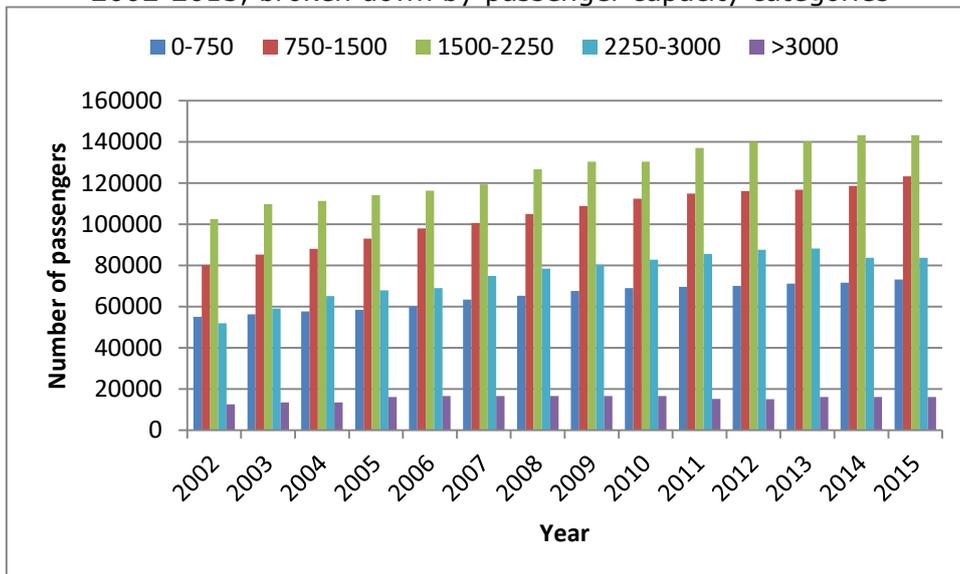
Figure 2.2-13: Total passenger capacity per year for the FIRESAFE fleet over the period 2002-2015, broken down by passenger capacity categories

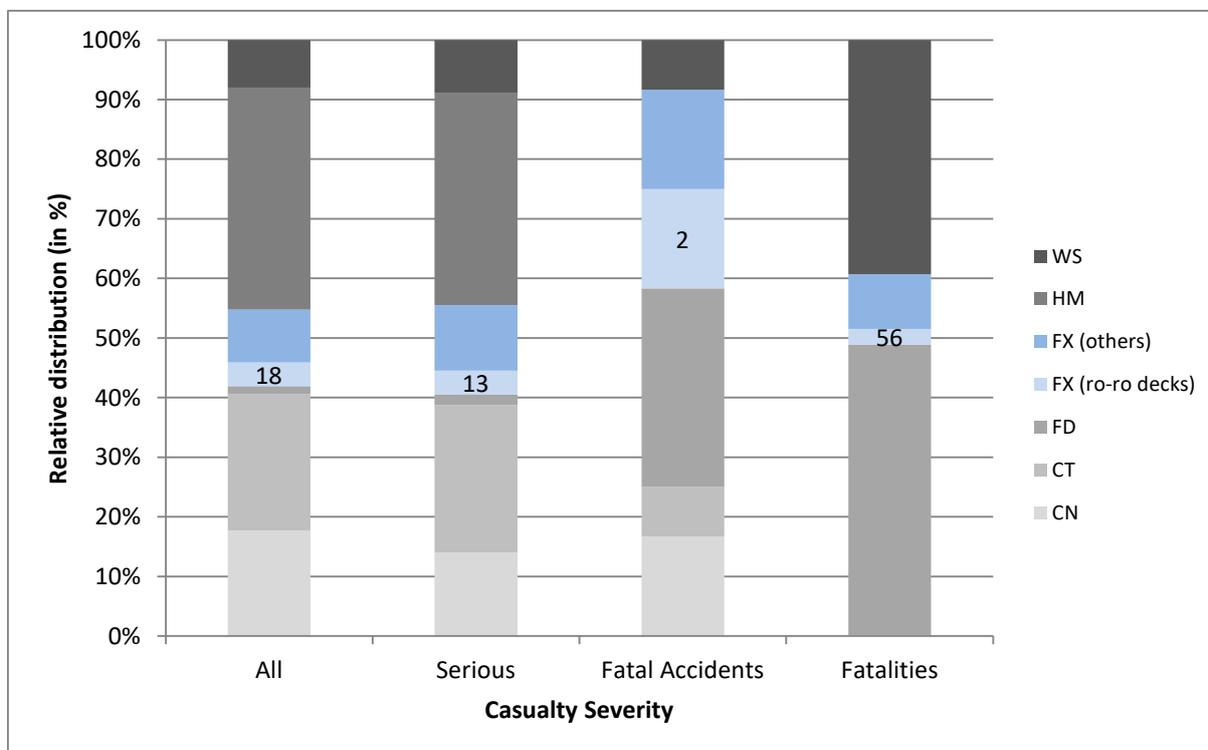
Figure 2.4-1: Relative distribution of casualty reports over the different accident categories on the FIRESAFE fleet between 2002 and 2015. Number of records for FX (ro-ro decks) provided by IHS. (WS: Wrecked/stranded, HM: Hull/machinery damage, FX: Fire/explosion, FD: Foundered, CT: Contact, CN: Collision)

Except for the Fire/Explosion accidents (and other accident types that had led to fires on ro-ro decks as identified during the data collection process), accident reports have not been reviewed, therefore the results presented in **Fel! Hittar inte referenskölla.2.4-1** might differ from previous FSA studies. The number of fatalities for the "Fires on ro-ro decks" fatal accidents corresponds to the ones reported in IHS. This number might vary in the following of the report as it depends on the source.¹⁵

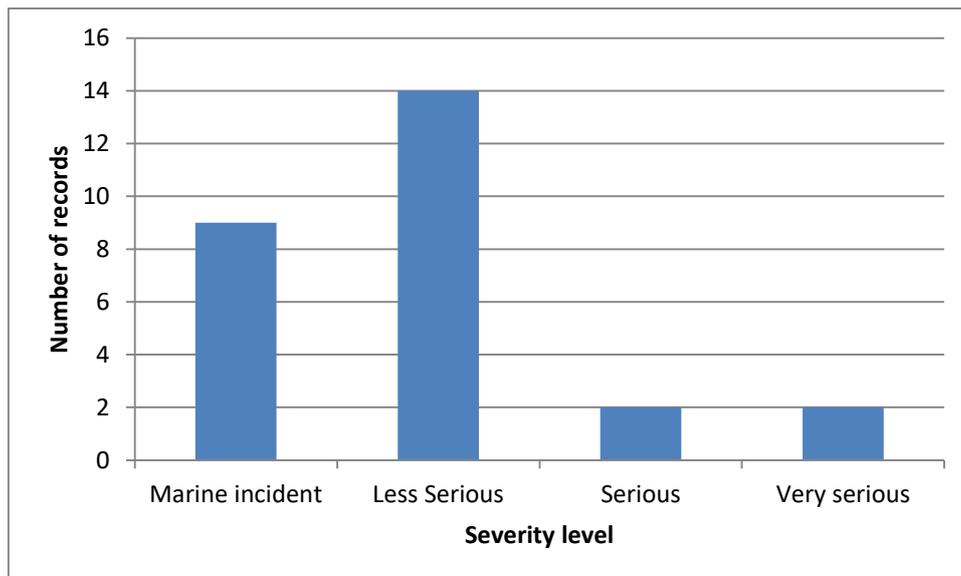
Figure 2.4-2: Number of occurrences according to severity, based on EMCIP database.

85% of the 27 fires on ro-ro decks occurrences on FIRESAFE compliant ships recorded in EMCIP databases between June 2010 and June 2016 have been classified as *Marine incident* or *Less Serious Casualty*. Only 28% of the records were classified as *Non-Serious* in IHS.

Therefore, statistics based on EMCIP database have been produced to give a picture that is considered to be closer to the reality, in terms of severity level ratios, than what is reported in **Fel! Hittar inte referenskölla**.. These results are shown in Figure 2.4-2.

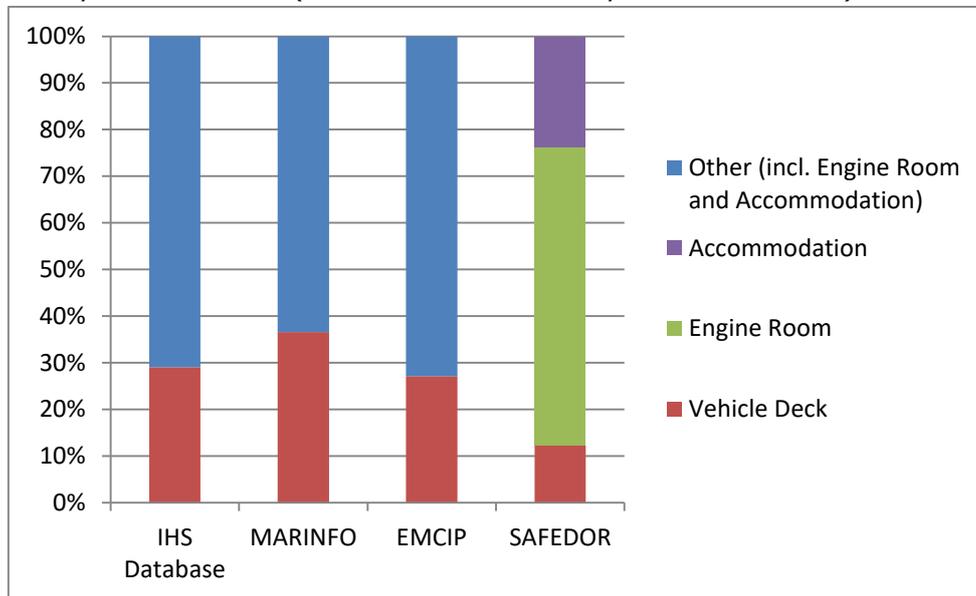
Statistics on IHS Casualty Database and MARINFO are based on accidents on FIRESAFE compliant ships during the period of study (2002 and 2015). EMCIP statistics has been computed from accident data on an undefined fleet of RoPax from June 2010 to June 2016. As for SAFEDOR, the ships considered are RoPax of 1,000 GRT and above and the period of study is 1994-2004 (no filter on the severity of the accidents).

Figure 2.4-3: Relative distribution of fire origin on RoPax ships in different accident data sources.

Due to the different periods and fleets considered, no conclusion should be drawn from Figure 2.4-3 on a potential increase in the proportion of fires on ro-ro decks or potential enhancement of fire safety in engine room and accommodation. However, it is worth noting the good degree of consistency between IHS Casualty Database, MARINFO and EMCIP, all around 30%, and the important difference with SAFEDOR (12%), the origin of this difference has not been ascertained. This proportion in SAFEDOR is close to what had been found in EMC MP08 (11%).

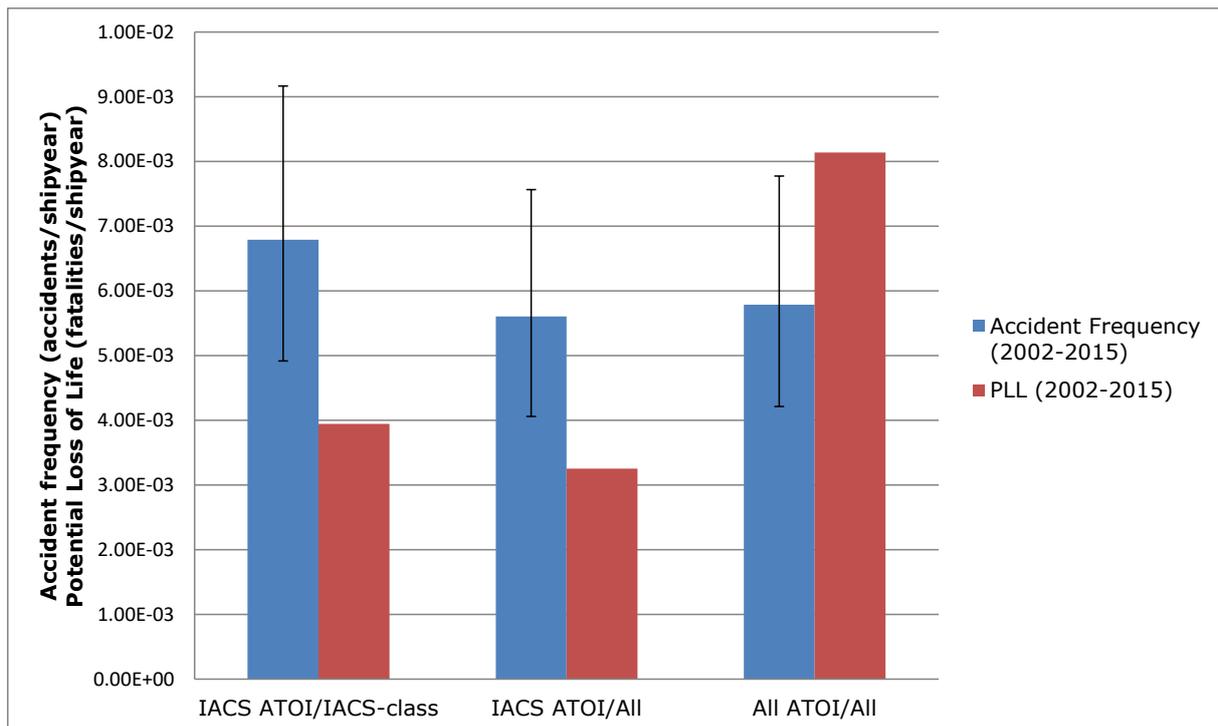
Figure 2.4-4: Impact of the IACS-class filtering criterion on the accident frequency and Potential Loss of Life.

While the consideration of the IACS parameter decreases the number of shipyears by about 20%, there was only one accident having occurred on a FIRESAFE-compliant ship which was not classed by an IACS society at the time of incident. This explains the increase in frequency between the *All* fleet and the *IACS-class* fleet. However, this unique accident was a fatal accident causing 27 fatalities, therefore the PLL of the *All* fleet significantly increases.

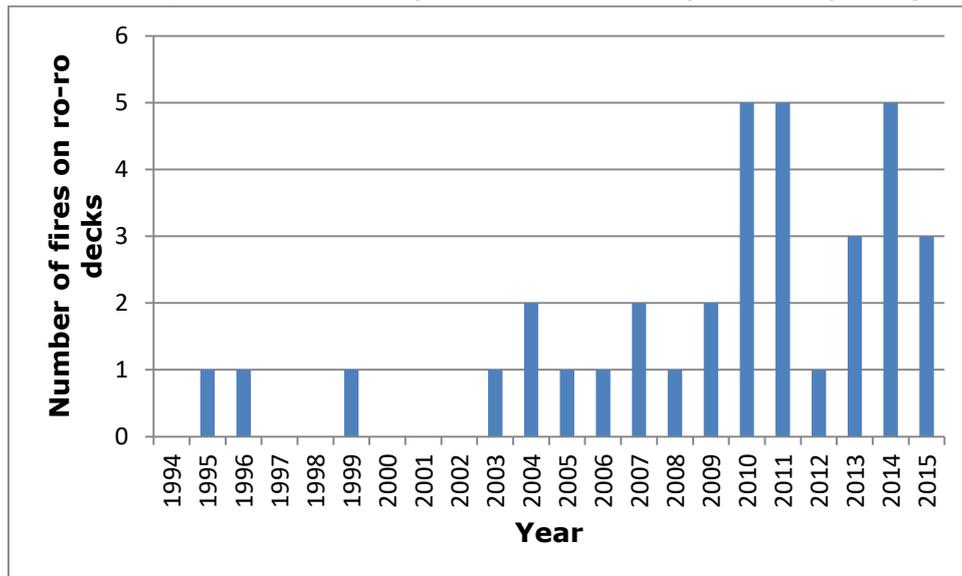
increase in the number of accidents per year can be observed after 2004. This figure should be read while keeping in mind that, due to the selected filtering criteria, the fleet under consideration is growing during the period 1994-2015.

Figure 2.4-5: Number of fires on ro-ro decks per year on FIRESAFE compliant ships (1994-2015).

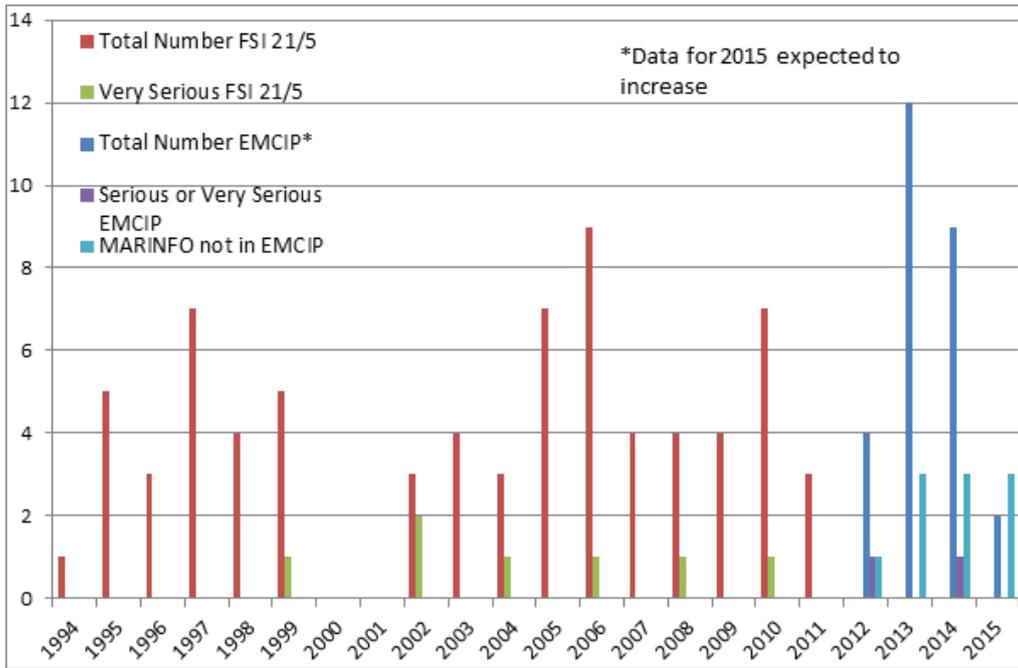
Figure 2.4-6: Fires on ro-ro decks 1994-2015 (from MSC 97/19/3 - Fire safety of ro-ro passenger ships). (IMO, 2016c)

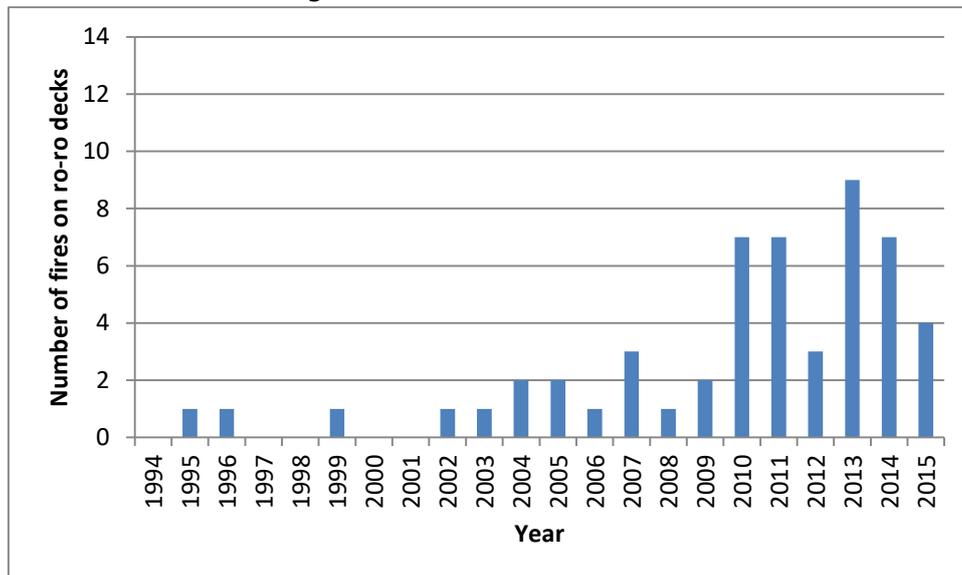
Figure 2.4-7 shows the number of fires on ro-ro decks recorded in the four databases (IHS Casualty database, MARINFO, EMCIP, and FSI 21/5). The high number of records after 2010 comes from the integration of EMCIP into the dataset considered.

Figure 2.4-7: Number of fires on ro-ro decks per year on FIRESAFE ships, considering all sources of data.

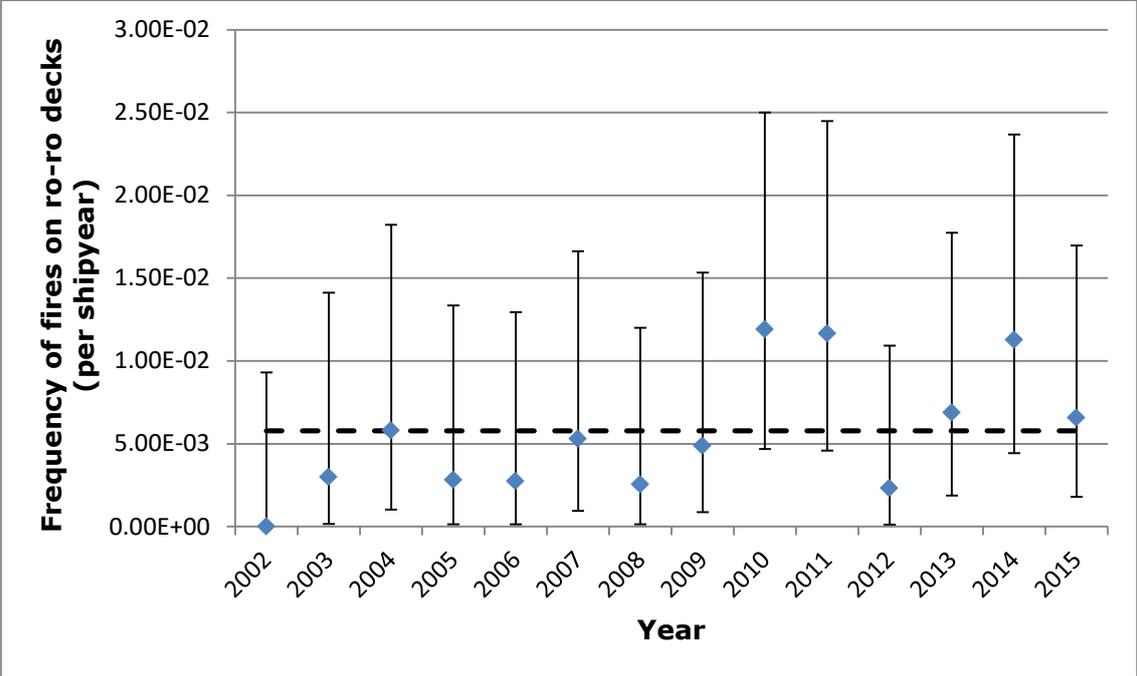
considered. The 14-year average accident frequency for FIRESAFE compliant ships is calculated to 5.79E-03 per shipyear (CI_{90%} [4.21E-03; 7.77E-03]). The annual accident frequency of fires on ro-ro decks is shown in Figure 2.4-8.

Figure 2.4-8: Annual accident frequency of fires on ro-ro decks with 90 % confidence interval²² between 2002 and 2015 and the 14-year average.

As indicated in the document FSI 21/5, there is no discernible downward trend in the frequency of accidents and no significant increase in the underlying risk of fire ignition could be ascertained in the recent years.

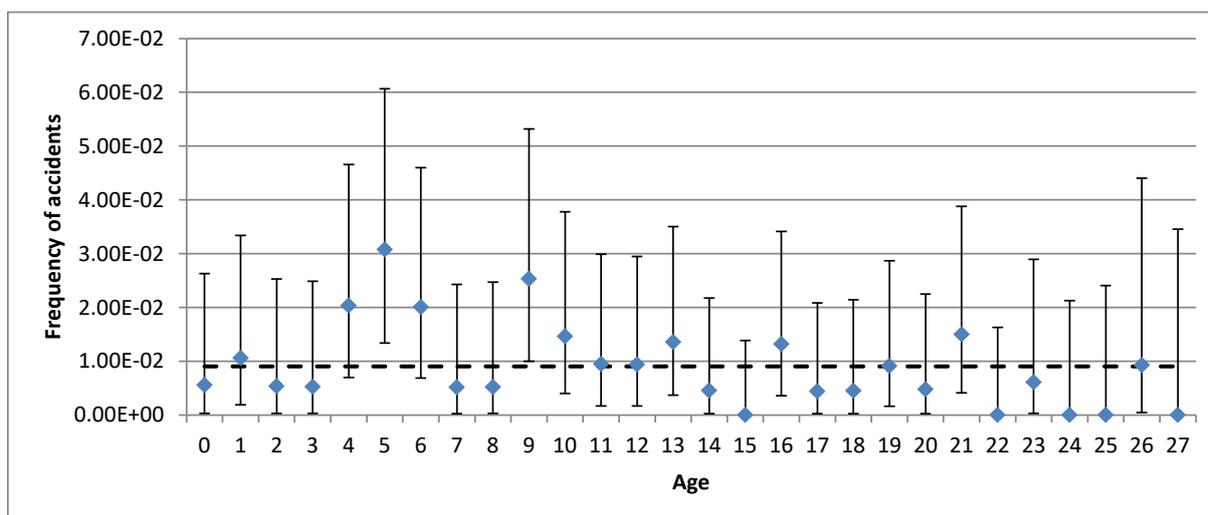
Based on Figure 2.4-9, the impact of ship age on the accident frequency cannot be ascertained.

Figure 2.4-9: Accident frequency per age at date of incident and 90 % confidence interval and average for the whole fleet at risk over the period 2002-2015.

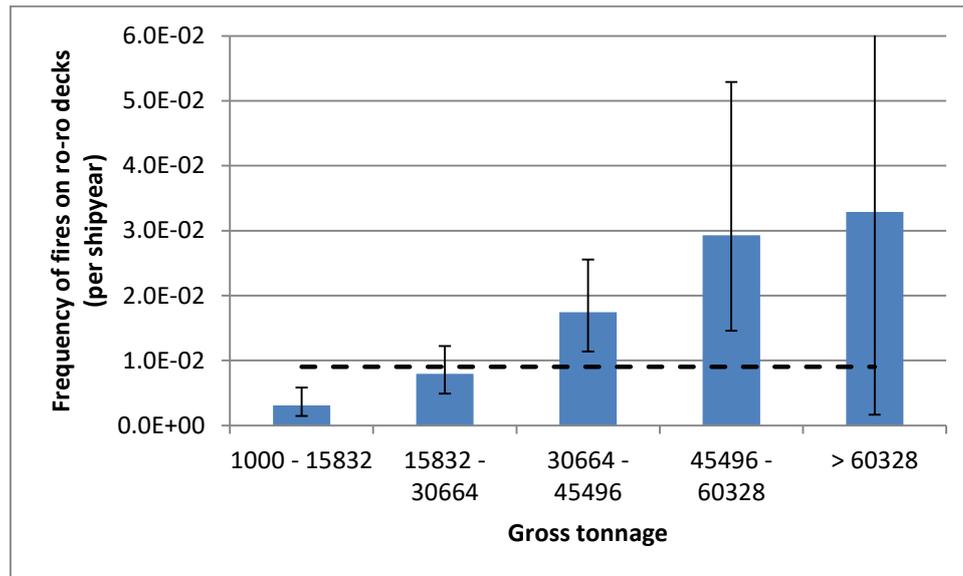
The impact of the ship size on the accident frequency on the FIRESAFE fleet between 2002 and 2015 has been investigated. There seems to be an increasing trend for larger ships, as indicated in Figure 2.4-10. However, it must be noted that the number of shipyears for the size category (GT>60328) is very low (about 30 shipyears over the full period) to provide an accurate estimation of the accident frequency for that period, as clearly shown by the large confidence interval.

Figure 2.4-10: Frequency of fires on ro-ro decks per size (GT) with 90 % confidence interval between 2002 and 2015 and average for all categories.

The confidence interval for the GT>60328 size segment has been cut short to maintain the readability of the figure, the upper bound being at 1.56E-01 fires on ro-ro decks per shipyear.

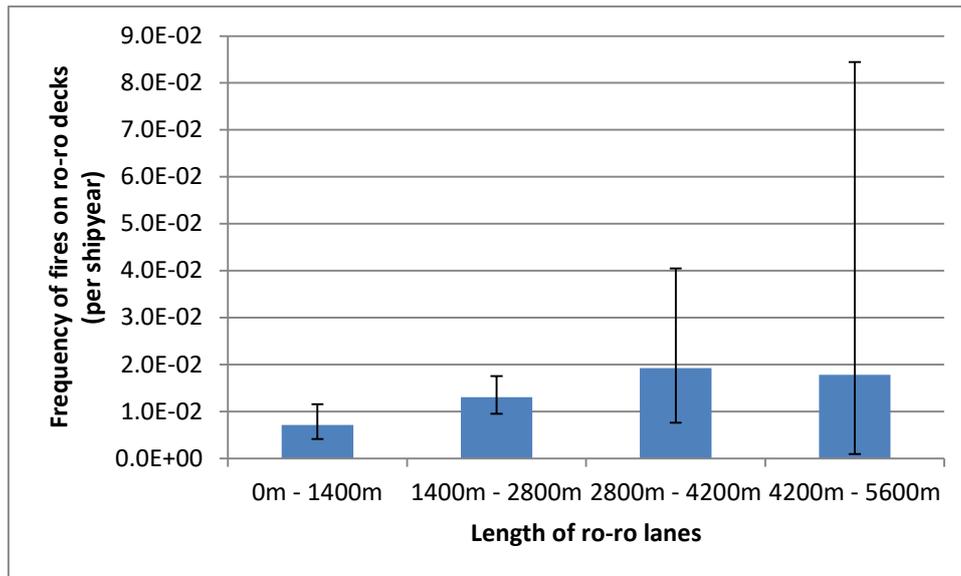
The number of lane meters (or length of ro-ro lanes) is available in IHS World Fleet database. However, this information was provided only for 368 ships out of the 490 ships of the FIRESAFE fleet. The frequency of fires on ro-ro decks for the fleet for which this information was available is reported in Figure 2.4-11 for different size categories.

Figure 2.4-11: Frequency of fires on ro-ro decks per length of ro-ro length category between 2002 and 2015 with 90% confidence interval (note that the fleet considered is not the entire FIRESAFE fleet at risk due to lack of data on lane meters).

As for the gross tonnage, there seems to be an increasing trend for ships with high number of lane meters. However, due to the large confidence intervals, which indicate that this trend could be explained only by stochastic variations, no conclusion will be drawn from that figure.

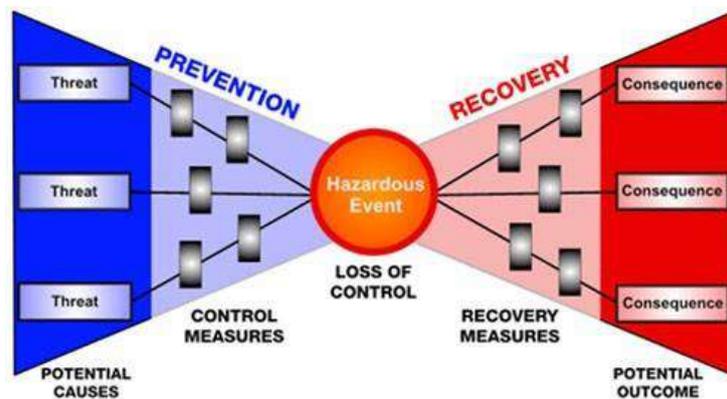
The concept used for the current Fire HazId was developed based on a well-known model in risk management called the Bow Tie model. It is a barrier risk model developed to assist the identification and management of hazards. The Bow Tie model is illustrated in Figure 2.5-1.

Figure 2.5-1. Illustration of the Bow Tie model, a barrier risk model for identification and management of hazards.

The Bow Tie model consists of different elements that build up the risk picture. The risk picture revolves around a hazardous top event. The top event is something with potential to cause harm unless it is controlled, in this case a ro-ro space fire. Focus is turned to one side at a time beginning with the threats on the left-hand side. These are potential causes for the top event which are explored through different escalation factors and control measures. Thereafter potential outcomes are investigated together with escalation factors and different recovery measures. The different control measures are barriers populated on either side of the model that are described by Table 2.5-1:

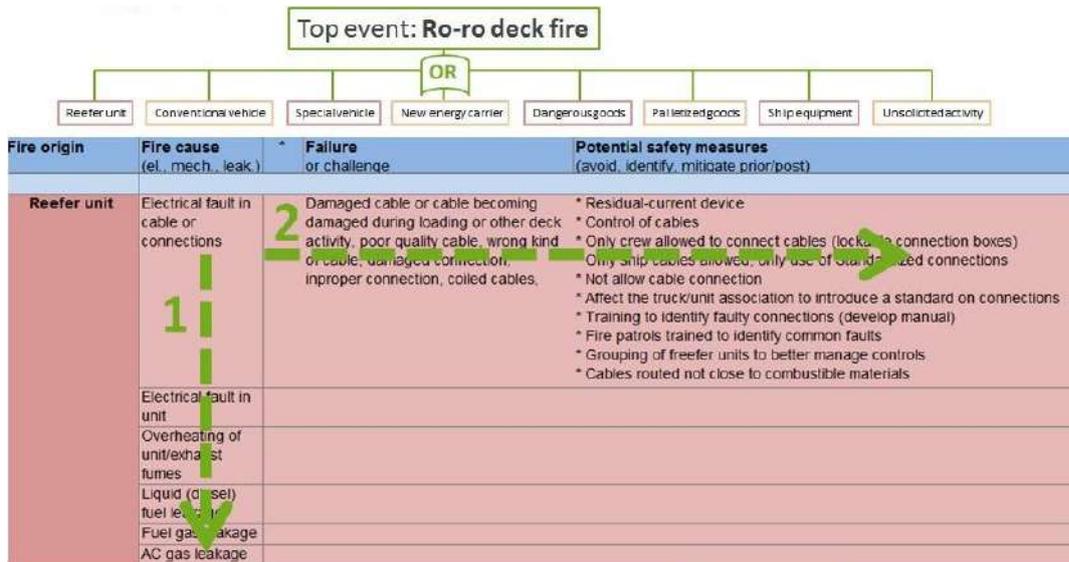
Each of these categories of fire origins were first considered with regards to fire causes (1 in Figure 2.5-2). Fire is generally caused by electrical fault, mechanical overheating, leakage of easily flammable substance or chemical reaction, which were used as leading factors in identifying fire causes. As illustrated in Figure 2.5-2, each fire cause was then connected to potential challenges or failures which could be the reason for the fire cause (2). Thereafter potential safety measures were identified for each challenge, as illustrated in Figure 2.5-2. Then potential failures/challenges and safety measures were identified for the next fire cause. A field was also provided for comments regarding each fire cause.

Figure 2.5-2. Illustration of how the fire prevention part of the Fire HazId was carried out.

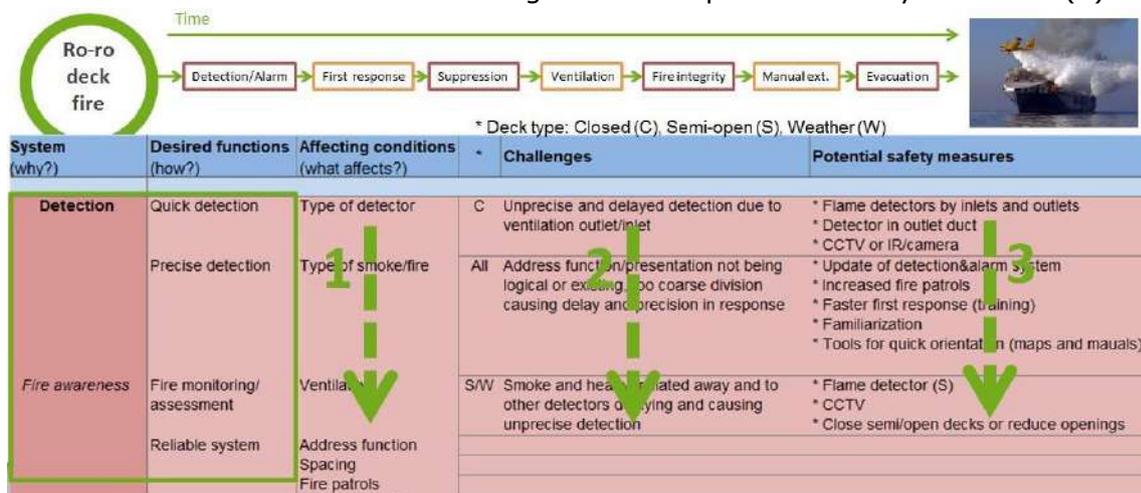
Each of these barriers was investigated after agreeing on purpose and desired functions. First the group brainstormed on affecting conditions (1) before forming distinguished challenges to reaching the desired functions (2). These steps are illustrated in Figure 2.5-3. Thereafter was for each challenge discussed potential safety measures (3).

Figure 2.5-3. Illustration of how the fire recovery part of the Fire HazId was carried out.

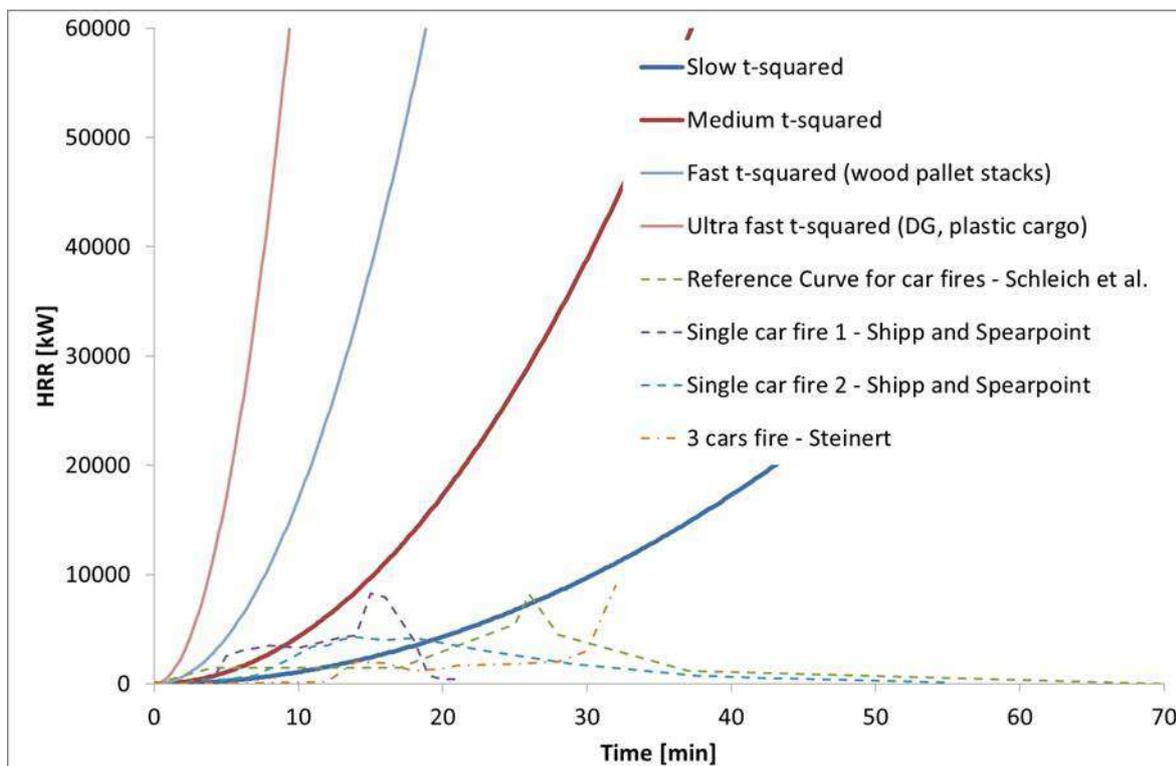
The fire growth in car fires has been studied in a number of research projects. Some of these studies were consolidated by Yuguang Li [Li Y,2004] and it was shown that the fire growth in parked cars varies between 0.003 kW/s^2 (denominated "slow" fire growth) and 0.012 kW/s^2 ("medium" fire growth). A number of relevant fire scenarios to support this are presented in Figure 2.7-1.

Figure 2.7-1 – Slow, medium, fast and ultrafast t-squared fires compared to a number of actual car fire tests and a reference car fire curve

Based on these experiences from car fires a medium fire growth is considered to be the expected fire growth rate for ro-ro deck fires, in most car fire scenarios this can be considered conservative. However, it should be noted that on a ro-ro space there is potential for fires with a more rapid fire growth e.g. in case of a large fuel spill, dangerous goods or other kinds of combustible cargo.

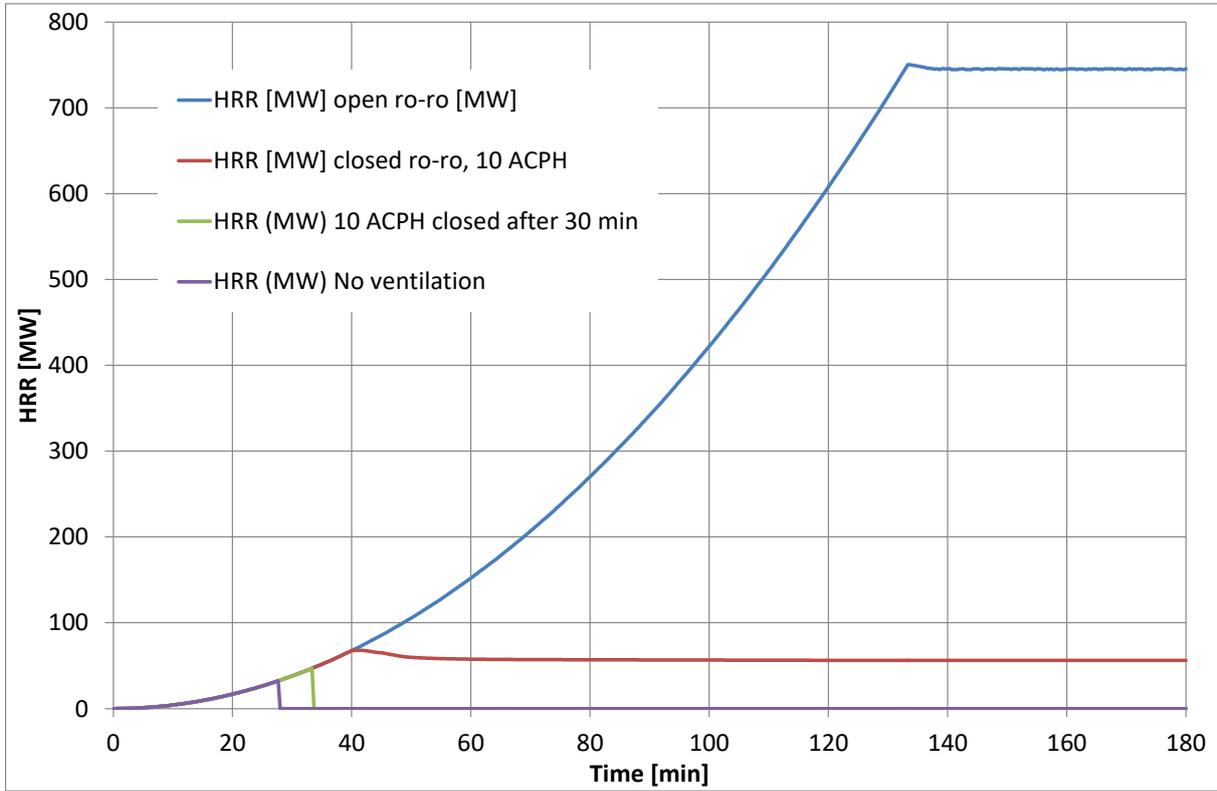
All simulations were performed assuming a medium fire growth rate and the fire was always allowed to grow until ventilation control was reached. The resulting heat release rate data is presented in Figure 2.7-2 .

Figure 2.7-2 - Heat release rates as a function of time for varying levels of ventilation

It is not obvious that a ro-ro deck fire will continue to grow until ventilation control is reached. However, Figure 2.7-32 clearly shows that the natural ventilation available on the open ro-ro deck will not be a limiting factor for the fire development before it reaches catastrophic dimensions that seriously threatens the entire ship is reached. A more detailed plot of the first 60 minutes of the same results is shown in Figure 2.7-3.
