EMSA/OP/01/2016

Study investigating cost effective measures for reducing the risk from fires on ro-ro passenger ships (FIRESAFE)

This is a study commissioned by the European Maritime Safety Agency, EMSA. It consists of two parts, investigating risk control options (RCOs) for mitigating the risk from fires on ro-ro decks. The first part considers RCOs in relation to *Electrical Fire as ignition risk* and the second part considers RCOs to mitigate the risk of *Fire Extinguishing Failure (with focus on drencher systems)*. The study considers both newbuildings and existing passenger ships, and has been done per the instructions and limitations in the Tender Specifications (EMSA /OP/01/2016).

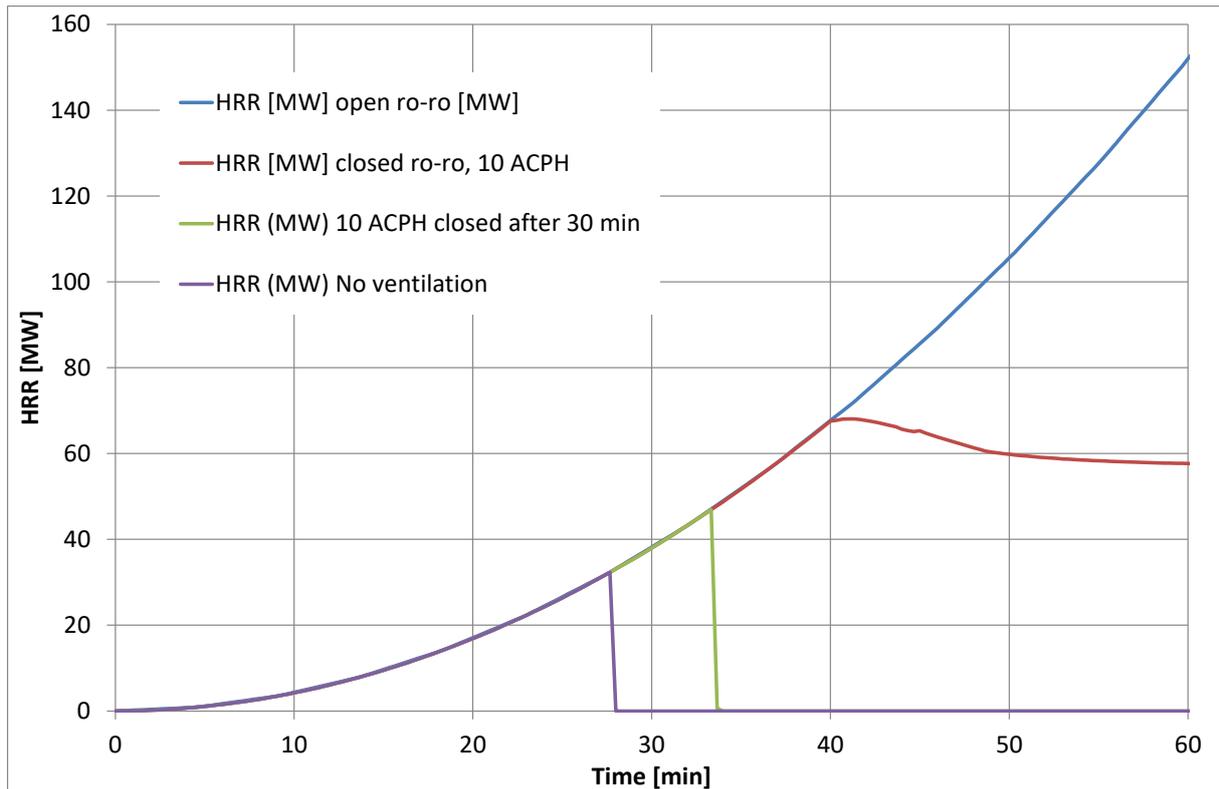
Figure 2.7-3 - Heat release rates as a function of time during the initial 60 minutes for varying levels of ventilation

It can be seen that if the mechanical ventilation, for any reason, is not turned off there will be a continuing ventilation controlled fire at about 60 MW. Further, if the ventilation fans and dampers are closed after 30 minutes the fire will reach about 45 MW before it self-extinguishes due to oxygen starvation just a few minutes after the ventilation is closed. If the ventilation is closed immediately after ignition the fire grows to about 30 – 35 MW before it self-extinguishes.

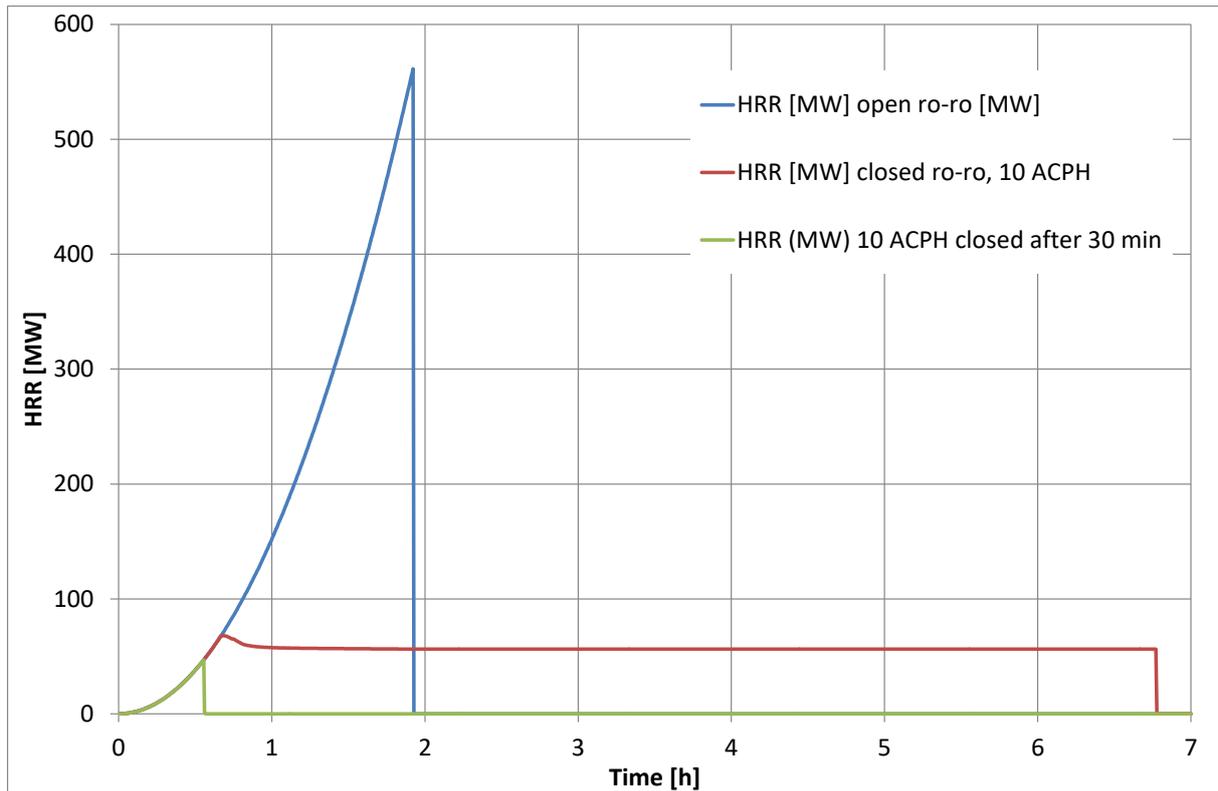
If a fire at ventilation control is not extinguished by manual means or by fixed firefighting systems, the fire will continue until the available fuel is consumed. If we consider the same ro-ro decks as above, there are sufficient lanes for about 200 cars. Each car (incl. fuel) has a fire load of about 5-8 GJ/car [Li Y,2004] hence, a total fire load of about 1 300 GJ can be expected if the deck is fully loaded with cars. Based on this, the duration of an uncontrolled car fire can be calculated for the different ventilation scenarios, see Figure 2.7-34.

Figure 2.7-4 - Duration of uncontrolled car fire at different ventilation rates (assuming all fires grow until ventilation control).

It can be seen that the scenario where the ventilation is completely closed after 30 minutes the fire self-extinguishes after about quickly thereafter and reaches a maximum heat release rate of about 45 MW. The other two scenarios where the fire is not extinguished with active firefighting means and the ventilation is not closed results in long lasting fires (2 - 7 hours) with a high-energy release rate. Such fires are not likely contained in the space of origin and it is likely that abandonment of the ship is required at such conditions.

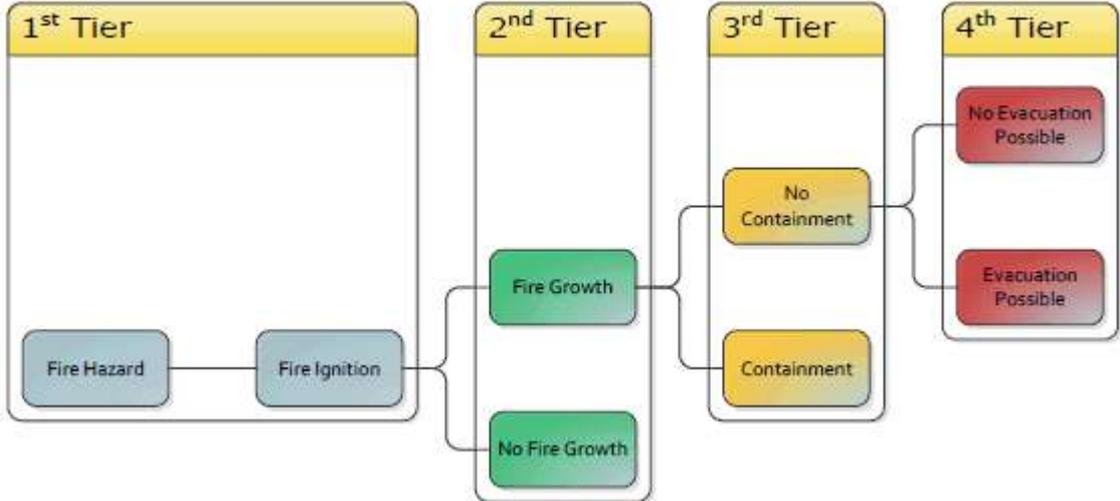
Based on the information that has been provided by EMSA stemming from the work of the GoE regarding the structure of the risk model, as well as the hazard identification (see Section Fire hazards/risks) and the fire scenarios identified (see Section Development of fire scenarios) in the previous step, a suitable risk model has been developed. Figure 2.8-1 provides the chain of event as provided by EMSA, which is composed of 4 tiers and is applicable to any spaces.

Figure 2.8-1: Fire risk model (extracted from document: 1st Correspondence of the Group of Experts on fire on ro-ro decks, EMSA, 2015).

It should be noted that the fire risk model, as provided by EMSA, does not explicitly mention fire extinguishing. This is included within the 2nd tier along with fire detection.

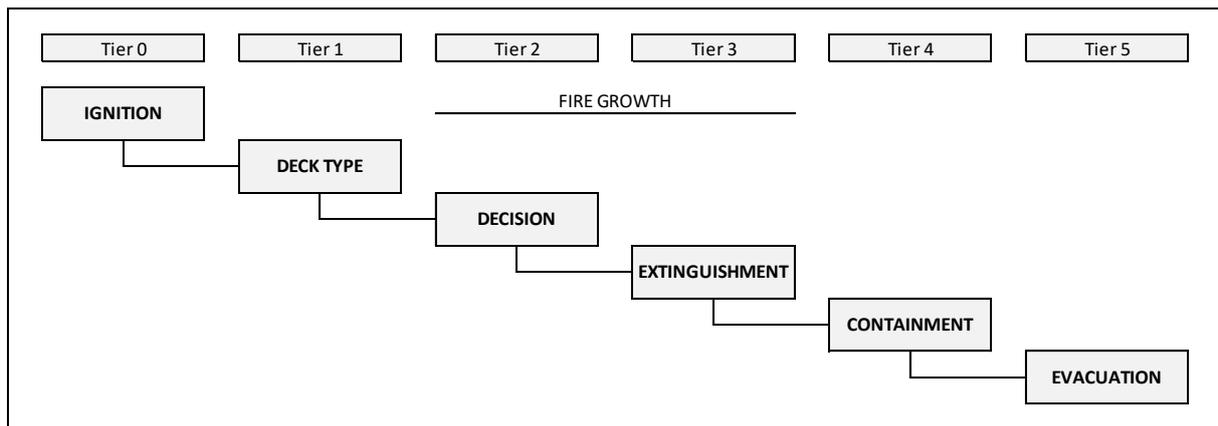
Therefore, for the purpose of the study, the chain of event has been modified as shown in Figure 2.8-2. The fire growth tier has been expanded into Decision (which include the detection and decision time) and Extinguishing. Both tiers are further explained in the following.

Figure 2.8-2: Fire risk model as modified for the FIRESAFE study.

It can be noted that compared to the fire risk model provided by EMSA, a tier has been added to consider the deck configuration on which the fire started. This tier is further explained in the following.

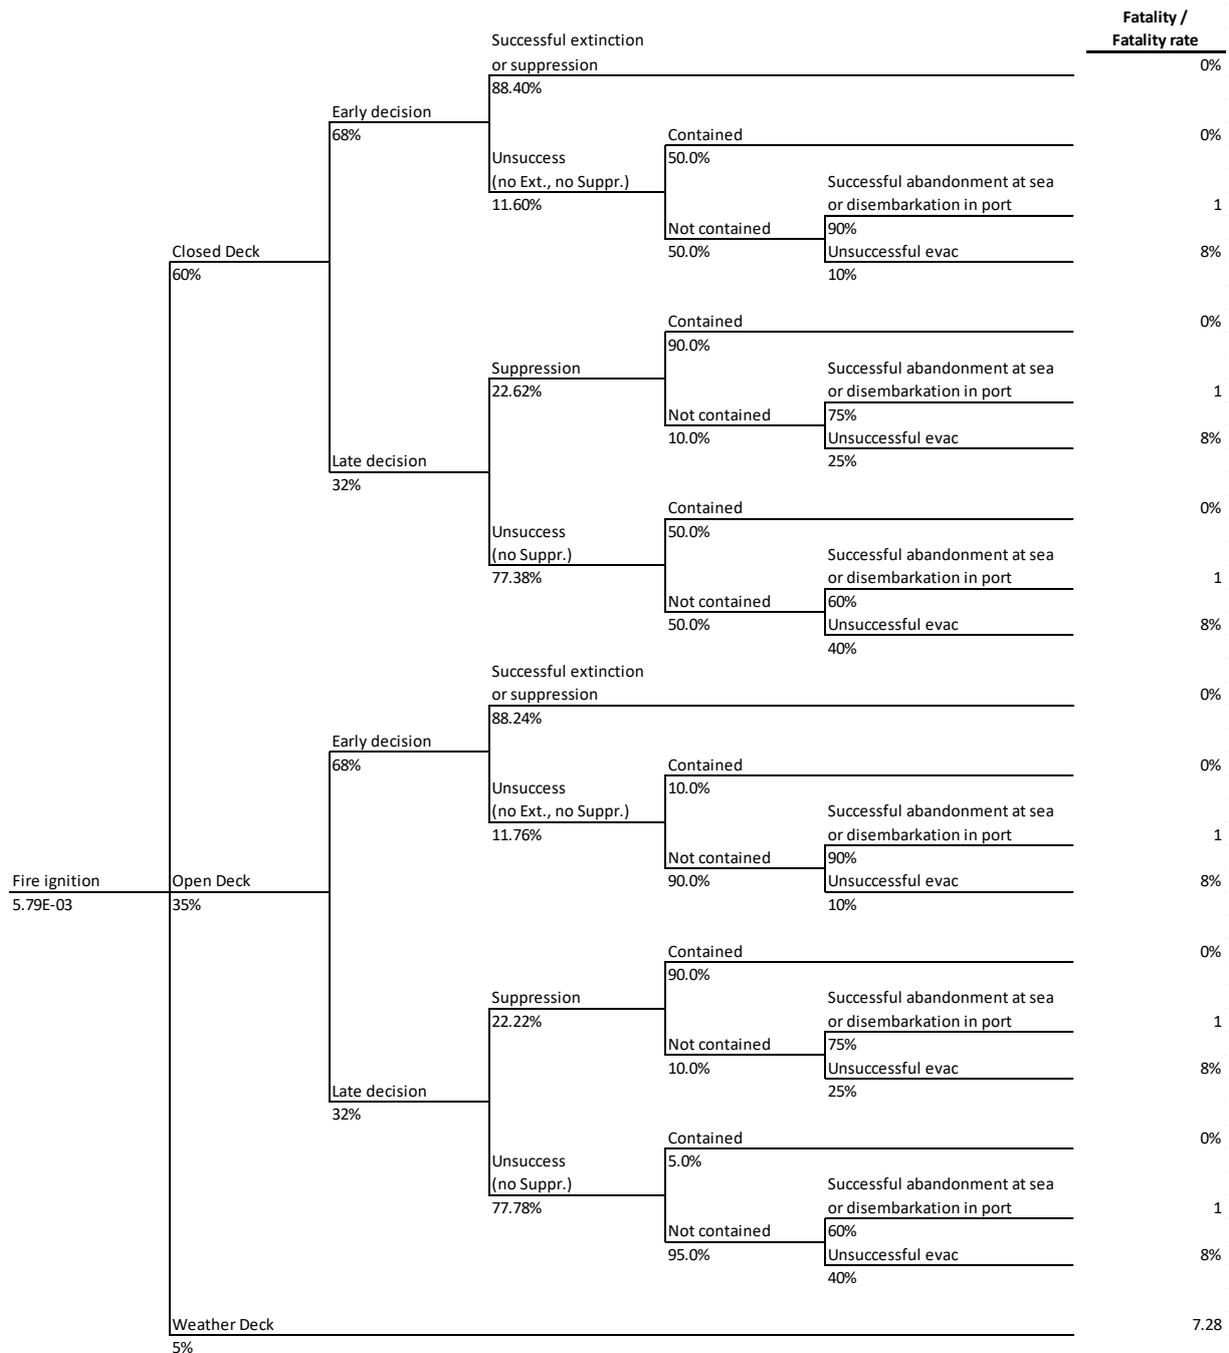
When the evacuation is successful, a 1 equivalent fatality fixed value has been assigned to take into account the frequent injuries and possible indirect fatalities following such evacuation.

Figure 2.8-3 The Main Risk Model (fatality rate is in some branches in the event tree expressed as fixed number of fatalities)

Closing of the openings in an open ro-ro-space will have other positive effects, such as restricting the possible spread of smoke and fire. This will affect the containment part of the Main model since the deck should no longer be considered as open but as closed (see figure 2.8-3). The probability of treating the open deck as a closed deck was estimated by SP, BV and Stena based on the reliability and effectiveness of such a system in case of a fire. This likelihood was estimated to 70%. Detection will not be affected since the openings will not be closed until after a fire alarm.

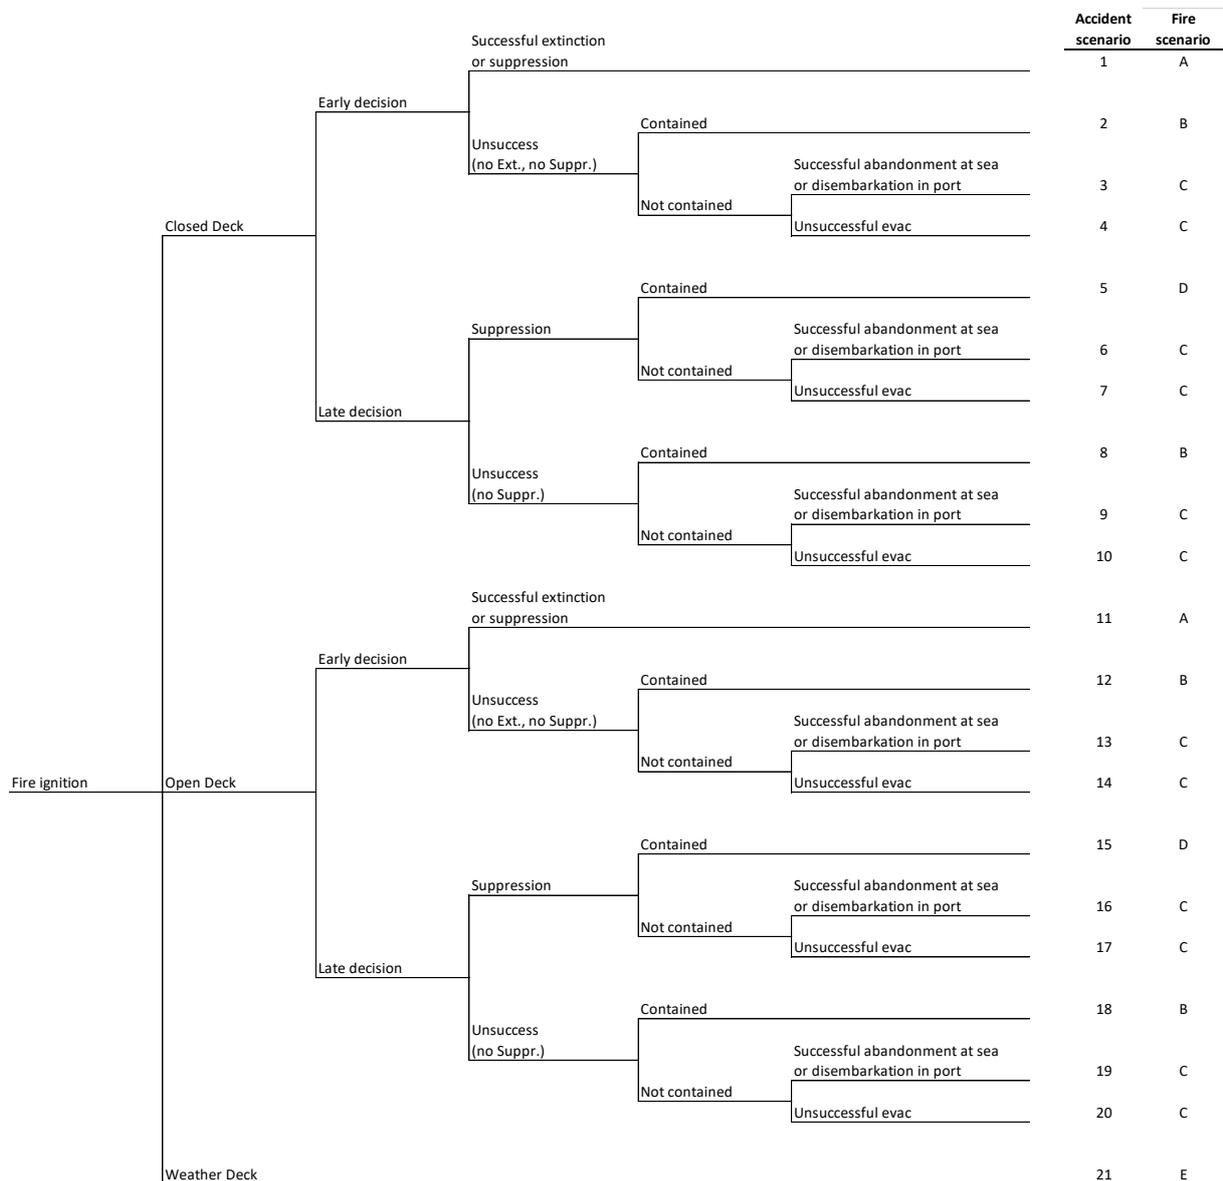
In the Main risk model, there are 21 branches that represent the different accident scenarios. These could be group into 5 different fire scenarios, A to E. Below will these four scenarios and their associated costs be discussed. The details of the cost estimates can be seen in Table 2.9-1.

Figure 2.9-1 Accident and fire scenarios

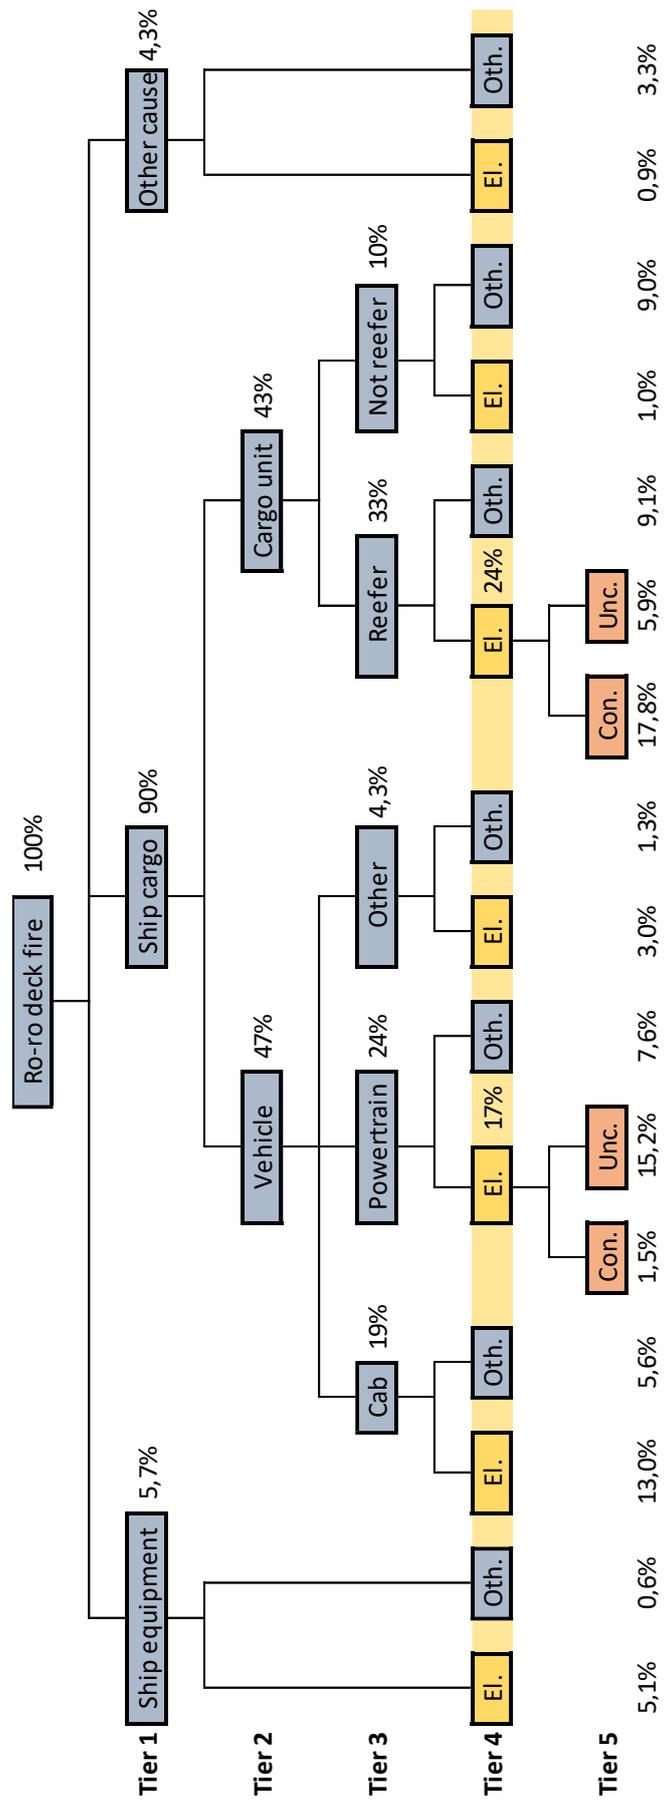
Each distinguished category of fire origin was further divided in *Electrical* and *Other* (tier 4), referring to whether the fires were caused by electrical fault or not. Electrical fires in vehicle powertrains and reefer cargo units were further divided in *Connected* and *Unconnected* (tier 5), to distinguish fires in vehicles and cargo units connected to the ship power supply. The fire risk model with the five tiers is illustrated in Figure 3.1-1.

Figure 3.1-1. Fault tree risk model for electrical fire as ignition source on ro-ro deck.

For the FIRESAFE study, a tiered approach was used. It was decided to use categories of ro-ro deck fires similar to the ones documented in FSI 21/5 (IMO, 2012) as basis for the tiers in the development of a risk model for probability estimations. The model was developed similar to a fault tree, with potential causes leading to a top event (in this case *Ro-ro deck fire*) are derived and structured. The fires documented FSI 21/5 (see table 1 of Annex 6 of that document) were reported in the eight categories presented in table 3.1-1 above. The first seven categories of fire origins were divided in two main categories: *Ship equipment* and *Ship cargo*, leaving the category *Other cause* as a third main category (tier 1). The latter includes for example fire due to cargo shift and arson. The category *Ship equipment* includes both fixed and portable equipment, i.e. both equipment fixed to the ship as well as equipment which is portable and potentially plugged in to the ship's electrical system. As illustrated in Figure 3.1-1, the *Ship cargo* category was first divided in *Vehicle* and *Cargo unit* (tier 2), to distinguish between fires originated in vehicles used to carry cargo onboard and fires originated in cargo units, such as reefer units, trailers, trucked vehicles, etc. Fires on vehicles were divided in the categories *Cab*, *Powertrain*, and *Other* (tier 3). In the cab are included temporary and permanent electrical installations which could cause fire in the cab, such as electrical seats, lights, heaters, flammable liquids, kettles, mobile units and other items which could occur in a cab. The powertrain can be defined as the components of a vehicle that generate power to the road surface and include engine, transmission, drive shafts, differentials, and wheels. Elements such as breaks, tanks, batteries and electrical systems are also seen as elements of the powertrain, except from the electrical systems inside the cab. Furthermore, the electrical system of carried cargo unit/trailer is not included in this category but in the *Cargo unit* category. This was further sub-categorized in the two categories *Reefer* and *Not reefer* (tier 3), to separate refrigerated units from other cargo.

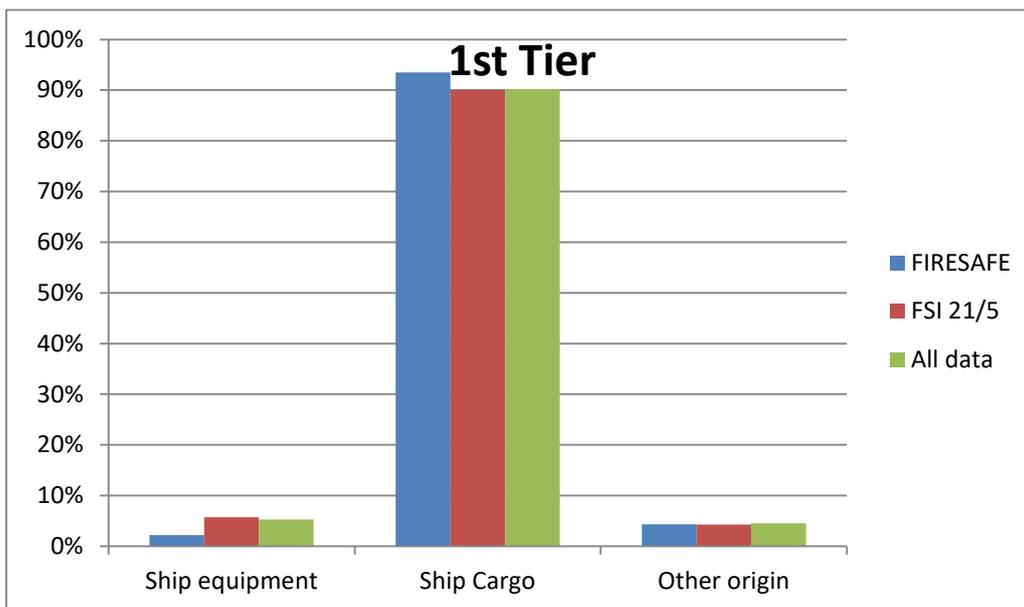
For the data available in FSI 21/5, the incidents were carefully scrutinized and categorized. During this work personnel from SP working with fire cause investigations of vehicle fires (trucks, buses, forest, tractors, wheel loaders, forest vehicles, etc.) were consulted. The categorizations of the incidents in the three different datasets were compared, as presented in Figure 3.1-2, Figure 3.1-3, Figure 3.1-4, and Figure 3.1-5, below.

Figure 3.1-2. Distribution of accident reports over the first tier three categories (Ship Equipment, Ship Cargo, Other origin) for different datasets.

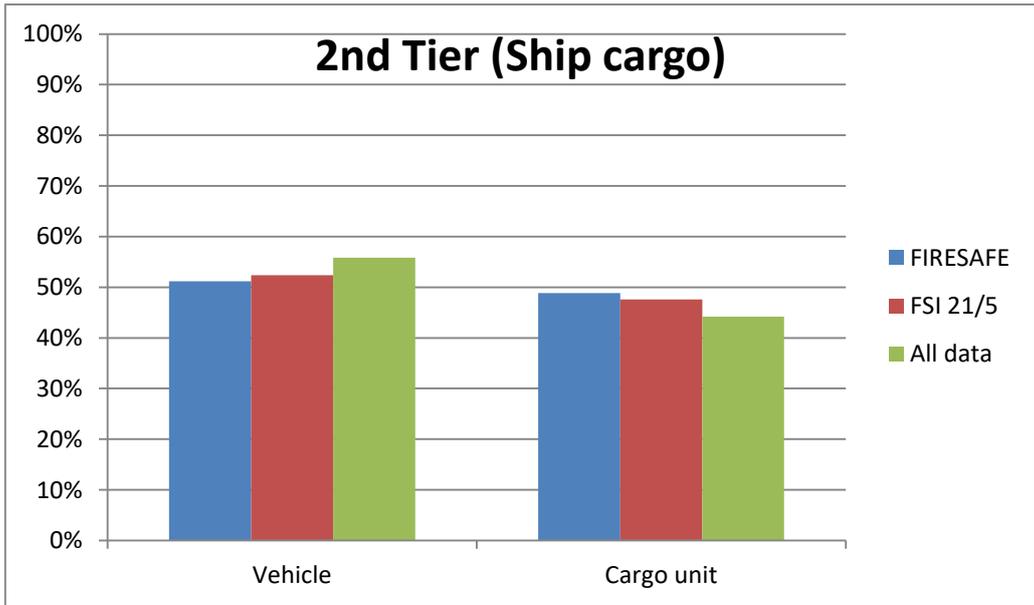
Figure 3.1-3. Distribution of accident reports over the second tier two categories (*Vehicle, Cargo Unit*) for *Ship Cargo* for different datasets.

It should firstly be noted that the different data sources show very similar results when organized in the categories selected for this study³⁷. It is hence likely that the variability between the different data sources is smaller than the uncertainty of each data source. This argues that any of the datasets could be used to populate the risk model for electrical fire as ignition source on ro-ro deck.

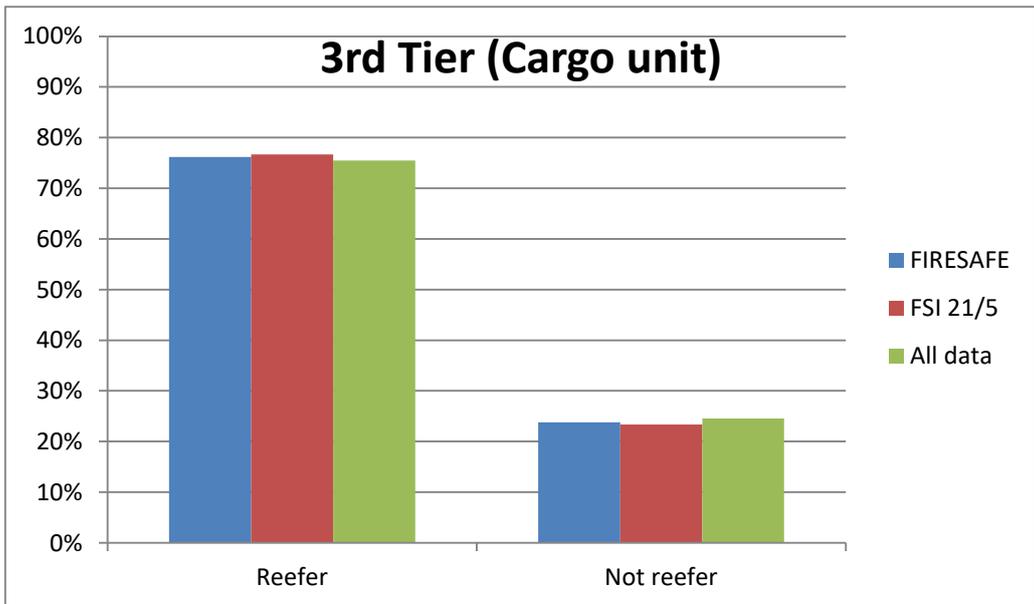
Figure 3.1-4. Distribution of accident reports over the third tier two categories (*Reefer, Not reefer*) for *Cargo Unit* for different datasets.

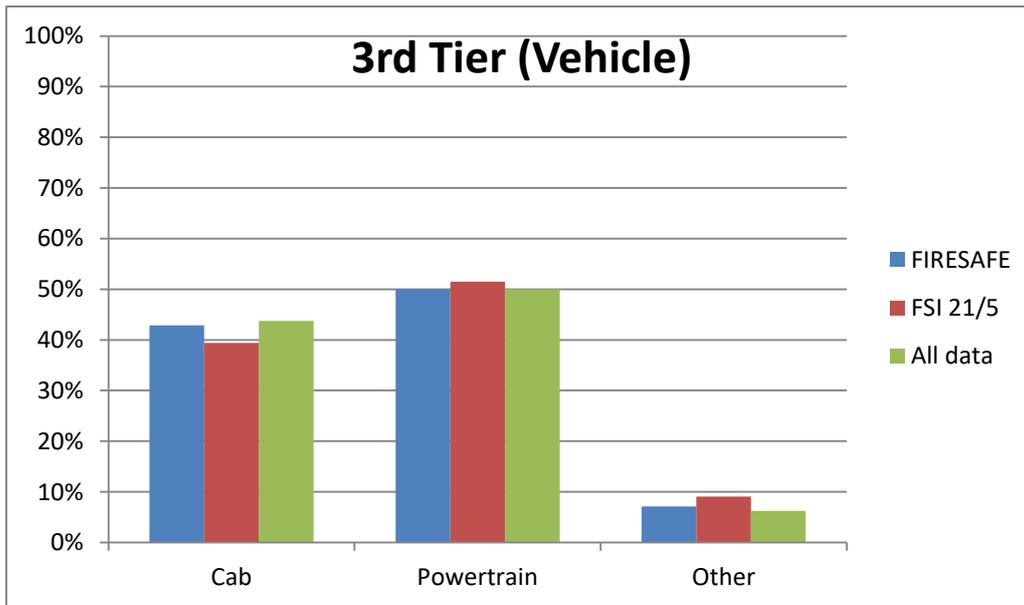
Figure 3.1-5. Distribution of accident reports over the third tier three categories (*Cab, Powertrain, Other*) for *Vehicle* for different datasets.

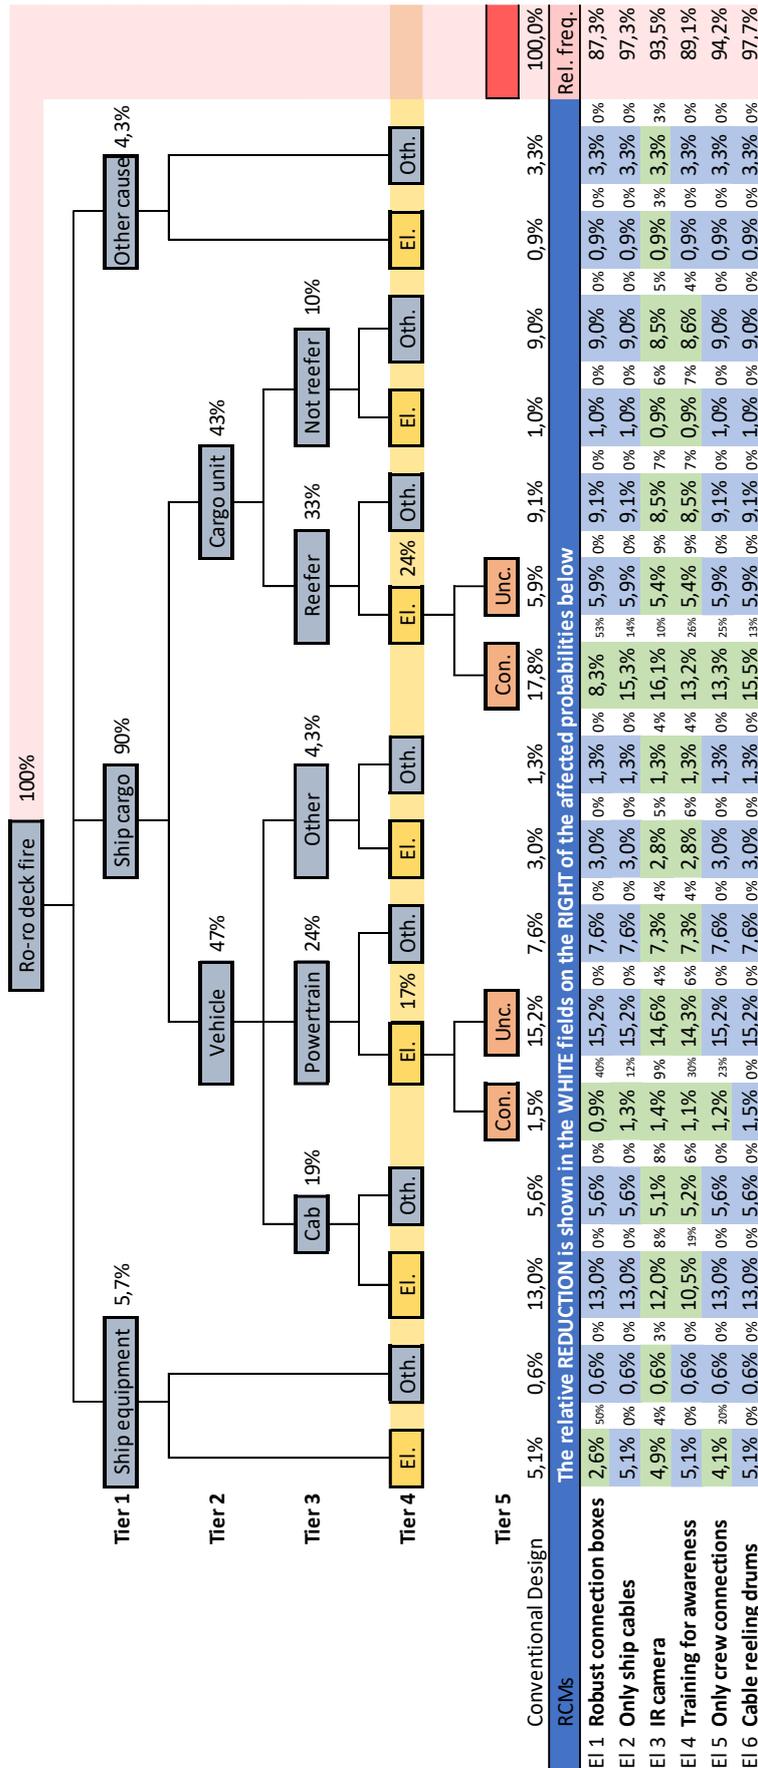
Figure 3.4-2. Fault tree risk model for electrical fire as ignition source with estimated effects of RCOs.

The list with the RCOs, affected nodes, important factors to consider, and the average values of the estimations are presented in Figure 3.4-1. The averaged estimated effects of the RCOs were linked to the risk model for electrical ignition sources on ro-ro deck, as illustrated in Figure 3.4-2. The concluding effects on the probability and frequency of fire and fire with electrical ignition source are presented, respectively, in Table 3.4-1.

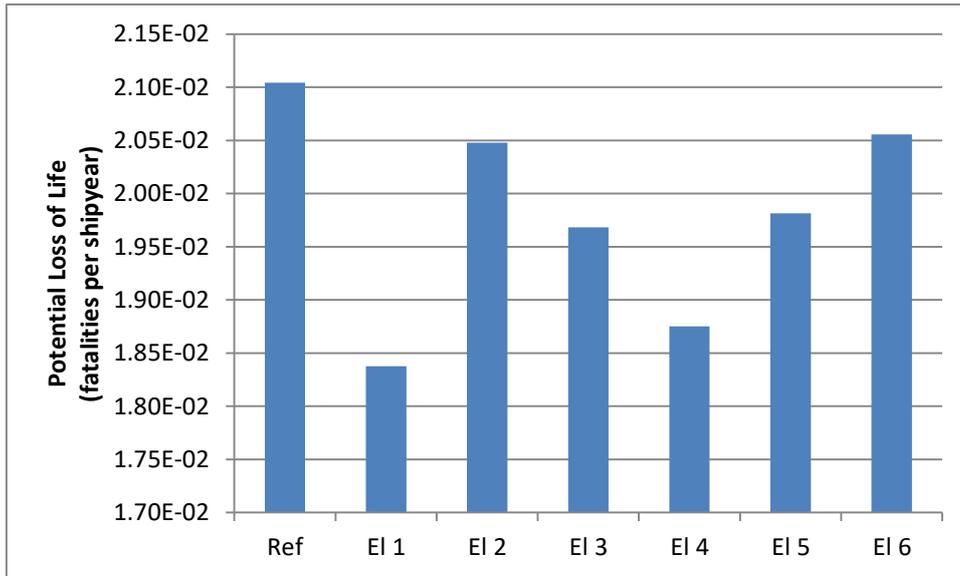
Figure 3.5-1: Potential loss of life for the generic vessel and after (individual) implementation of the RCOs (Electrical fires)

Figure 3.5-1, Figure 3.5-2 and Figure 3.5-3 provide the PLL, PLC, and PLS, respectively, for the reference ship without RCOs and after the implementation of the individual RCOs.

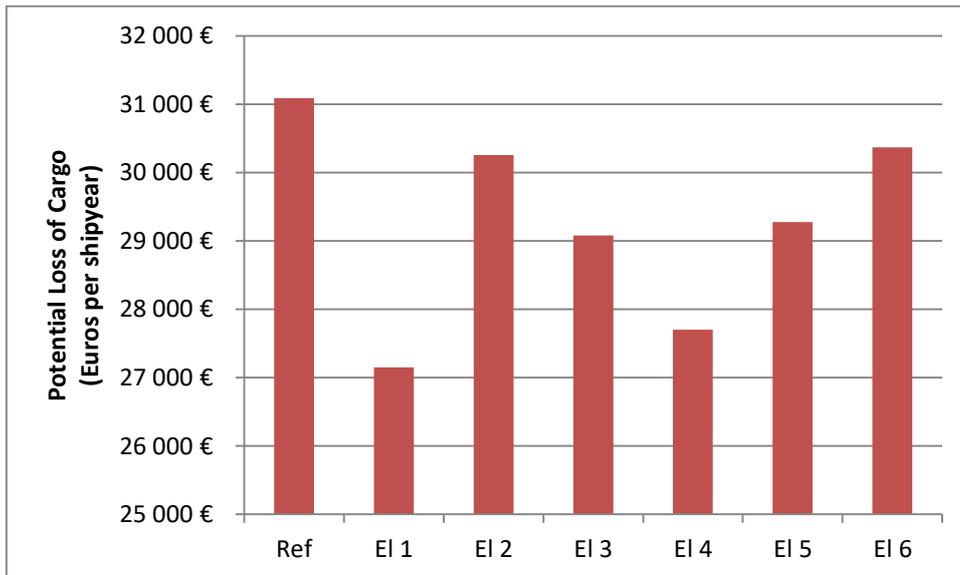
Figure 3.5-2: Potential loss of cargo for the generic vessel and after (individual) implementation of the RCOs (Electrical fires)

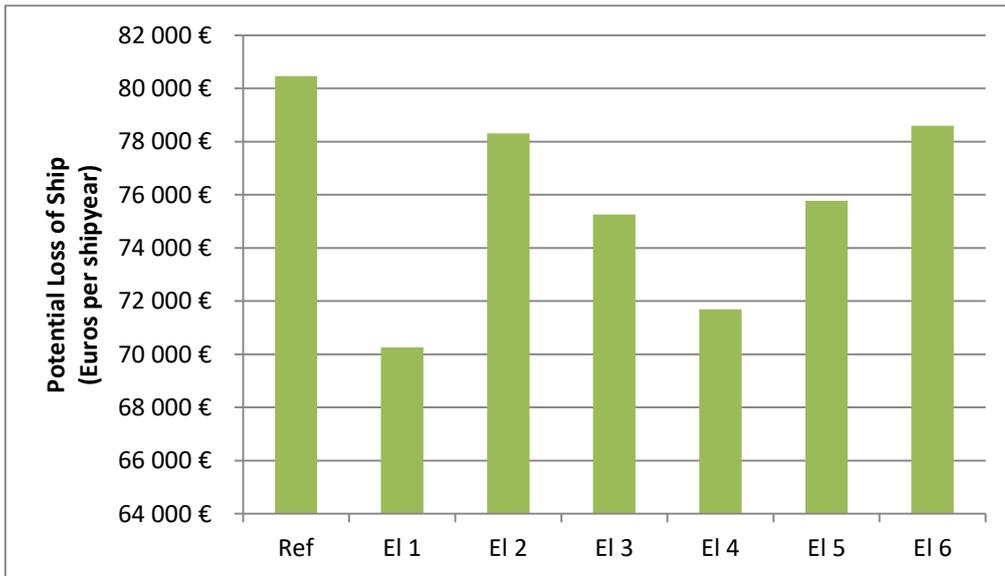
Figure 3.5-3: Potential loss of ship for the generic vessel and after implementation of the (individual) RCOs (Electrical fires)

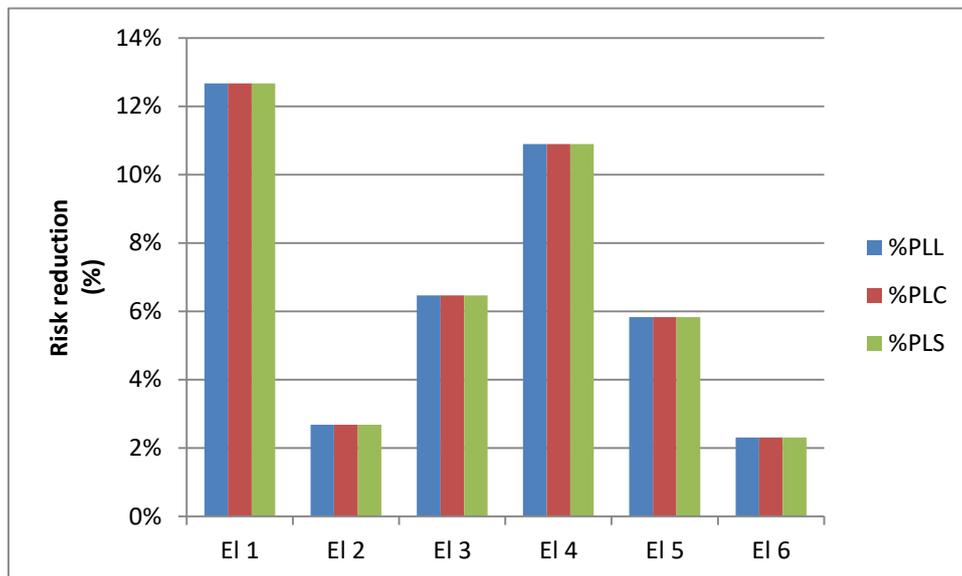
Figure 3.5-4: Risk reduction (Life, Cargo, Ship) in percentage after the (individual) implementation of the RCOs (Electrical fires)

The highest risk reduction is achieved by the RCO *EI1: Robust connection boxes*. This can be explained by the high efficiency of that risk control options (frequency reduction: 53%) on the connected reefer fires, which is the biggest contribution (17.8%) to the total fire ignition risk.

Summary of the risk reduction efficiency is provided in Figure 3.5-4 to allow easier comparison of the efficiency of the RCOs about loss of life, loss of cargo and loss of ship. The percentage of risk reduction is the same for PLL, PLC and PLS, since the RCOs have been applied before the initiating event. Therefore, only the initial accident frequency in the event tree has been impacted (hence impacting the outcome with the same percentage everywhere).

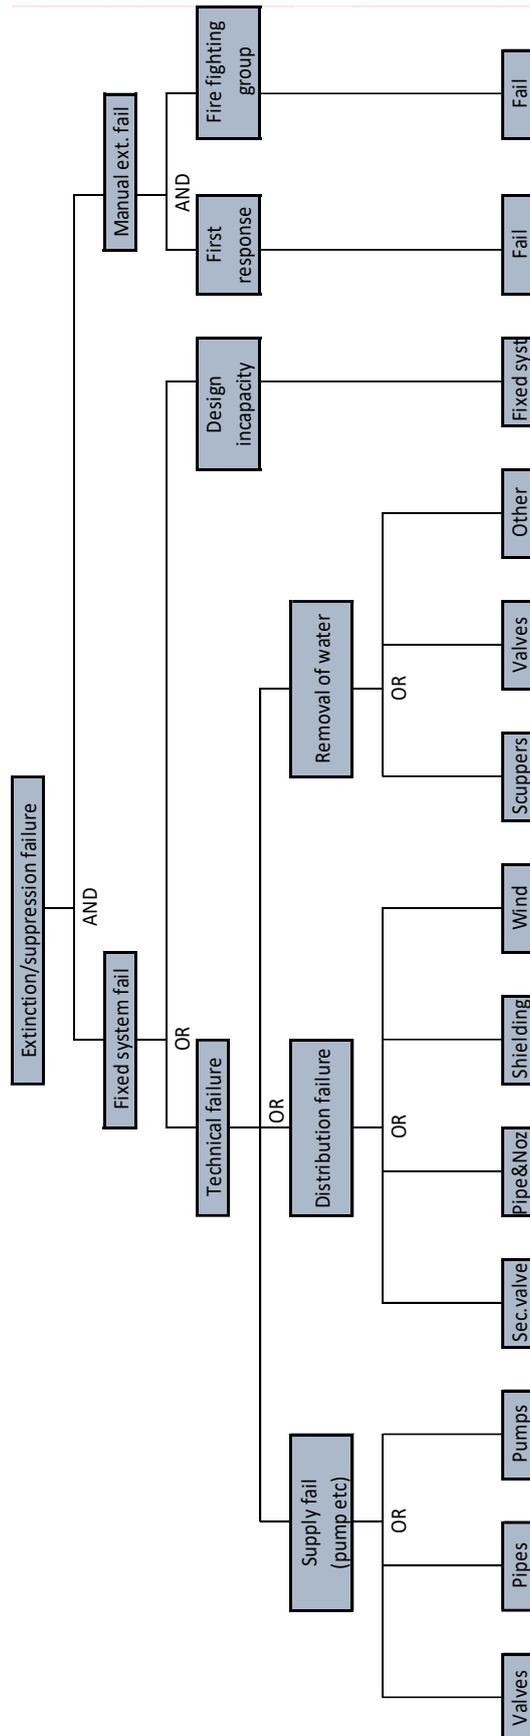
Figure 4.1-1 Fault tree risk model for extinction/suppression of fire on ro-ro deck.

A fault tree was developed to model fire suppression failure, illustrated in Figure 4.1-1. A drencher system was used as starting point for the model since it was requested by EMSA to focus on this type of extinguishing system. Other extinguishing systems may be analysed in a similar way but the current risk model must be adapted to such system. It was conceptually divided in the three main parts which can fail, following the way of the water: *Supply fail*, *Distribution failure*, and *Failure in removal of water*. These parts were together categorized as *Technical failure*³⁹, which implies that there is no discharge from the system, or at least significantly lower discharge than designed. It can also be the case that the system discharges water as designed but that this discharge is insufficient, due to the system being undersized or due to the fire being larger than the design fire. A large pool fire of flammable liquid fuel could for example give rise to such a fire. This fault was referred to as *Design incapacity*, which together with *Technical failure* can cause *Fixed system fail*. Extinguishment or suppression is also possible by manual means, both in a potential *First response* by a runner or adjacent crew member and in an organized ingress by the *Firefighting group*. Manual firefighting was divided in these branches by an AND gate in the risk model, to illustrate that both activities need to fail for manual extinguishment to fail. For *Extinguishment/suppression failure* to occur, both *Manual extinguishment fail* and *Fixed system fail* were considered necessary.

Each of the nodes *Supply fail*, *Distribution failure*, and *Failure in removal of water* was further divided in sub-categories. On the supply side the system was divided in *Valves* (referring to main inlet valves), *Pipes* (including filters), and *Pumps* (including power supply, mechanical parts, redundancy, and human operation). The distribution part was divided in *Sectioning valves* (mechanical parts and human operation), *Pipes & Nozzles* (including clogging), *Shielding* (e.g. obstruction of water spray by truck roof situated right below nozzle), and *Wind*. Removal of water was divided in *Scuppers* (clogging by debris), *Valves* (referring to outlet valves), and *Other* (including potential pumps necessary under waterline as well as effects of heel and list).

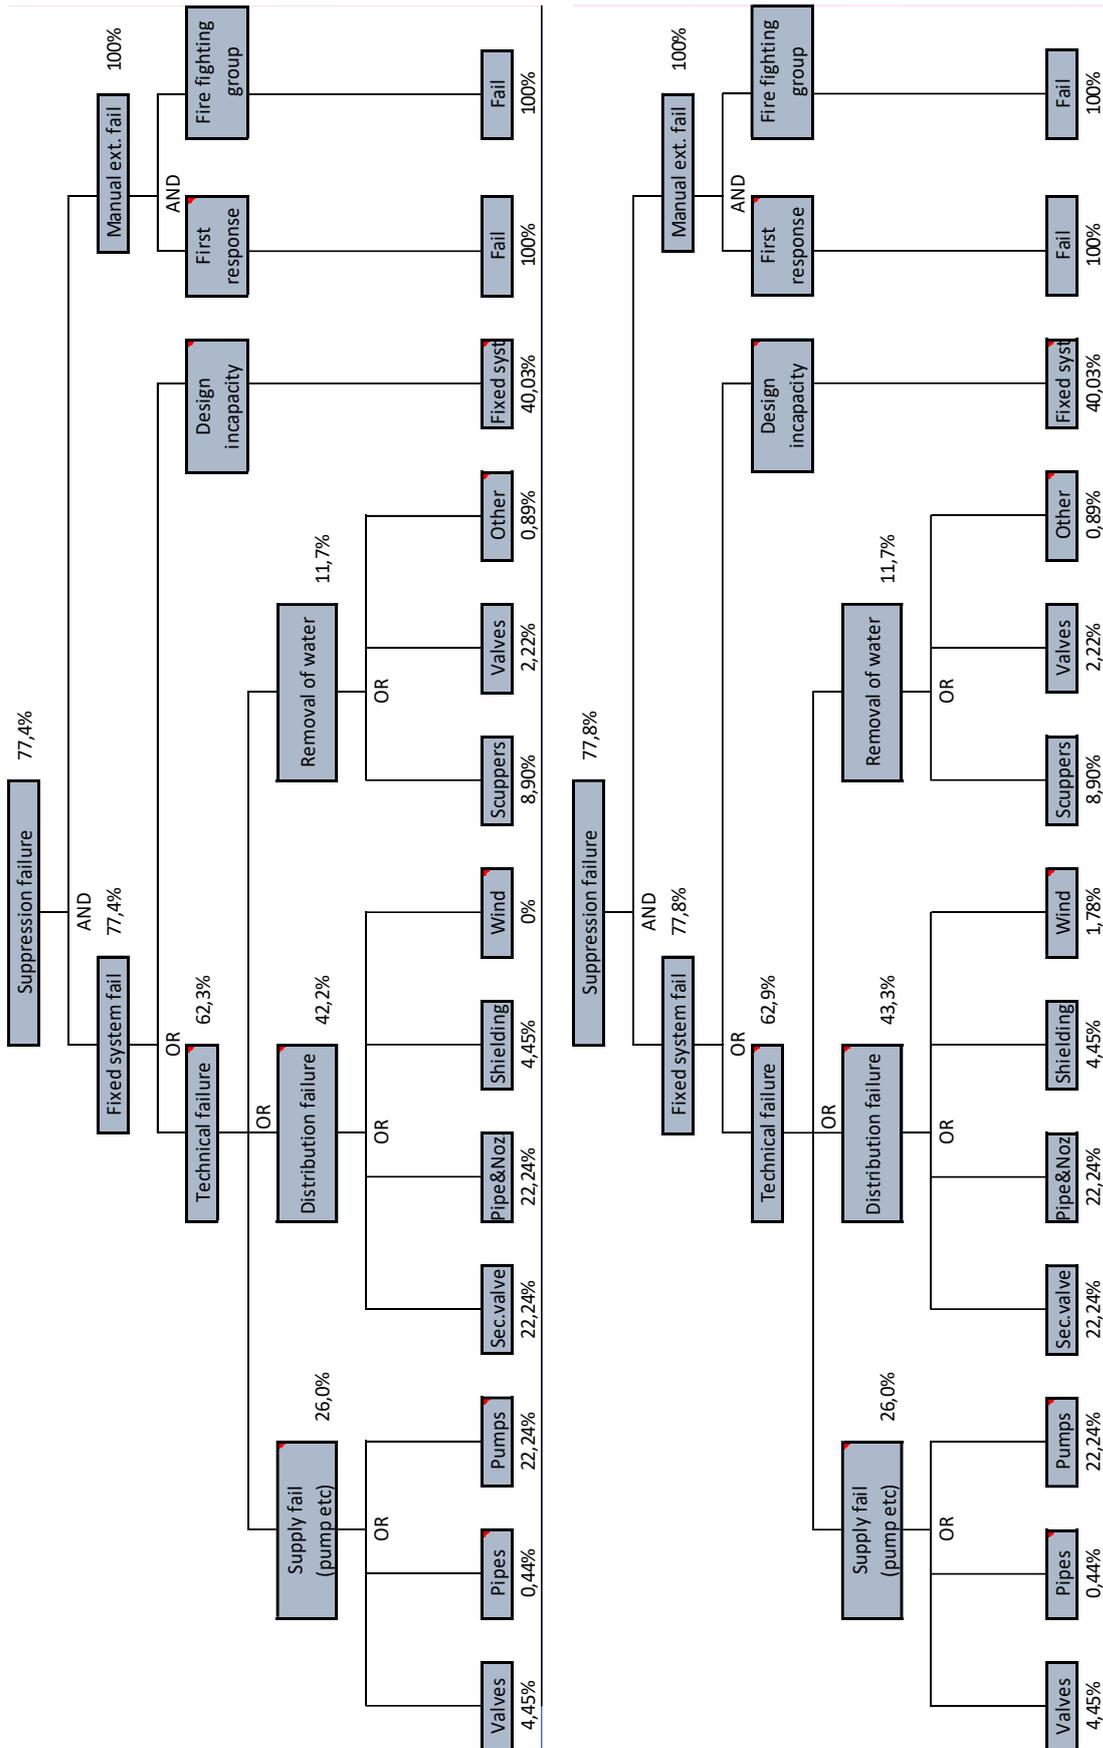
Figure 4.1-3. Fault trees for suppression failure in case of late decision of extinguishment.

The resulting probabilities for the early and late decision, divided on open and closed deck respectively, are presented in Figure 4.1-2 and Figure 4.1-3.

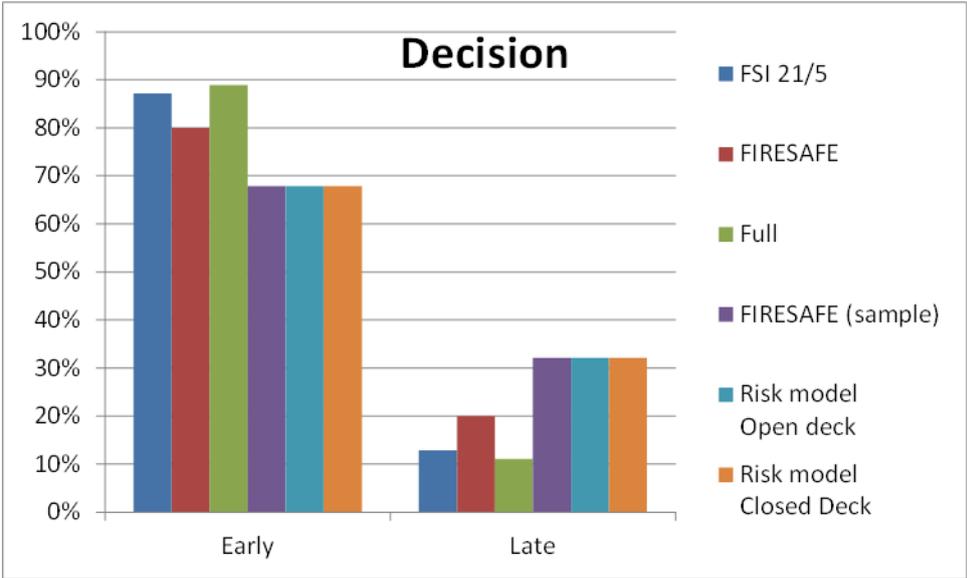
Figure 4.1-4 Comparison of datasets

The comparison is presented in the figures below. Difference in favour of Early Decision, Successful suppression or extinguishment, and containment in the FSI 21/5, All data, and FIRESAFE datasets come from the fact that these datasets include much more Marine incidents and Less Serious Accidents than in the FIRESAFE sample. Nonetheless, some trends can be detected.

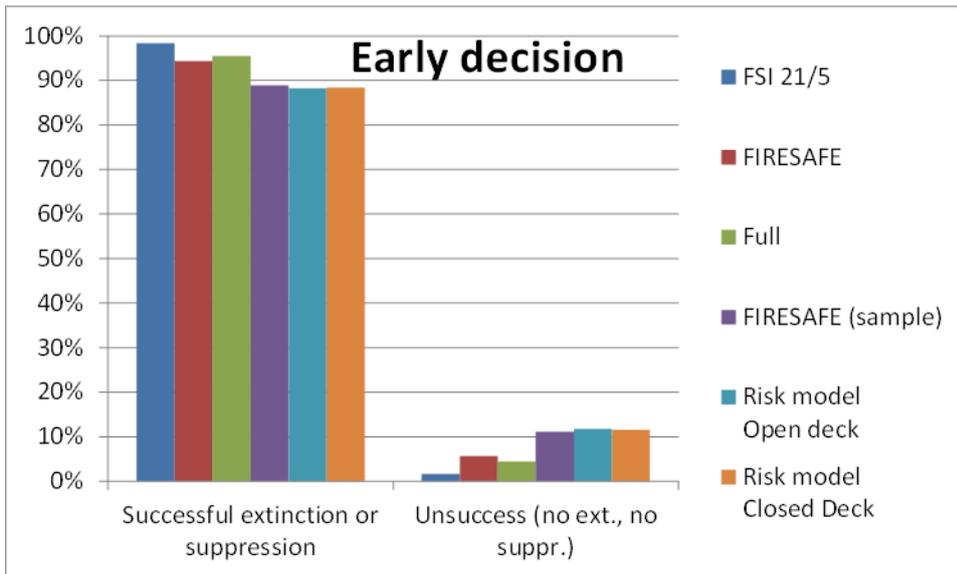
Figure 4.1-5 Comparison of datasets

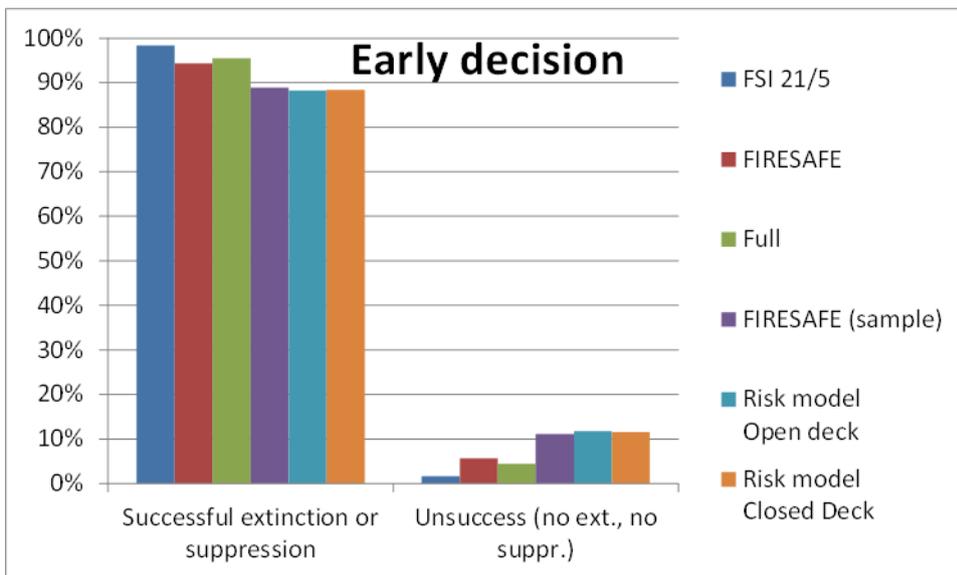
Figure 4.1-6 Comparison of datasets

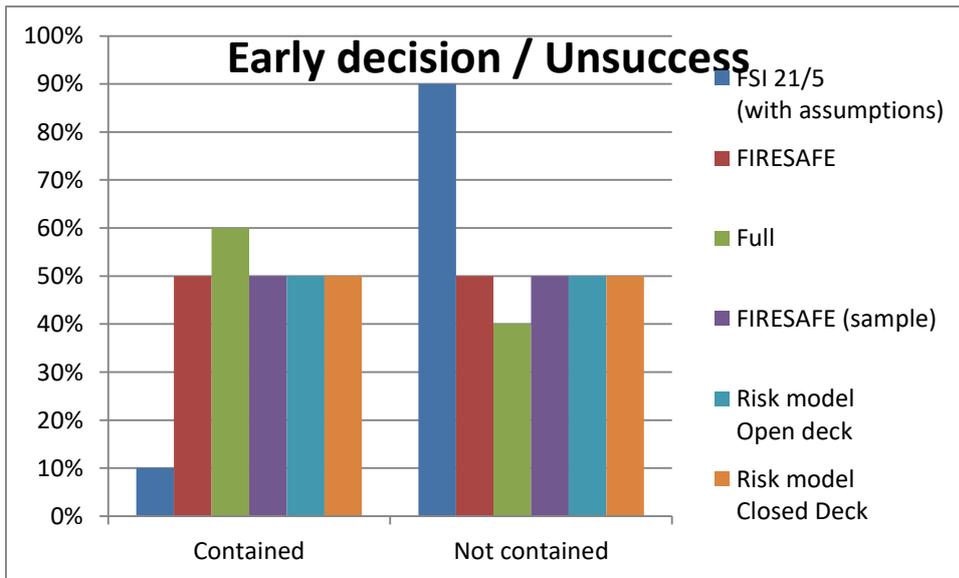
Figure 4.1-7 Comparison of datasets
