EMSA/OP/01/2016

Study investigating cost effective measures for reducing the risk from fires on ro-ro passenger ships (FIRESAFE)

This is a study commissioned by the European Maritime Safety Agency, EMSA. It consists of two parts, investigating risk control options (RCOs) for mitigating the risk from fires on ro-ro decks. The first part considers RCOs in relation to *Electrical Fire as ignition risk* and the second part considers RCOs to mitigate the risk of *Fire Extinguishing Failure (with focus on drencher systems)*. The study considers both newbuildings and existing passenger ships, and has been done per the instructions and limitations in the Tender Specifications (EMSA /OP/01/2016).

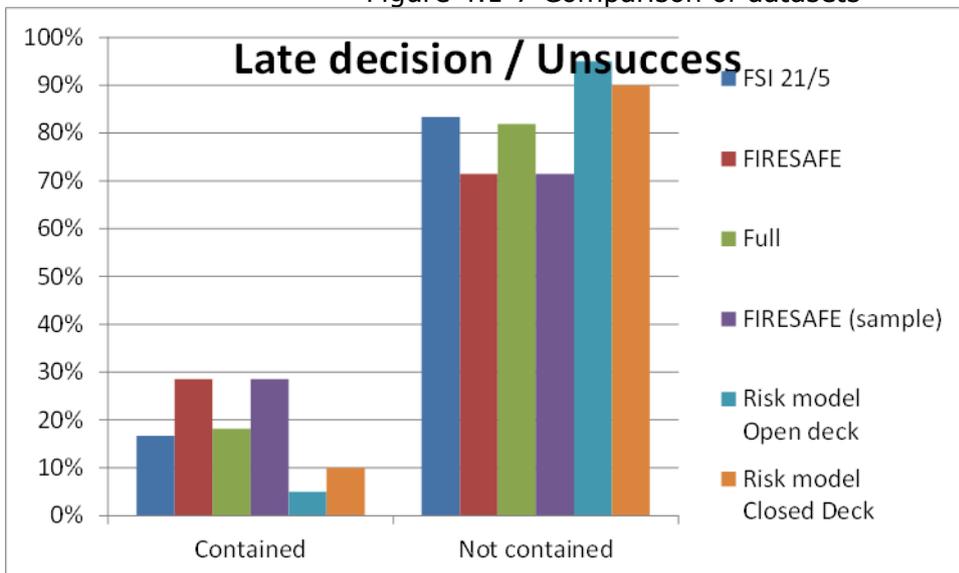
Figure 4.1-8 Comparison of datasets

The comparison is presented in the figures below. Difference in favour of Early Decision, Successful suppression or extinguishment, and containment in the FSI 21/5, All data, and FIRESAFE datasets come from the fact that these datasets include much more Marine incidents and Less Serious Accidents than in the FIRESAFE sample. Nonetheless, some trends can be detected.

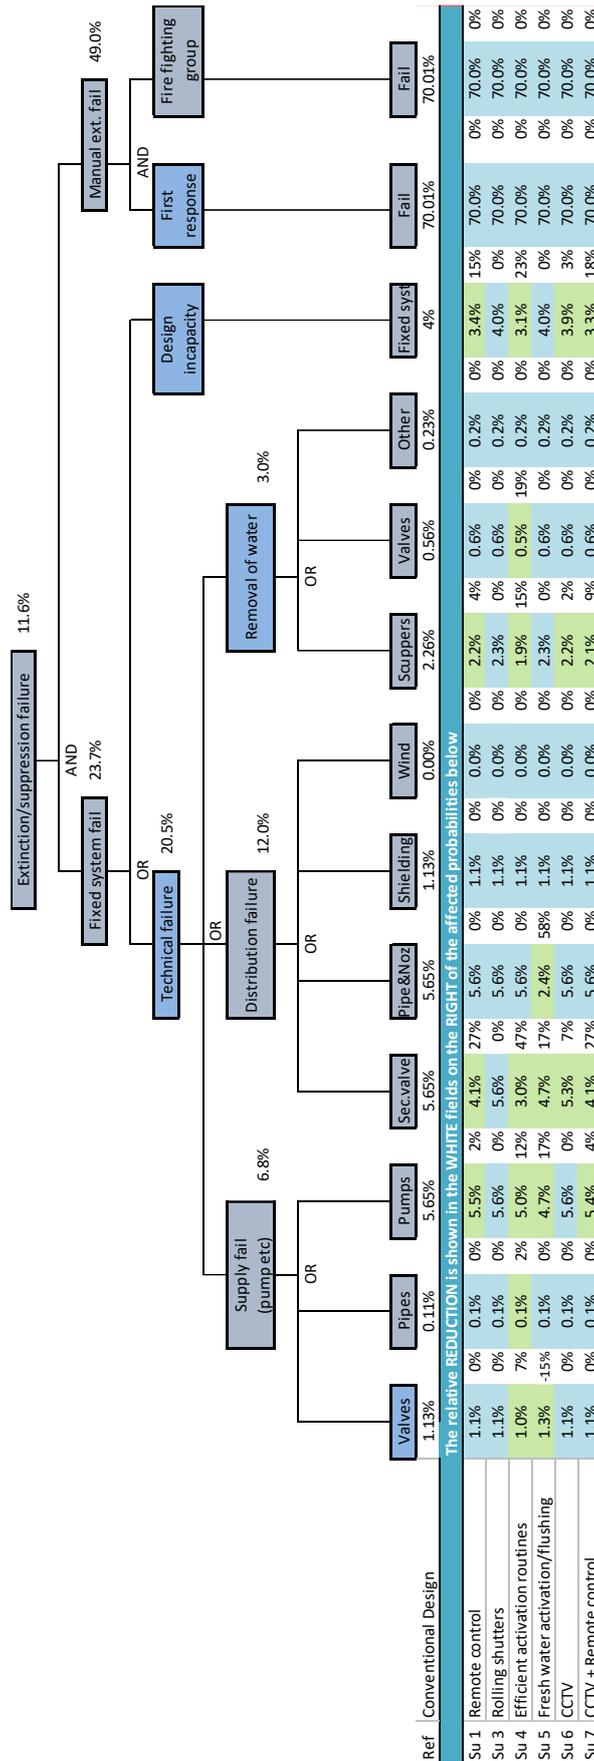
Figure 4.4-2. Model for suppression fail in case of early decision and closed deck, with RCM effects.

The list with the RCOs, affected nodes, important factors to consider, and the average values of the estimations are presented in Figure 4.4-1. The averaged estimated effects of the RCOs were linked to the risk model for suppression failure on ro-ro deck, as illustrated in Figure 4.4-2, Figure 4.4-3, Figure 4.4-4, and Figure 4.4-5. The concluding effects on the probability of extinction/suppression failure are presented in Table 4.4-1.

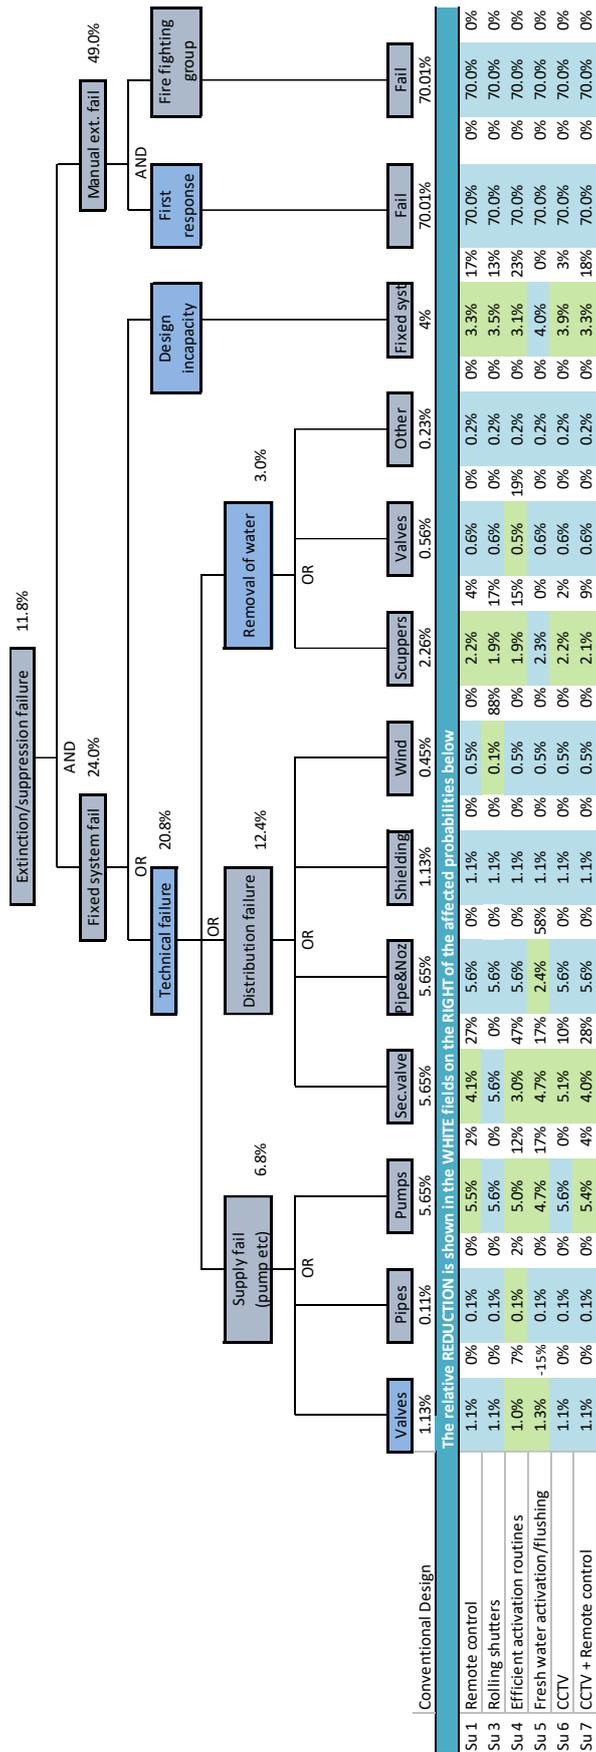
Figure 4.4-3. Model for suppression fail in case of early decision and open deck, with RCM effects.

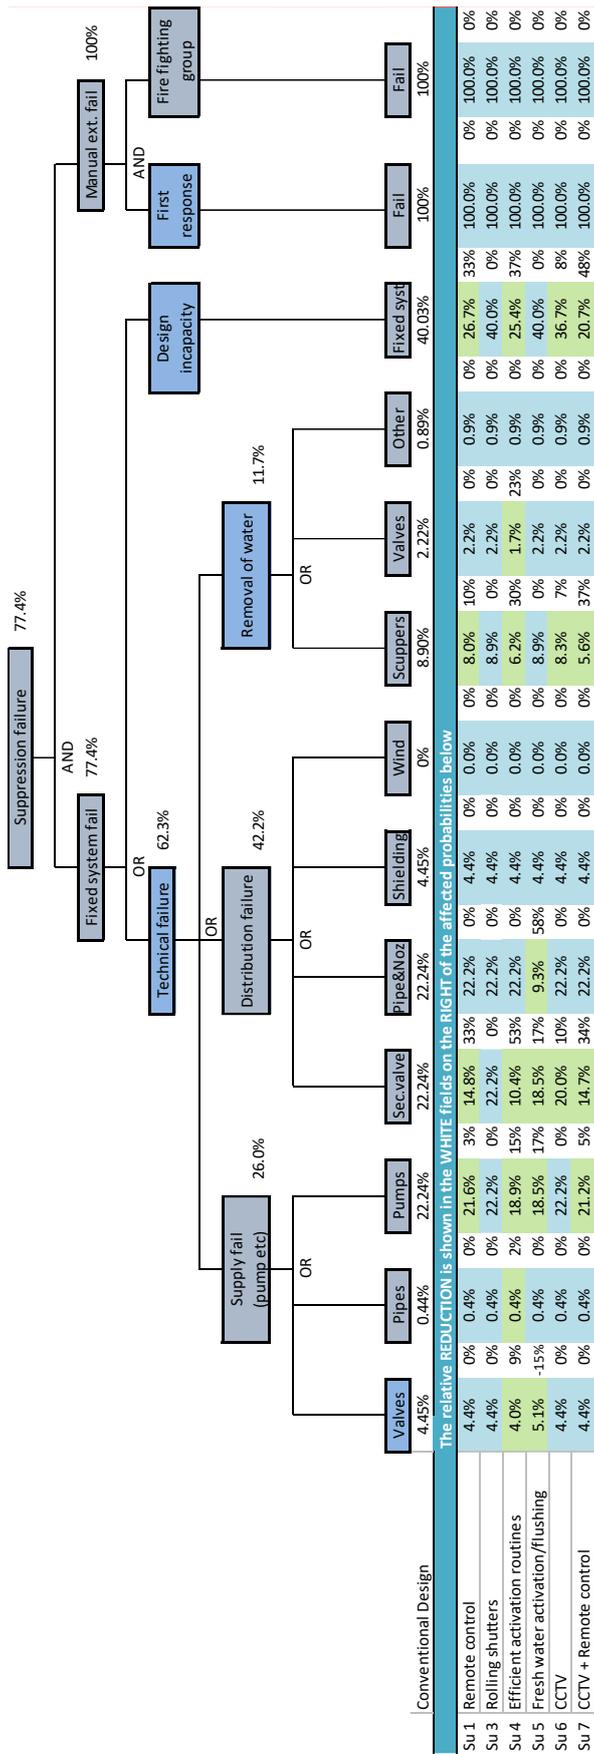
Figure 4.4-4. Model for suppression fail in case of late decision and closed deck, with RCM effects.

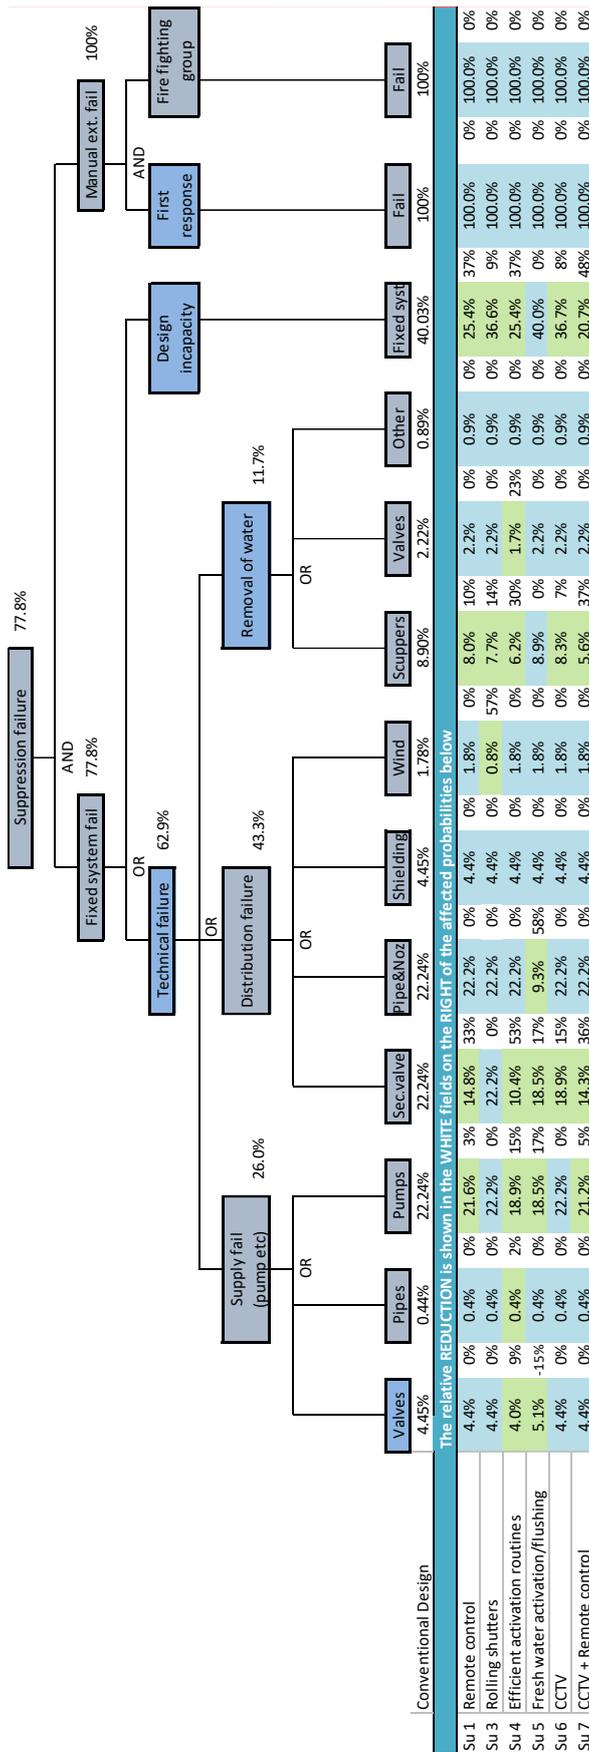
Figure 4.4-5. Model for suppression fail in case of late decision and open deck, with RCM effects.

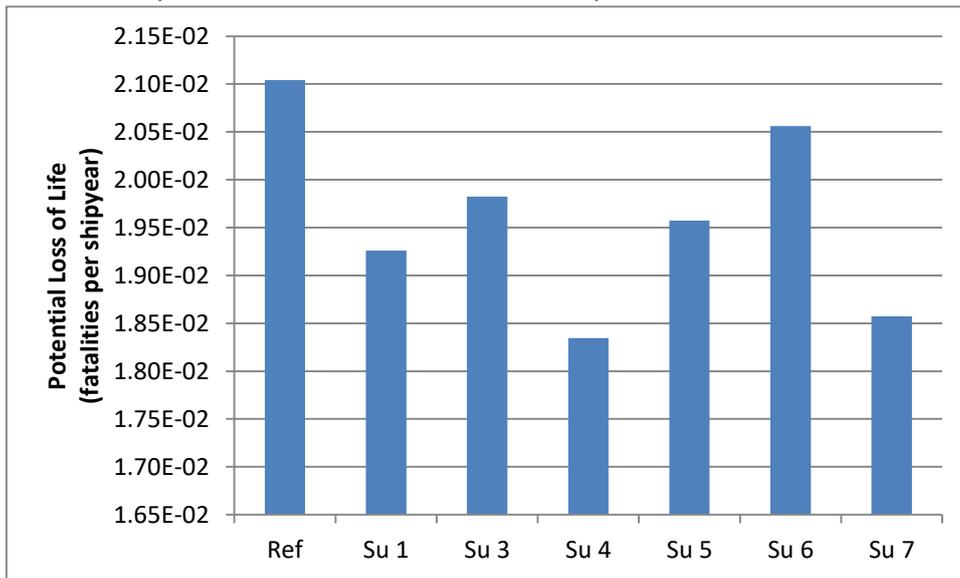
Figure 4.5-1: Potential loss of life for the generic vessel and after (individual) implementation of the RCOs (Fire suppression failure)

Figure 4.5-1, Figure 4.5-2 and Figure 4.5-3 provide the PLL, PLC, and PLS, respectively, for the reference ship without RCOs and after the implementation of the individual RCOs.

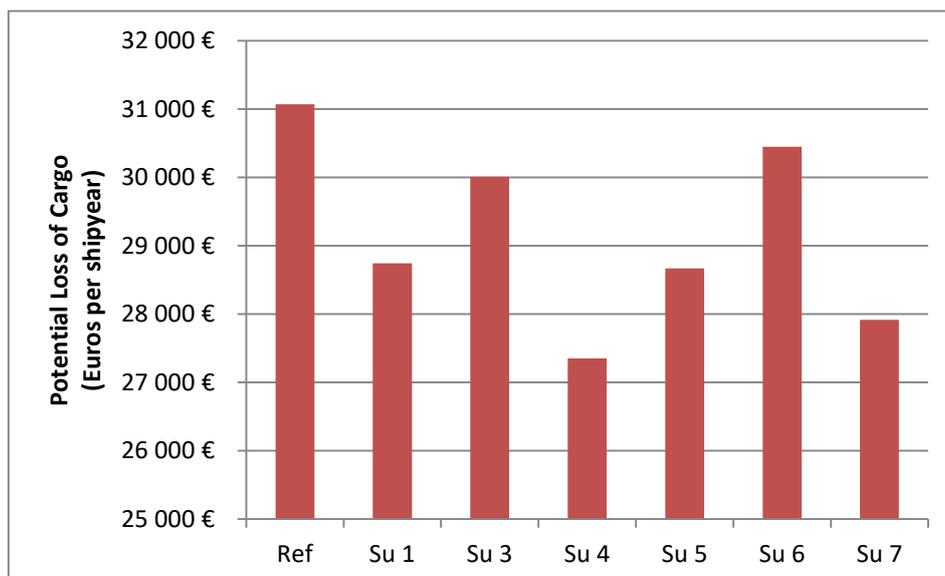
Figure 4.5-2: Potential loss of cargo for the generic vessel and after (individual) implementation of the RCOs (Fire suppression failure)

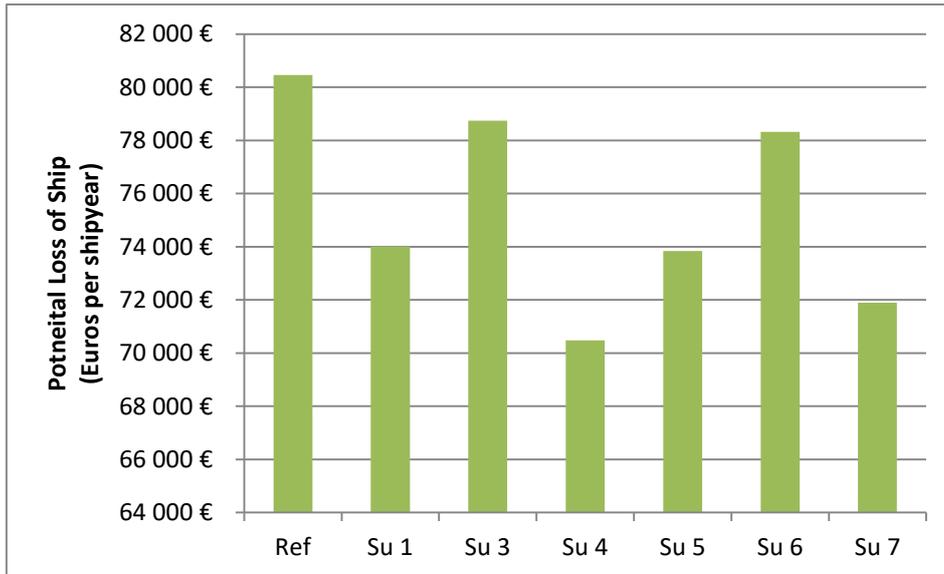
Figure 4.5-3: Potential loss of ship for the generic vessel and after (individual) implementation of the RCOs (Fire suppression failure)

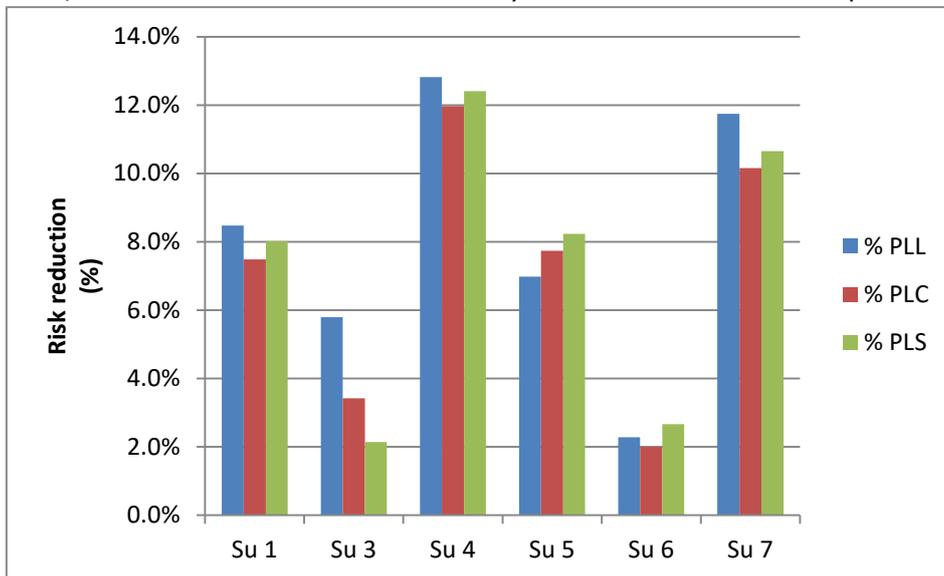
Figure 4.5-4: Risk reduction (Life, Cargo, Ship) in percentage after the (individual) implementation of the RCOs (Fire suppression failure)

The highest life risk reduction is achieved by the Su4: Efficient activation routines.

Summary of the risk reduction efficiency is provided in Figure 4.5-4 to allow easier comparison of the efficiency of the RCOs with regard to loss of life, loss of cargo and loss of ship.

Since the RCOs for Fire suppression do not impact uniformly over the risk model branches and because the ship damage, cargo damage and life consequences are different from one branch to the other, the contribution of the RCO is different with respect to PLL, PLC and PLS. This is reflected by the color bars for one specific RCO.
