International
Chamber of Shipping
Shaping the Future of Shipping

2020 FUEL OIL QUALITY AND SAFETY SURVEY

On 24 February 2020 BIMCO, The International Chamber of Shipping (ICS), INTERCARGO and INTERTANKO launched The Fuel Oil Quality and Safety Survey with the aim to get a greater understanding of the quality of the new fuel oils and possible safety implications of the IMO 2020 sulphur regulation.

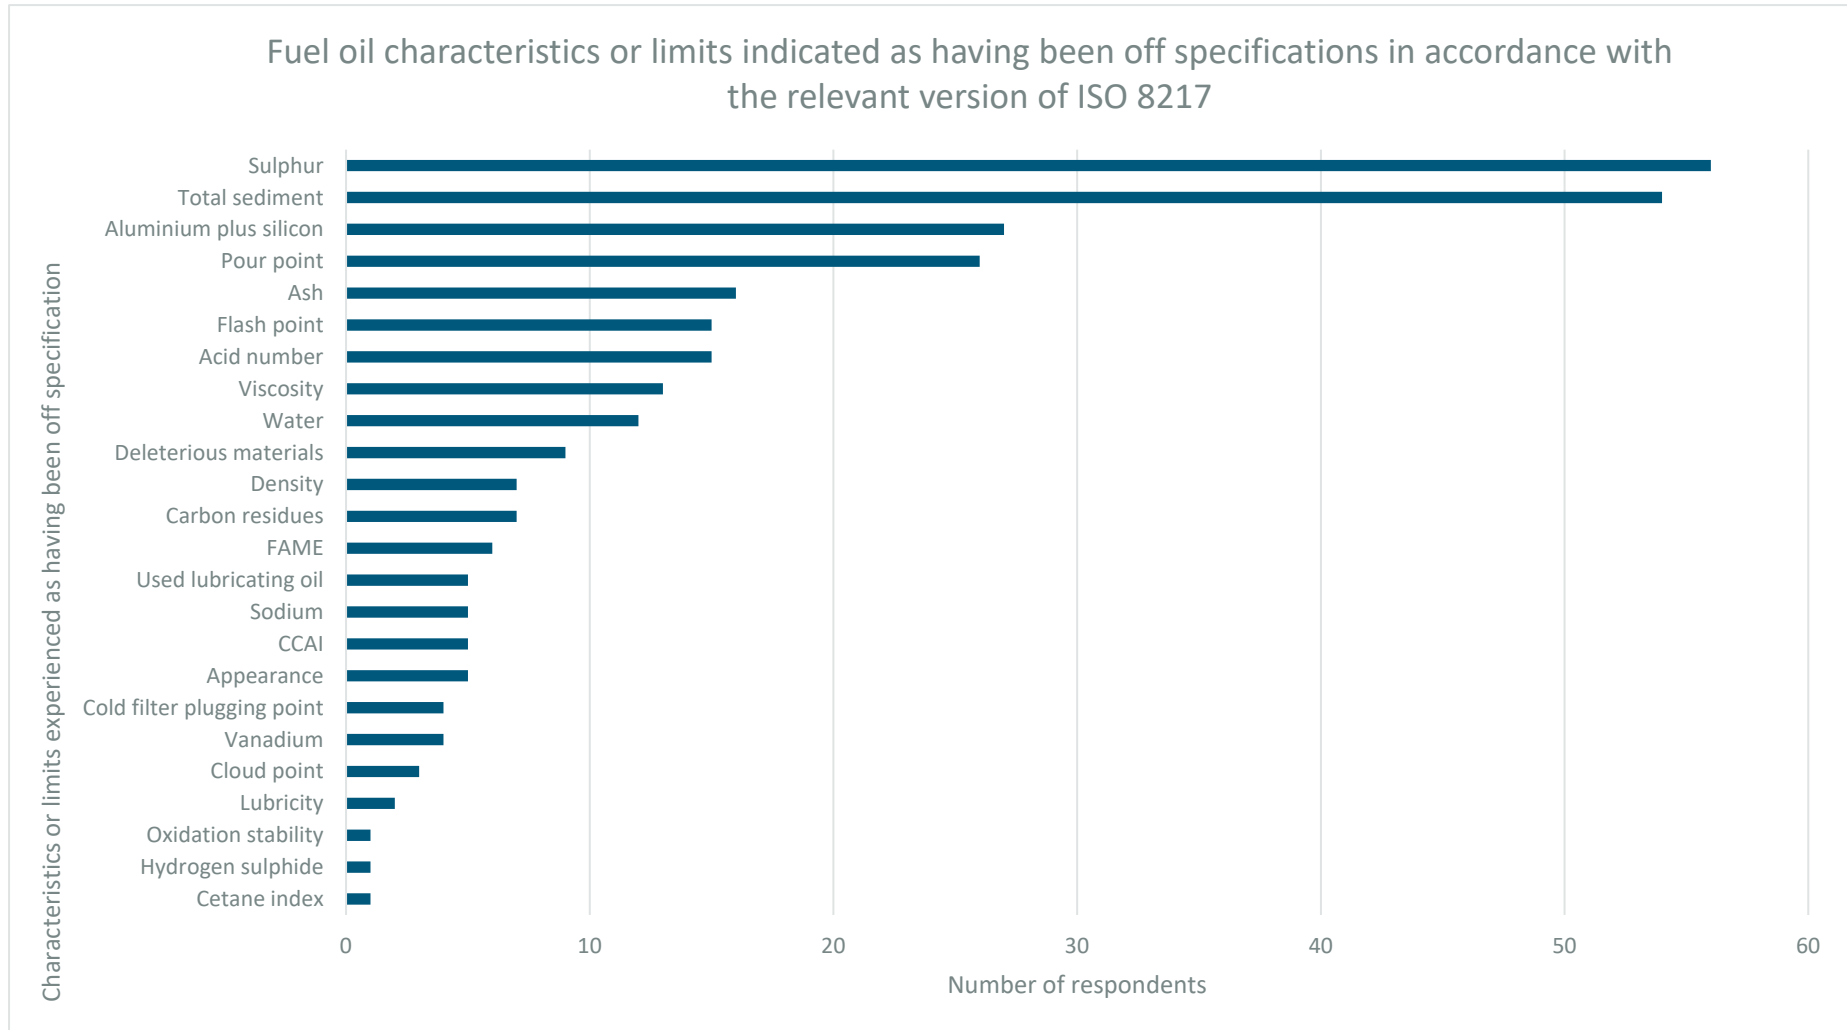
Annex C – (Q2-2) Fuel oil characteristics or limits indicated as having been off specifications in accordance with the relevant version of ISO 8217

The eight most selected characteristics or limits in accordance with ISO 8217 as experienced being off specifications (off-spec):
