## Bulker focus

Carriage of grains and soya beans

2023

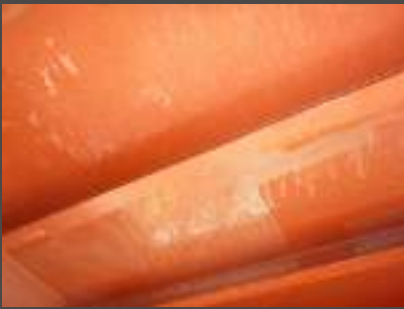
*Image (i) - Ship's sweat*  
(Courtesy CWA)

Ship's sweat can be defined as the consequences from a change in temperature leading to condensation forming on the interior steelwork, which often drips down onto the cargo surface. The condensation forms when the warm humid air in the headspace comes into contact with the relatively cooler steelwork, such as the hatch covers, and then drips back onto the cargo and runs down the sides of the holds, creating a characteristic pattern of damage: the drip lines.

The increase in moisture content of the cargo directly wetted by water dripping creates an environment favourable for mould growth. Mould is alive and its metabolism releases heat into the environment as it grows which in turn creates a favourable environment for self-heating of the cargo. The mould growth exacerbates the rate at which warm moist air is released into the headspace creating a condensation positive feedback loop.

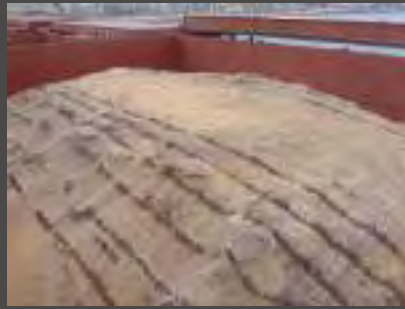
*Image (ii) - Ship's sweat*  
(Courtesy CWA)

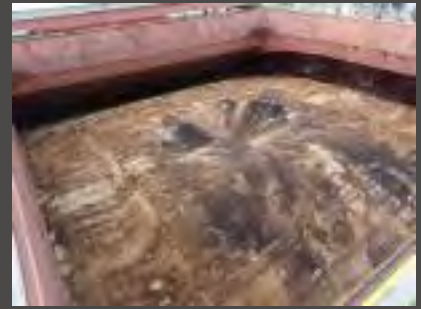
*Image (iii) - Ship's sweat and cargo self-heating*  
(Courtesy CWA)

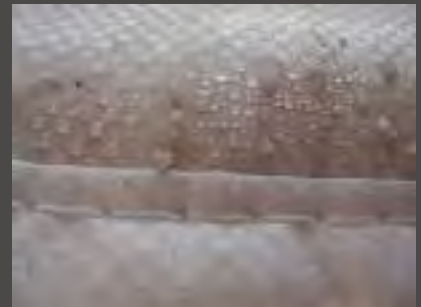
*Image (iv) - Cargo sweat*  
(Courtesy CWA)

Cargo sweat occurs under the same principle as ship's sweat: a change in temperature leads to formation of condensation when warm and humid air encounters a colder surface. In this case however, the cooler surface is not the steelwork but the upper layer of the cargo itself. This will occur if a cargo loaded in a cold climate is exposed to warmer air, either due to the hatch covers being opened or incorrect ventilation of the holds. The water vapour present in the introduced ambient air condenses on the cargo surface, which then leads to mould growth and localised heating in the same manner as ship's sweat.

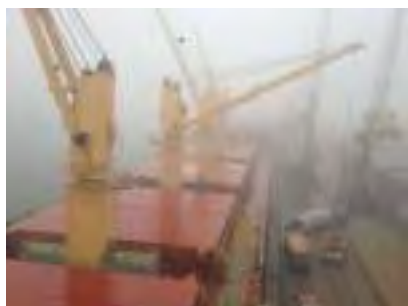
*Image (v) - Loading in poor weather*

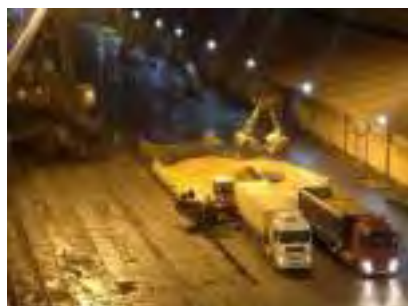
*Image (vi) - Loading in poor weather*
